AVIATION OCCURRENCE REPORT

05-002

Cessna 172, ZK-LLB, collision with terrain while low flying,
7 km south of Gibbston

29 January 2005

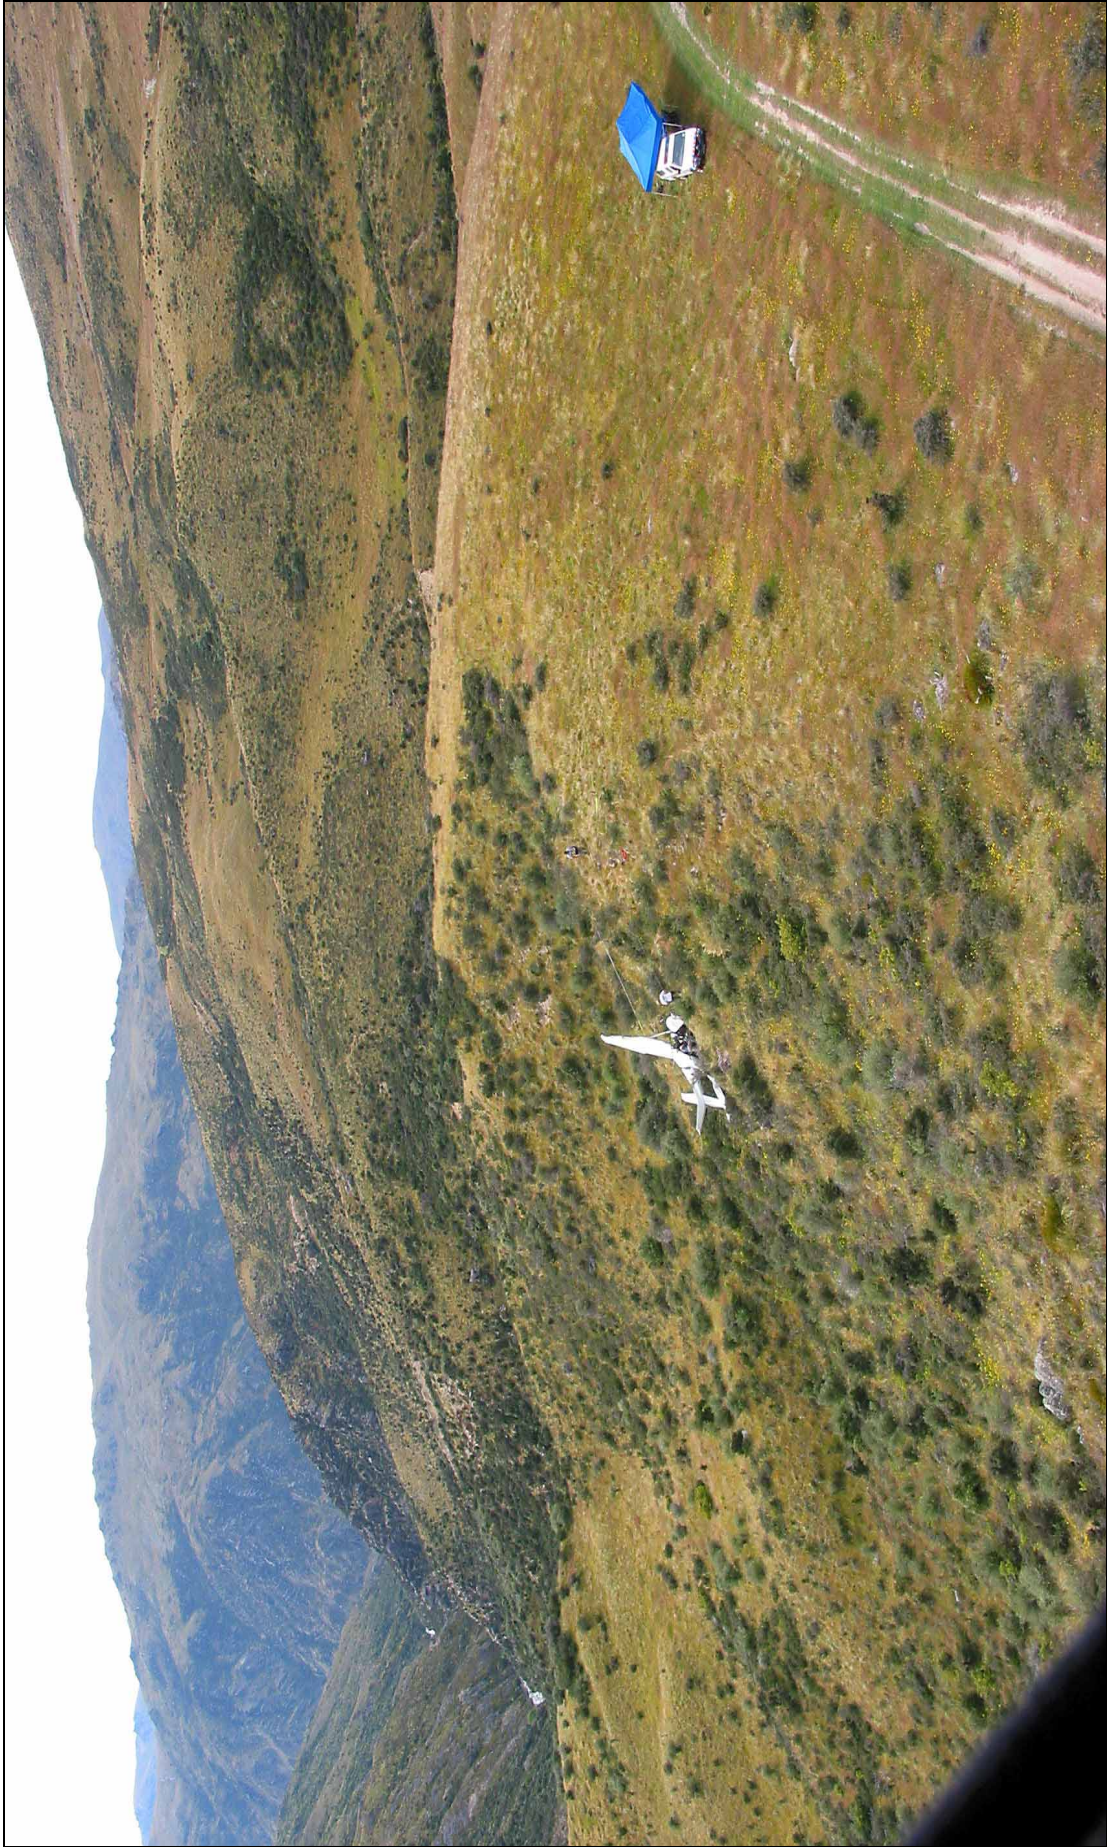
ZK-LLB accident site looking southeast

- 1.12.1 ZK-LLB was lying on its right side on the southern side of Doolans Creek Valley, facing uphill on a southerly heading, at an altitude of 2580 feet. The matagouri and tussock-covered valley sloped locally down at about 35° to Doolans Creek about 400 feet below. Some 20 feet above the aircraft the valley side flattened to a small terrace about 150 m wide, which carried a farm track around the hillside.

- 1.12.2 The first impact mark on the valley side was from the right wing tip, 7 m northwest of the aircraft. The final position of the aircraft was consistent with it having cartwheeled and rolled to the right about this wing tip to collide nose-first with the valley side. An impact mark containing the red lens from the left navigation light indicated that the left wing had collided with the valley side with the aircraft banked some 50° to the right. While the right wing tip mark did not directly indicate the flight path or attitude of the aircraft, its position in relation to the shape of the valley inferred that the aircraft was in a left turn, and probably nearly parallel to the valley when the right wing struck the terrain. The main undercarriage had not struck the valley side during the initial collision with the right wing tip, indicating that the angle of bank in the left turn was less than about 25°.

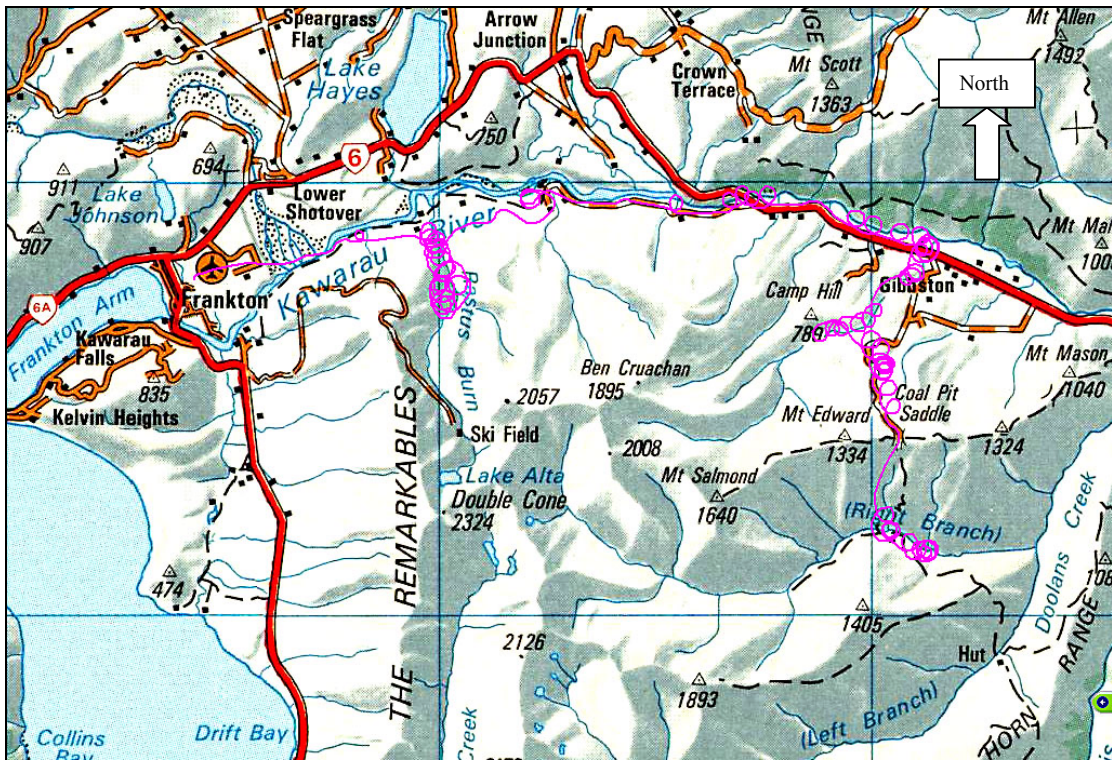
Figure 1
GPS track of the flight

1.11.3 The recovered GPS data confirmed the reported flight path. After take-off the aircraft flew 18 left-hand circles over Rastus Burn until 1109, at GPS altitudes between 1700 and 3400 feet. The ground speed while circling averaged about 60 knots. It then flew east along the Kawerau River, with occasional circles, maintaining about 1800 feet, to arrive near Gibbston at 1123. After 7 circles near Gibbston it flew southwest in a series of left-hand circles, climbing up Coal Pit Road to cross Coal Pit Saddle at 3800 feet, at 1142. The aircraft descended to the south from the saddle into Doolans Creek, a confined valley running east between local peaks some 4500 feet high. At 1143, 8 more left-hand circles were flown, descending to the southeast along Doolans Creek from 3700 to 2700 feet at 1149. The last 4 circles of this series were essentially over the same area of the valley. The last GPS position was at 1149, at 2617 feet, and was close to the accident site.

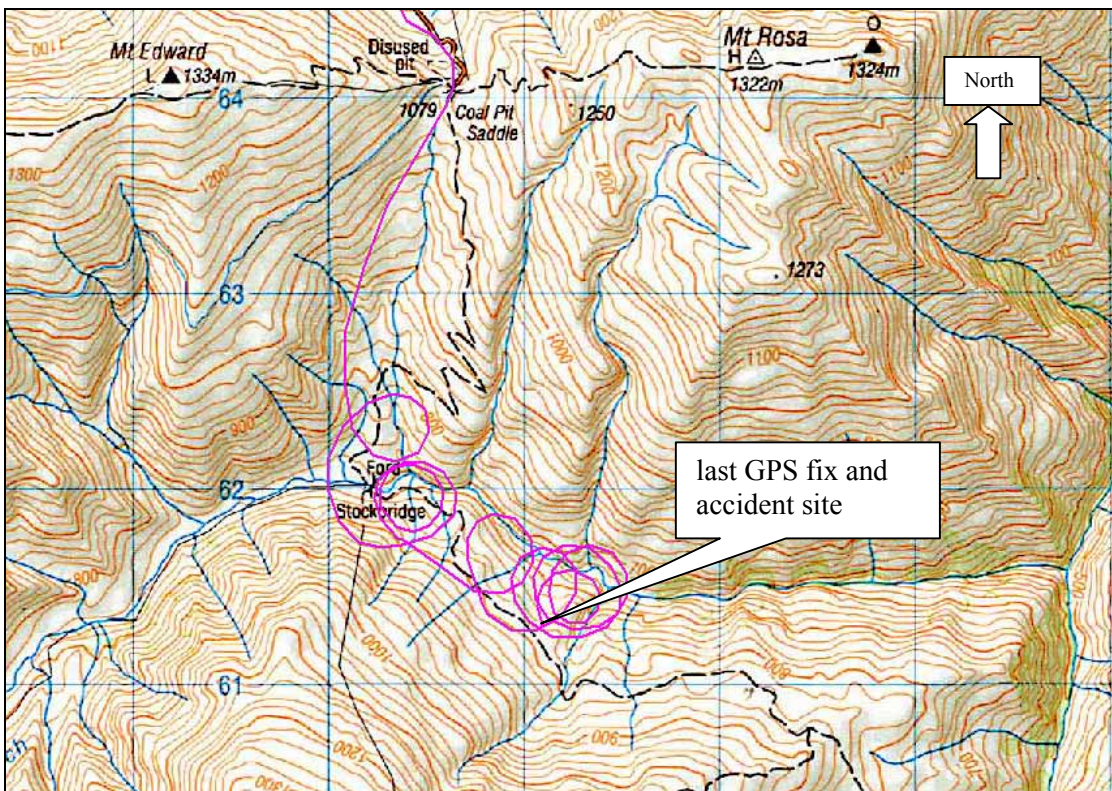
Figure 2
GPS track of the last part of the flight in Doolans Creek Valley

- 2.2 The GPS track plot showed that the aircraft was being flown in a series of 4 circles over approximately the same area when the collision occurred. The GPS data table showed that the series of circles was initially level, then slowly decreasing in altitude, from 3000 to 2800 feet over about 90 seconds. Then, over about 18 seconds, the altitude decreased by about 190 feet, during the last half-turn, to the final GPS fix at 2617 feet. This last circle was tighter than the previous ones, taking 36 seconds, compared with about 48 seconds. Most circles during the flight took 40 to 50 seconds.

- 2.3 A circle at 60 knots in 48 seconds would require about 20° of bank, while a circle in 36 seconds would require about 30° of bank. While either turn would be regarded as a gentle to moderate manoeuvre, and well within normal operational parameters, a turn with 30° of bank at 60 knots would require a deliberate increase of engine power to maintain both altitude and airspeed. The theoretical increase in induced drag while turning, compared with straight flight at the same slow speed, is 13% at 20° bank, and 33% at 30° bank. From a pilot's perspective an increase in engine speed of about 100 to 200 RPM would be required and should be applied by increasing the throttle as the bank was increased. The pilot was experienced in low-level low-speed circling, and would be expected to coordinate power changes with manoeuvres as a matter of course.

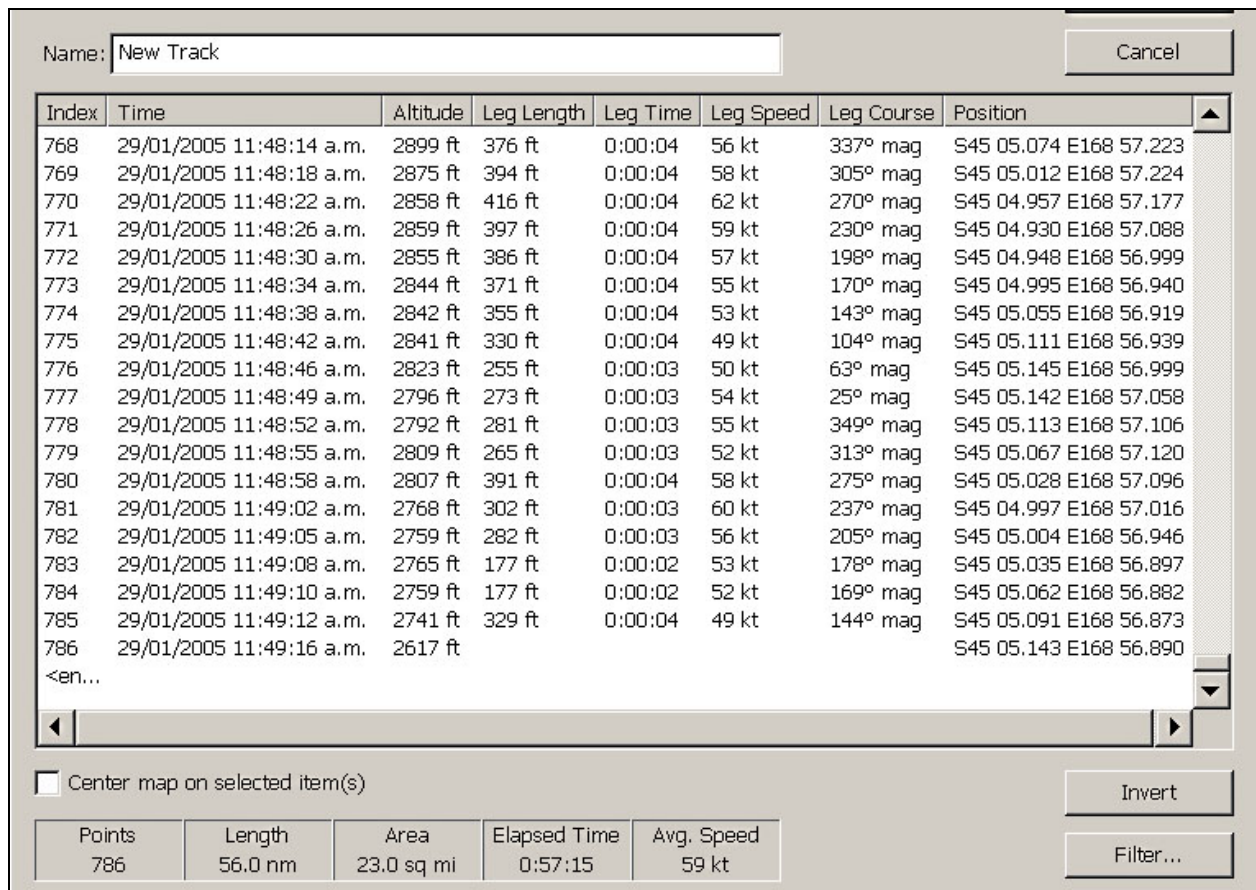
Figure 3
GPS data table

- 2.6 A random downdraught associated with thermal activity could have led the aircraft to descend more rapidly during the last half-turn. The rate of descent, 190 feet in 18 seconds, or about 600 feet per minute, was similar to updraught strengths reported nearby by paraglider pilots that day. Such thermal turbulence should have been within the experience of the pilot, and any such downdraught should have been countered by his promptly increasing engine power, up to full power if needed. However there is no evidence of a downdraught, and this remains a hypothesis only.
