Report 00-008

Aerostar S81A hot air balloon ZK-SKY

power line incident

6 July 2000

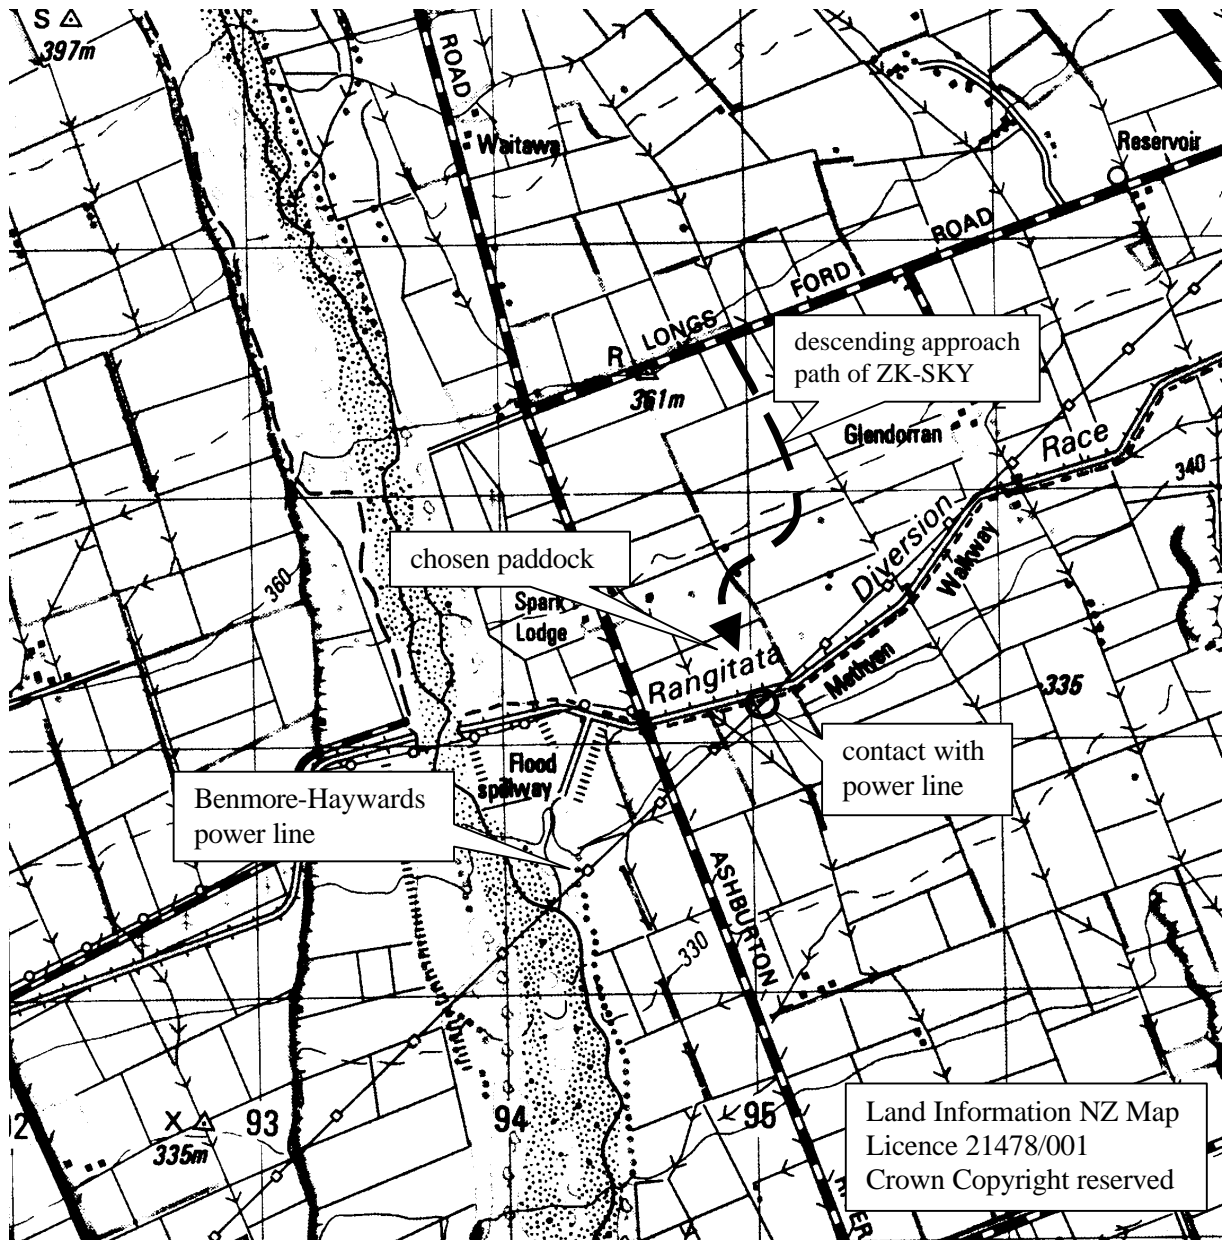
- 1.6 As the balloon crossed the upwind boundary of the chosen paddock its descent was checked at about 30 feet above ground level, and it continued in level flight to track slowly along the paddock. As it approached half-way along the paddock, still not descending, the pilot-in-command instructed the handling pilot to go around. This decision was made because he wanted to avoid a firm landing which might have resulted from venting the balloon at that height to achieve a landing in the paddock.

- 1.7 The handling pilot promptly operated all 3 burners for sufficiently long to start the balloon climbing at a reported rate of 350 feet per minute. He observed that they had climbed above the top earth wire of the major power line ahead, which ran across their track just beyond the end of the paddock, and was able to select and point out another paddock ahead for their landing.

- 1.8 At about this time the balloon started to descend again. The handling pilot again operated all 3 burners, but failed to restore the climb in time for the balloon to avoid the earth wire of the power line.

- 1.9 The balloon contacted the earth wire with the bottom of its envelope, above the basket suspension cables. The balloon stopped, held against the wire by the light wind. Continued heating with the burners was not effective in lifting the balloon clear, and the pilot-in-command decided that they should shut off the fuel tanks and vent the balloon to descend between the power line conductors underneath them. Both pilots did these tasks, and the balloon landed upright under the power line, about one metre from the edge of the Rangitata Diversion Race canal which crossed at that point. The envelope squeezed between the conductors as it deflated, to fall clear without suffering or causing any damage.

Figure 1
Descending approach path of hot-air balloon ZK-SKY
