Report 00-105

Lyttelton shunting service

derailment

27 April 2000

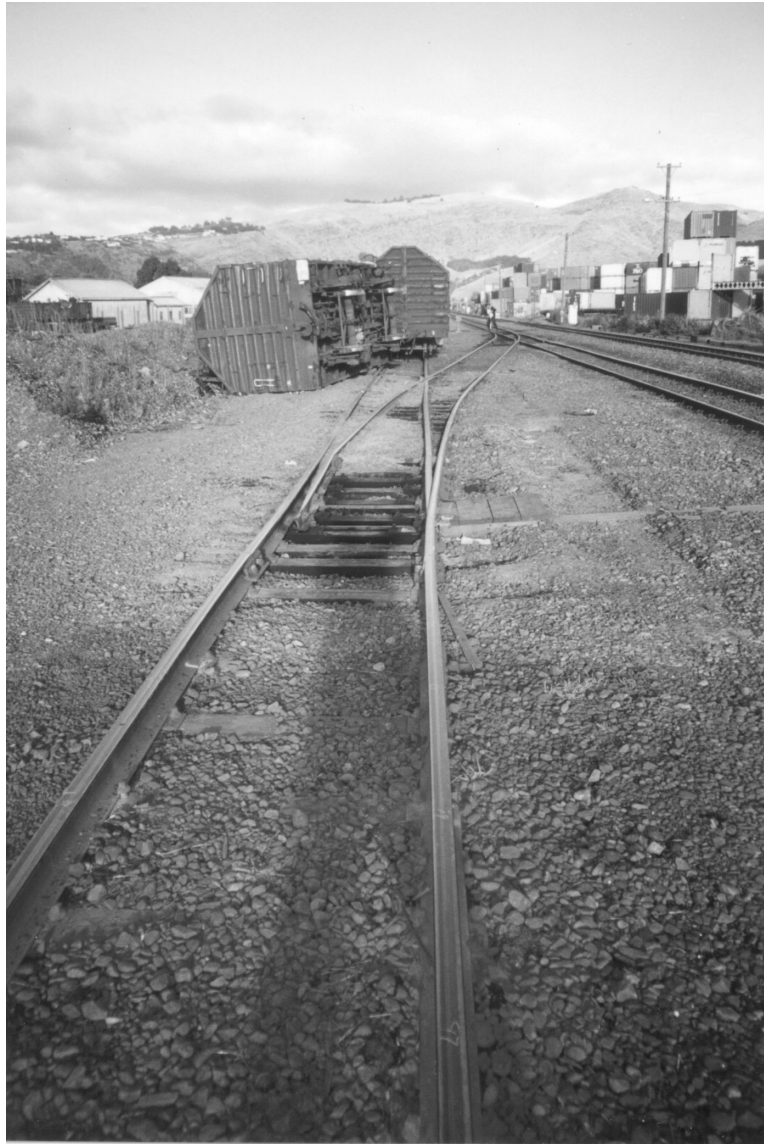
Figure 2
A view of the derailment site from the POD

- 1.1.5 The remote-control operator moved the shunt off with the throttle in notch one and estimated the shunt speed as “walking pace” as he negotiated TO 12 and TO 11. He did not feel or hear anything unusual. He turned to check his rake as he passed a gravel pile some 22 m past TO 11 points and saw the trailing wagon leaning over and about “1 m to 1.5 m above ground level”. He immediately applied the brakes and the shunt came to a stop with the rear of the locomotive (the remote-control operator’s position) 35 m from the point of derailment (POD) and the trailing wagon overturned. He did not recall seeing the rail operator when he made this check, but in his interview recalled seeing the high visibility markings which were part of the shunt jacket worn by the rail operator. Figure 2 is a view of the derailment site from the POD.

1.2.7 The fifteen sleepers between TO 12 and TO 11 were covered in ballast to sleeper top (refer Figure 2) and their conditions could not be assessed visually. The track was dug out and the sleepers and their fastening condition prior to and at the POD were assessed as follows:

- 2.3.1 Track in yards is surfaced to rail foot level to provide footing for shunting staff. Woolston was a standard yard in this respect (Figure 2).
- 2.3.2 This surfacing hid sleepers and rail fastenings and prevented visual identification of poor materials. This had always been a hurdle to be overcome when inspecting yards to ensure standards were maintained.

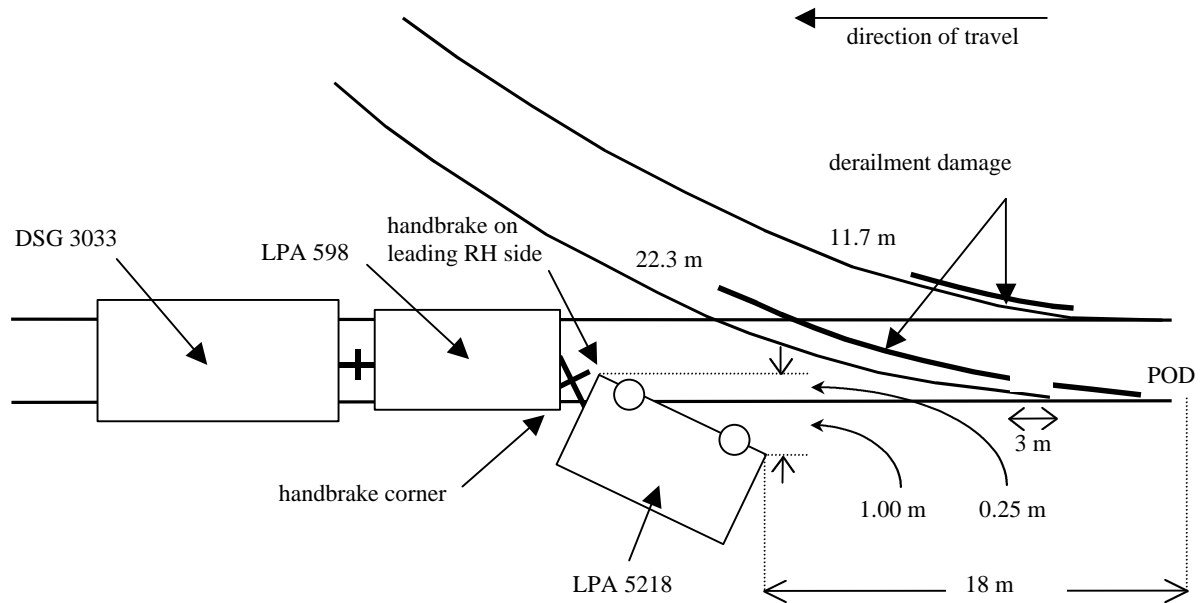
Figure 3
Position of the shunt following derailment
 (not to scale)

- The leading axle of wagon LPA 5218 came to rest 23.5 m from the POD.
- 1.2.2 There was heavy damage to the left-hand open switch on TO 11, and to the right-hand points boxing adjacent to TO 11.

- 1.2.3 Figure 3 shows the relationship of track damage to the final position of the shunt.

- 1.2.5 The position of the hand brake on LPA wagons is shown on Figure 3. Each hand brake corner was equipped with a handrail. The diagonally opposite corner to the hand brake was equipped with a footstep and hoop handrail. The other 2 corners of each wagon had a hoop footstep and variable height handrails.

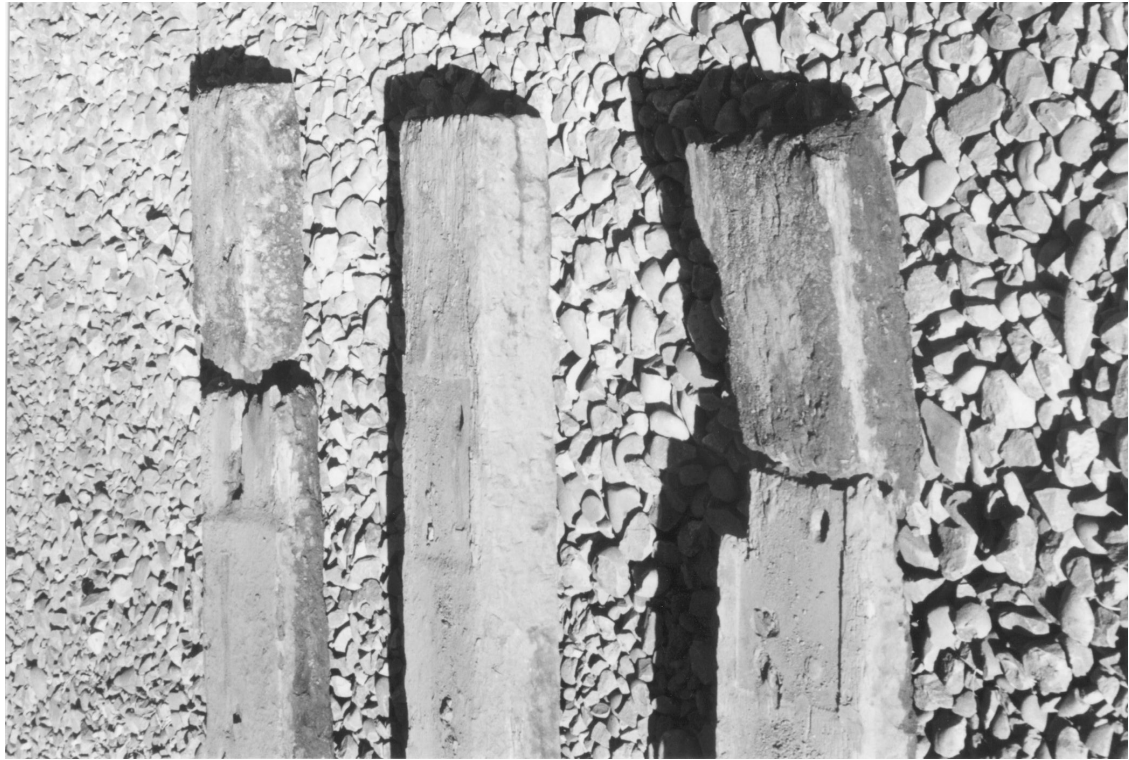
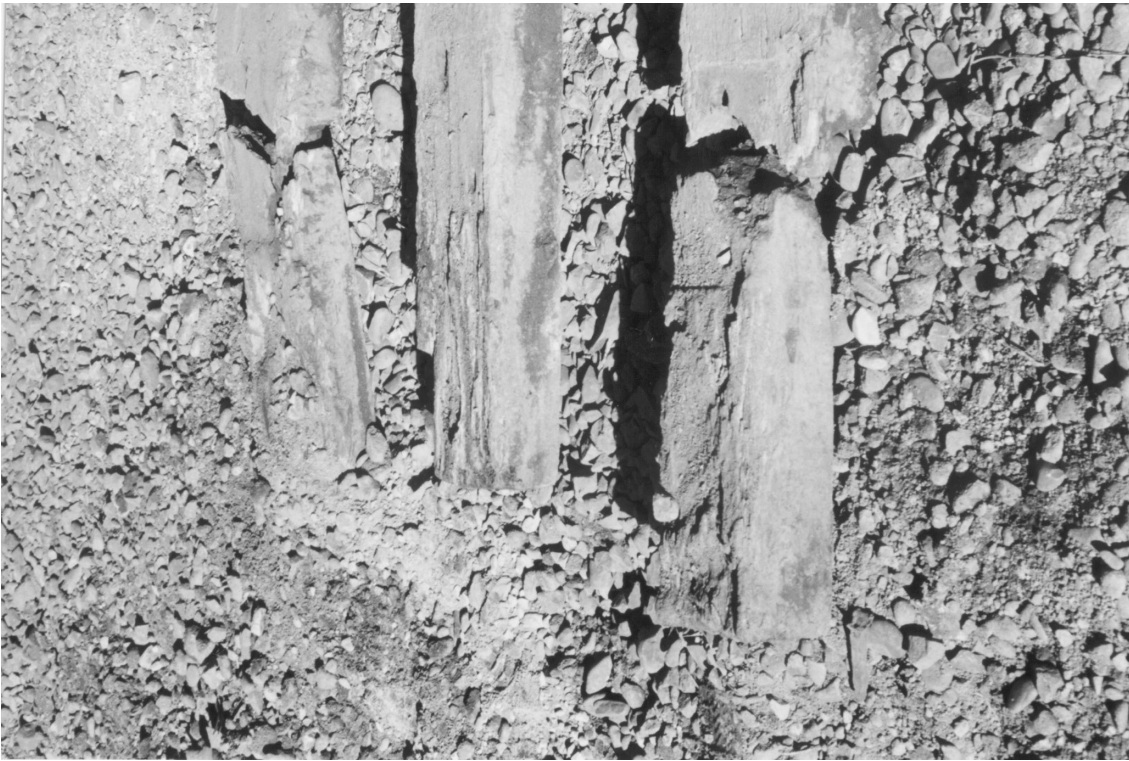
Figure 5
The ends of sleepers 4, 5 and 6 (bottom to top)

Sleeper 1 (at TO 12 points)	fair condition	fastenings tight	gauge 1083 mm
Sleeper 2	fair condition	fastenings tight	gauge 1083 mm
Sleeper 3	fair condition	fastenings tight	gauge 1081 mm
Sleeper 4	poor condition	broken at both rail seatings, fastenings ineffective	gauge 1081 mm
Sleeper 5	poor condition	fastenings ineffective	gauge 1091 mm
Sleeper 6 (just before POD)	poor condition	broken at both rail seatings, fastenings ineffective	gauge 1097 mm

Derailment damage affected assessment beyond sleeper 6, although, in general, sleepers were fair. Fastening integrity, particularly just past the POD, was variable. A 3-man gang with bars was able to move the left rail out 5 mm laterally and the right rail out 11 mm laterally at the POD following the derailment. Although this was an indication of rail movement there was evidence that the left-hand rail had rolled during the derailment about 2 m past the POD, making such post-derailment movement easier.

1.2.8 Figure 5 shows sleepers 4, 5 and 6 after removal.

2.1.1 Derailment markings and track condition indicated the leading axle of LPA 5218 derailed due to gauge spread when the left wheel dropped inside the rail. Gauge spread had been accentuated by the shunt's approach to the weakened straight track from a left-hand curve, which imposed lateral forces on the right rail on the straight. Sleepers 4, 5 and 6 did not supply any lateral restraint, and rail movement permitted the drop-in. About 4 m past the POD the improved sleeper condition and fastening integrity forced the right wheel to mount the rail.
