**Report 00-108**  
**shunting fatality**  
**Middleton**  
**10 May 2000**

**Abstract**

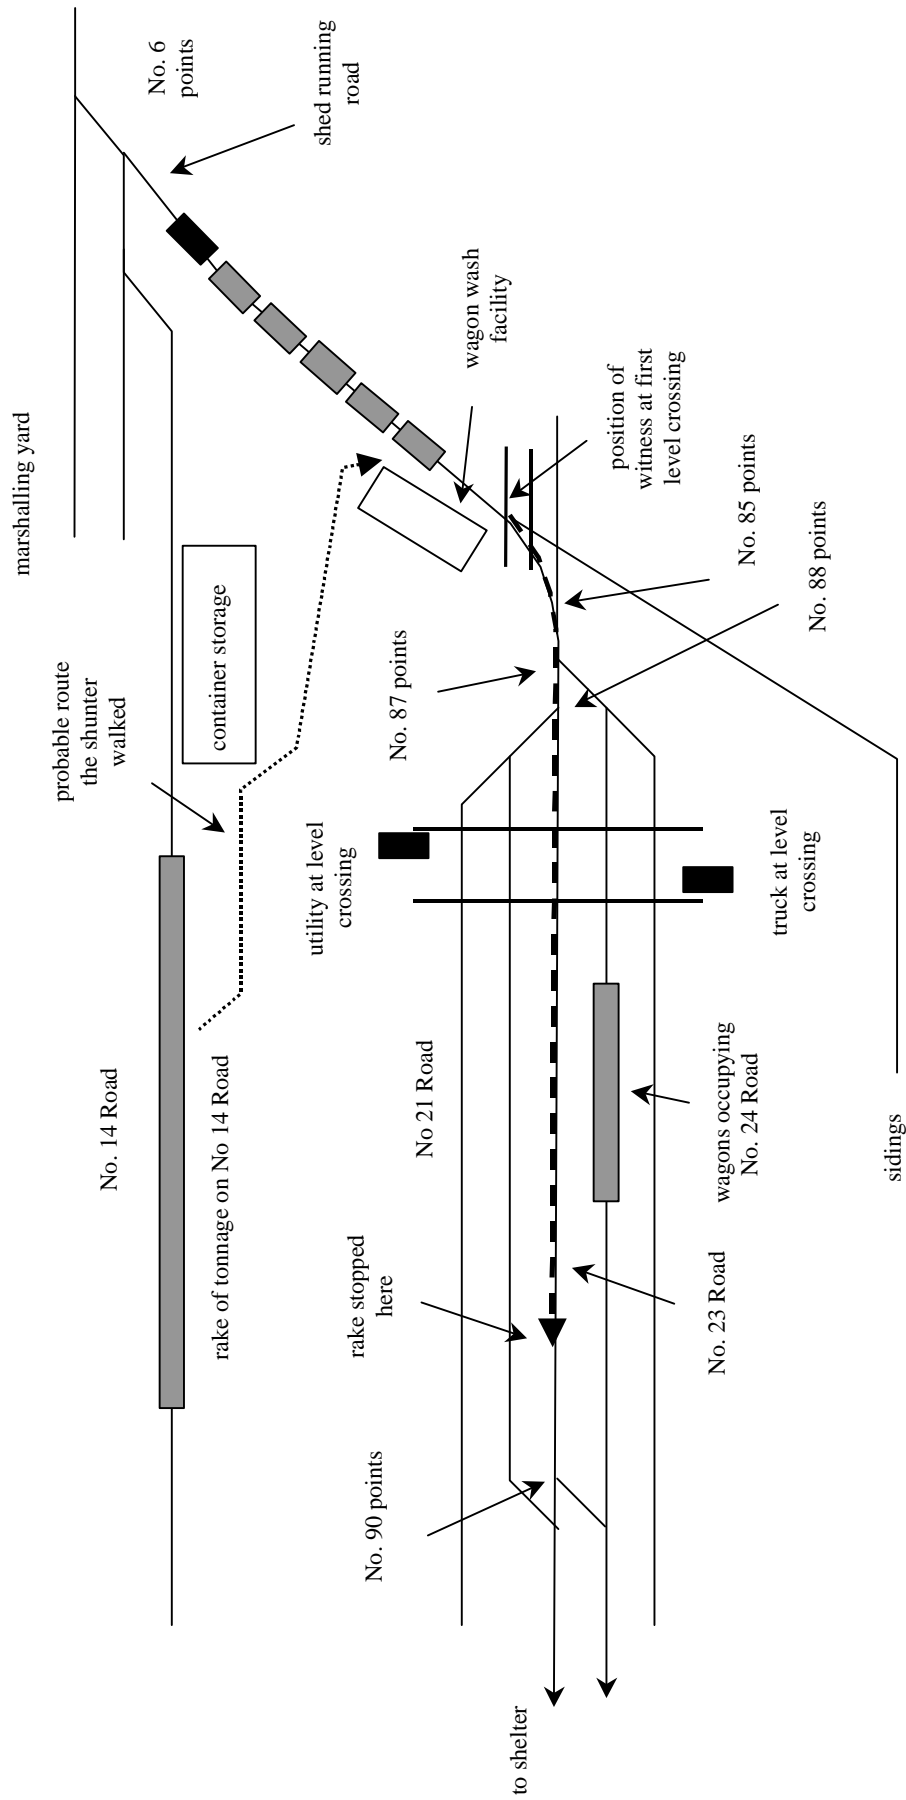
**Figure 1**  
**Plan of freight centre grid**

- 1.1.3 The RCO and shunter had broken up tonnage from a train which had earlier arrived in Middleton marshalling yard. Five wagons destined for No. 24 Road were cut out and left on the shed running road while the shunt positioned the other rake to No. 14 Road (refer Figure 1).

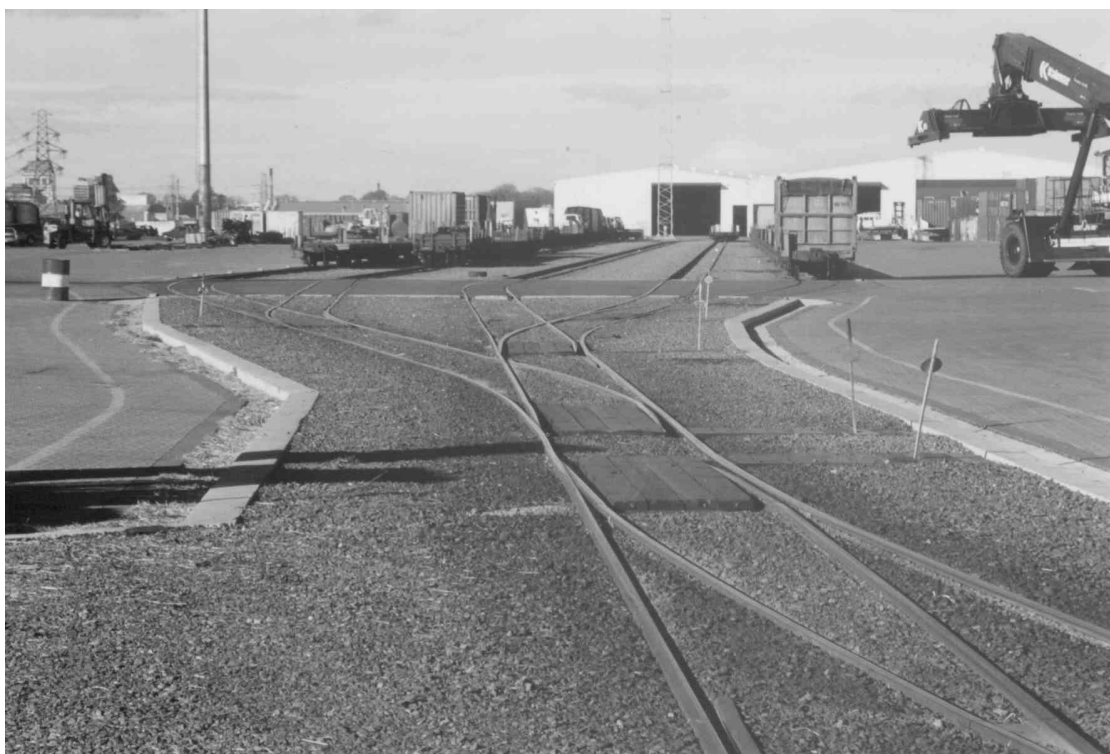
**Figure 2**  
**No. 85 points foreground with No. 87 points immediately behind**

- 1.1.11 The shed running road passed through No. 85 points which connected to another diverging road before reaching No. 87 points at the entrance to the freight centre grid which gave access to No. 23 Road (refer Figure 2).

- 2.1.7 Scuffmarks on the woodwork between the rails at No. 87 points, together with the scattering of personal effects from there into the freight centre grid indicated that the shunter had fallen at that point. It appears most likely that the shunter had attempted to board the rake a short distance before No. 87 points, probably at No. 85 points where the shed running road straightened up as it joined the other diverging road.

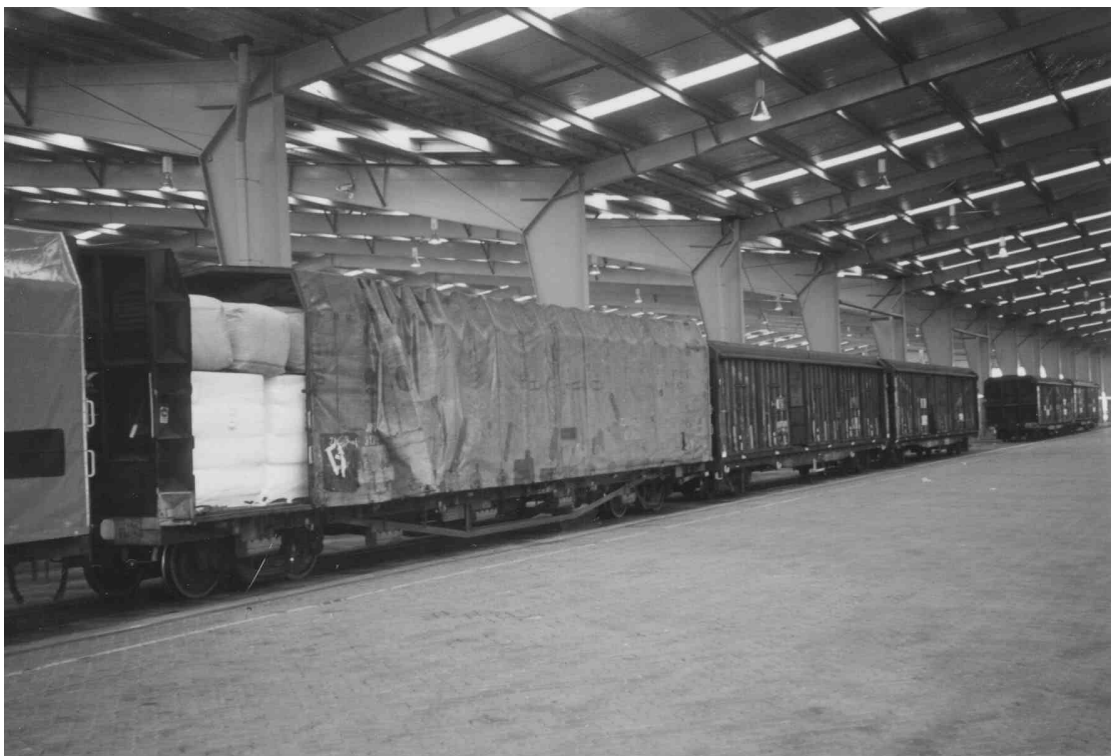
**Figure 4**  
**JPS class wagon**

- 1.3.1 JPS317 was the leading wagon in the propelling movement. It had originally been a UN class flat deck wagon but had later been converted to a JPS wagon by the addition of a concertina style canopy (refer Figure 4).

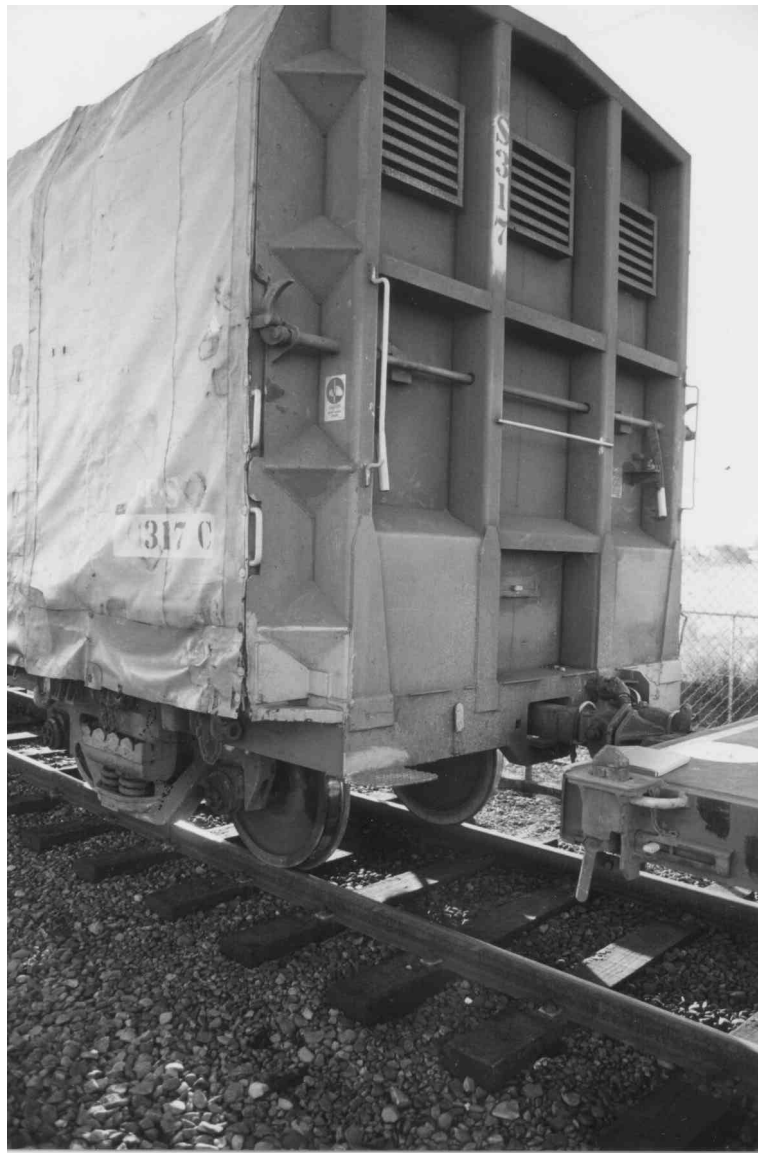
**Figure 5**  
**The leading end of JPS317 showing footstep and handgrip**

- 1.3.2 The footstep at the leading end of the wagon where the shunter was standing was 18.5 mm thick and made of chequer plate with a textured surface to prevent slipping. It measured 280 mm x 180 mm and was mounted 685 mm above rail level. Tranz Rail advised that it was not the correct type of footstep for a JPS wagon as it projected straight out from the end of the wagon instead of dropping towards the track in an "L" shape configuration. At the time the JPS wagons had been produced the correct height-above-rail level for footsteps had been 563 mm. The fact that an incorrect footstep had been fitted to JPS317 was the reason why the height-above-rail level exceeded that standard by 122 mm. Although the footstep did not conform to height above rail standards for that class of wagon, the actual flat surface on which the shunter stood met all other Tranz Rail standards.

- 1.3.5 There was a handgrip attached near the side of the wagon to provide assistance to shunters when boarding, alighting or holding on while riding the wagon (refer Figure 5). The handgrip on the edge of the wagon was positioned 1090 mm from the centre of the wagon, 1695 mm above rail level, which met Tranz Rail code requirements.

- 2.1.8 The shunter had probably grabbed the handgrip with his left-hand and put his left foot on the footstep in preparation for boarding the wagon. The height of the footstep was about 700 mm allowing for about 15 mm above rail height and, as the shunter was of average height, a step of this magnitude would have required him to launch off the ground with his right leg and pull up with his left arm simultaneously. The jerk of the wagon as it straightened may have caused him to overbalance beyond the footstep and towards the centre of the wagon. A natural reaction would be for him to throw out his right-hand in an attempt to grab the horizontal handgrip in the centre of the wagon to stop his fall. The finger mark trails in the dirt below the horizontal handgrip suggest that he missed it and fell under the wagon as it moved over No. 87 points.

- 2.1.9 Had the footstep been at the new maximum height of no more than 400 mm above rail height, the task of boarding the wagon would have been safer.

- 2.1.10 The footstep and the handrail being positioned 164 mm inside the outer edge of JPS317 could also be detrimental to safety. The shunter would have had to place his foot and reach with his hand inside the line, or in the path of the oncoming wagon, making it more difficult to pull out of the manoeuvre for any reason. The combination of the position and height of the footstep on the wagon in this case placed the shunter at greater risk.

- 2.1.11 Although the footstep on JPS317 was not the correct one and did not meet the standard for that particular class of wagon, it was within the specifications of other wagons within the fleet so it was not an unusual fitting. The flat area of the footstep was clean and free of any materials and met size requirements.

- 1.3.3 Tranz Rail has now established a new maximum height-above-rail level standard of 400 mm for footsteps (refer 4.3).
- 1.3.4 A horizontal handgrip attached to the centre of the wagon was positioned 1925 mm above rail level, which met Tranz Rail code requirements.

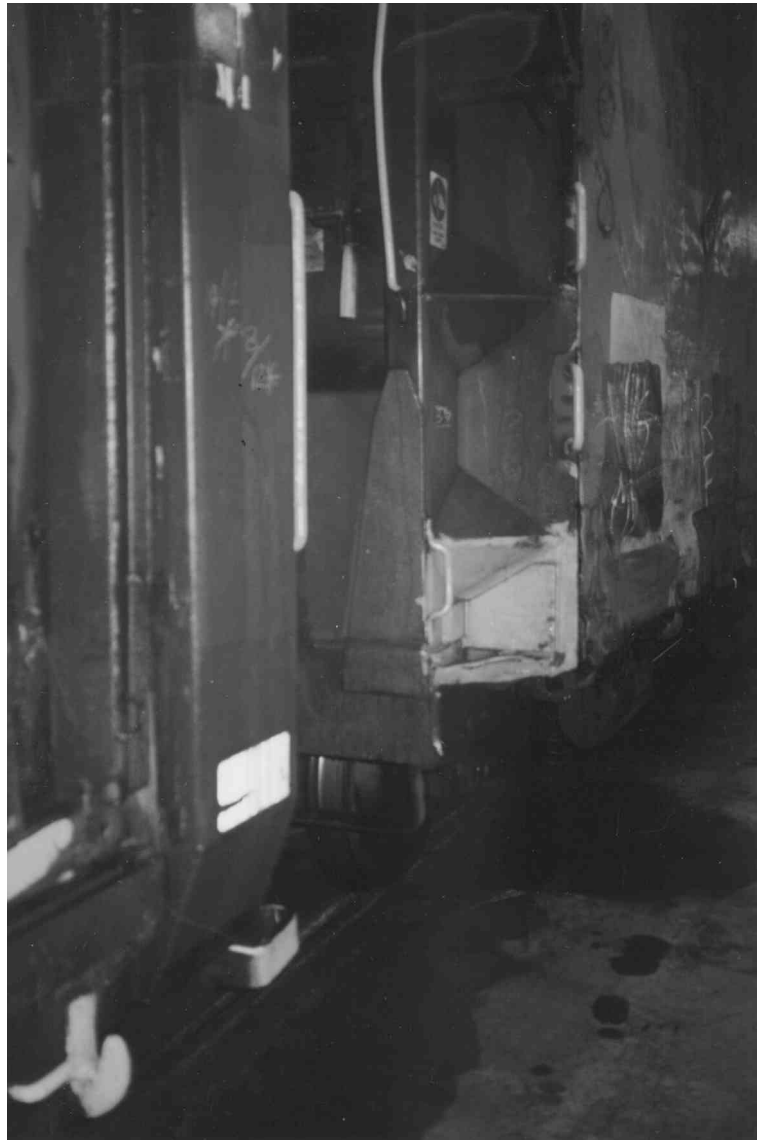
**Figure 6**  
**Variation in widths between ZP10178 and JPS317**

- 1.1.7 The ZP class wagon on which the RCO was riding was narrower than the leading JPS wagon and restricted his vision but he thought the shunter was on the leading end of the wagon to keep a lookout where they were going.

- 1.3.6 The footstep was attached to the wagon directly above the rail and 164 mm from the outside edge of the wagon.
- 1.3.7 The handgrips and footstep were clean, free of any foreign materials, and in good condition.
- 1.3.8 The external width measurement of JPS317 from centreline was 1400 mm and the external width measurement from centreline of ZP10178, the wagon on which the RCO was riding, was 1236 mm (refer Figure 6).
