Report 00-113

Train 378

derailment

22 July 2000

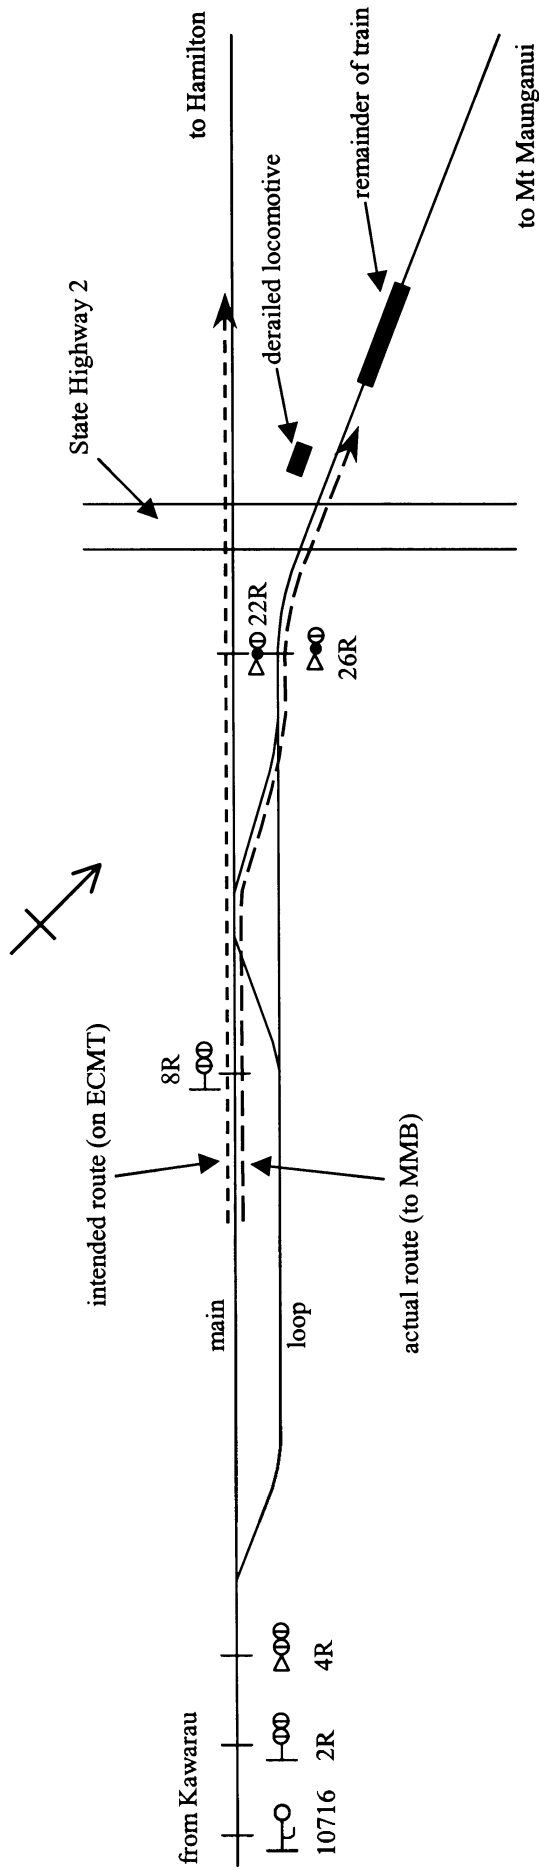
- 1.1.4 As Train 378 approached Te Maunga, the junction of the ECMT and the Mt Maunganui Branch (MMB), the LE was expecting a route to Tauranga and a planned crew changeover with Train 325 at Tauranga. However, the train controller (TC) had incorrectly set a route to the MMB. Figure 1 is a diagram of Te Maunga and the junction involved.

Figure 1
Te Maunga site diagram
(not to scale)

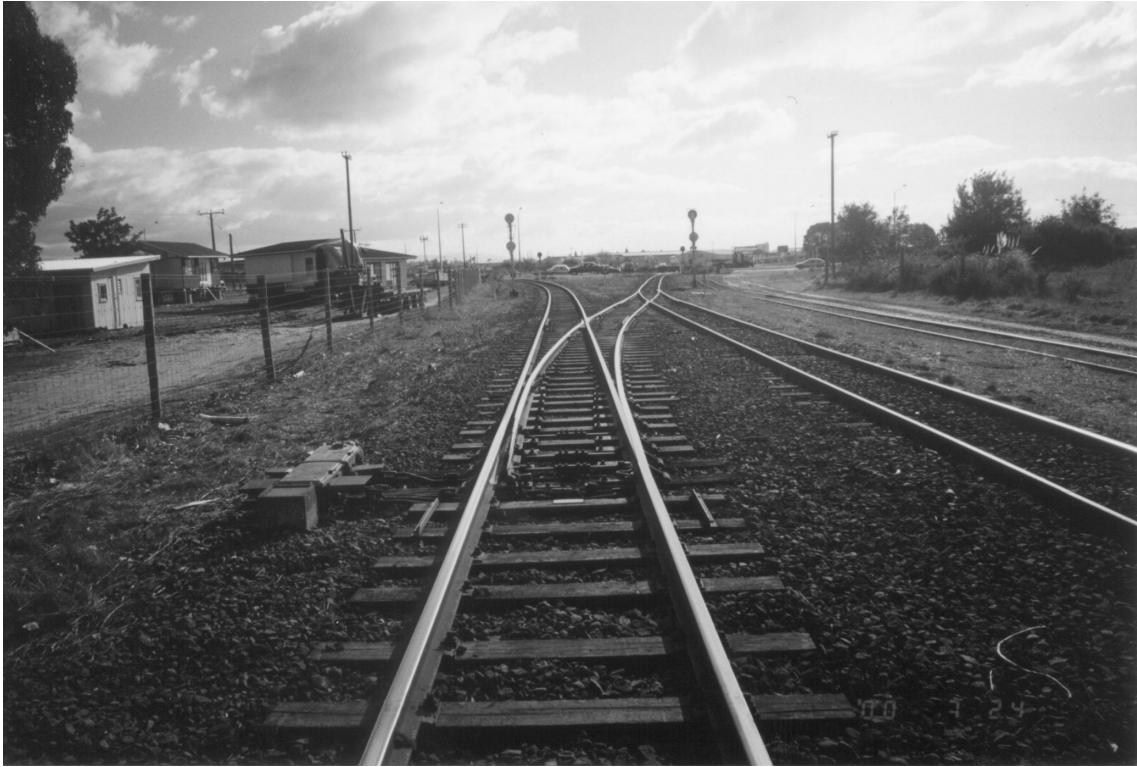
- 1.1.5 The signals indicating a medium speed route to Mt Maunganui were not correctly interpreted and acted on by the LE and his train was diverted from the ECMT through a 25 km/h crossover at a speed of approximately 76 km/h (see Figure 2).

Figure 2
View looking north showing the intended route of Train 378 (to the left)
and the actual route taken to the right, with SH 2 level crossing in the background

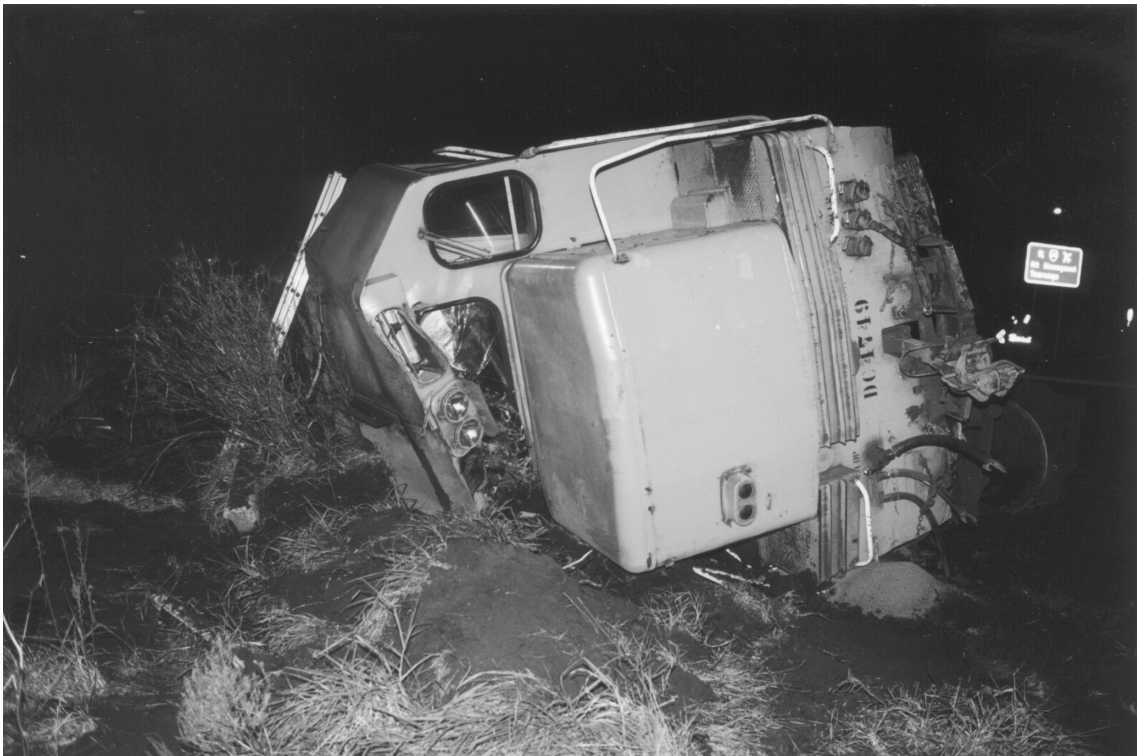
Figure 3
The leading (cab) end of DC 4749 looking in direction of travel
(the locomotive had pivoted end to end before coming to rest)

1.3.2 The locomotive came to a stop on the left side of the track and resting on the right (driver's) side some 4 m from the track as shown in Figure 3.

2.1.3 The impact of the derailed locomotive with concrete curbing on SH 2 resulted in the locomotive separating from the rest of the train and turning end to end before coming to rest on the driver’s side.

- 2.4.1 Despite the speed of the derailment and related damage to the cab of DC 4749 the cab did not separate from its mount and provided protection to the LE such that he suffered only minor injuries.

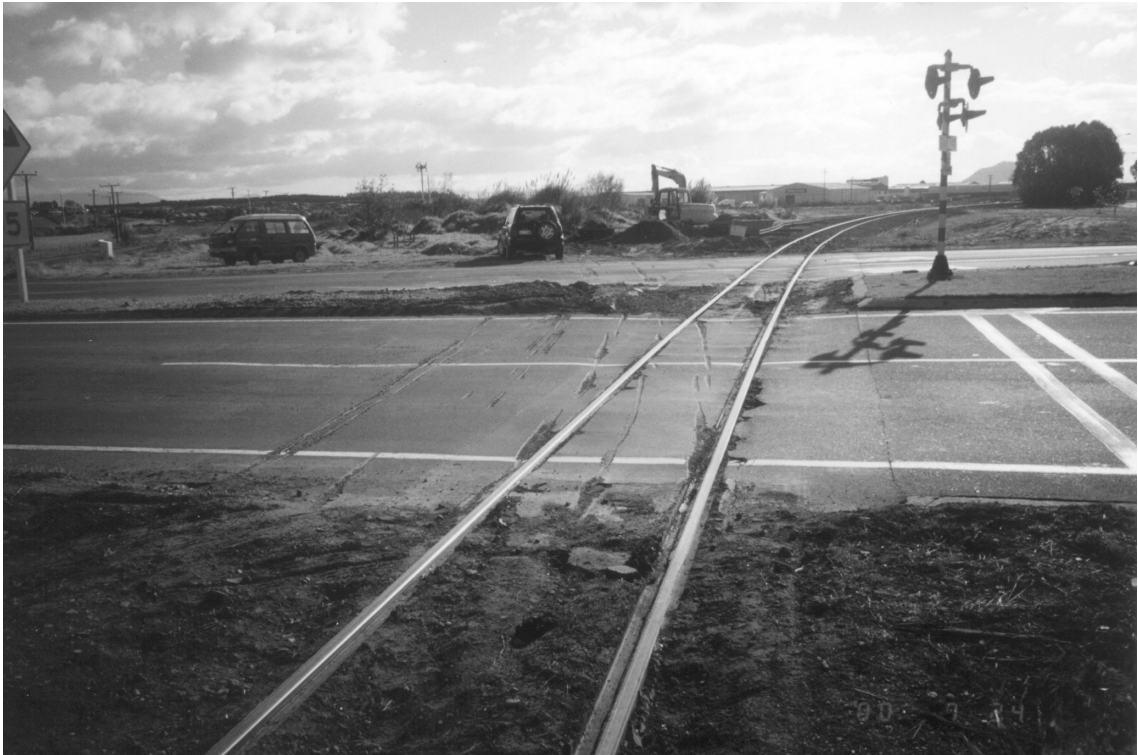
- 1.3.1 The following derailment markings were recorded at the site:
 - wheel marks on the railhead where a left wheel crossed and fell outside (the POD), about 70 m past the entry to No. 9 crossover
 - derailed wheels marks outside the left rail, continuing to the level crossing, some 60 m past the POD
 - multiple wheel markings for 25 m across SH 2 as the locomotive deviated up to 6 m to the left of track centre whilst still upright (see Figure 4).

Figure 4
Wheel marks of derailed DC 4749 crossing SH 2
(looking in direction of travel)

2.1.2 The high speed of Train 378 through the curved road of No. 9 crossover created lateral forces which resulted in weight relief on the left side. This allowed the leading left wheel to climb the rail and derail, followed by the remainder of the locomotive axles and the leading axle of the leading wagon.
