Report 00-115

Train 521

derailment

Westmere, near Wanganui

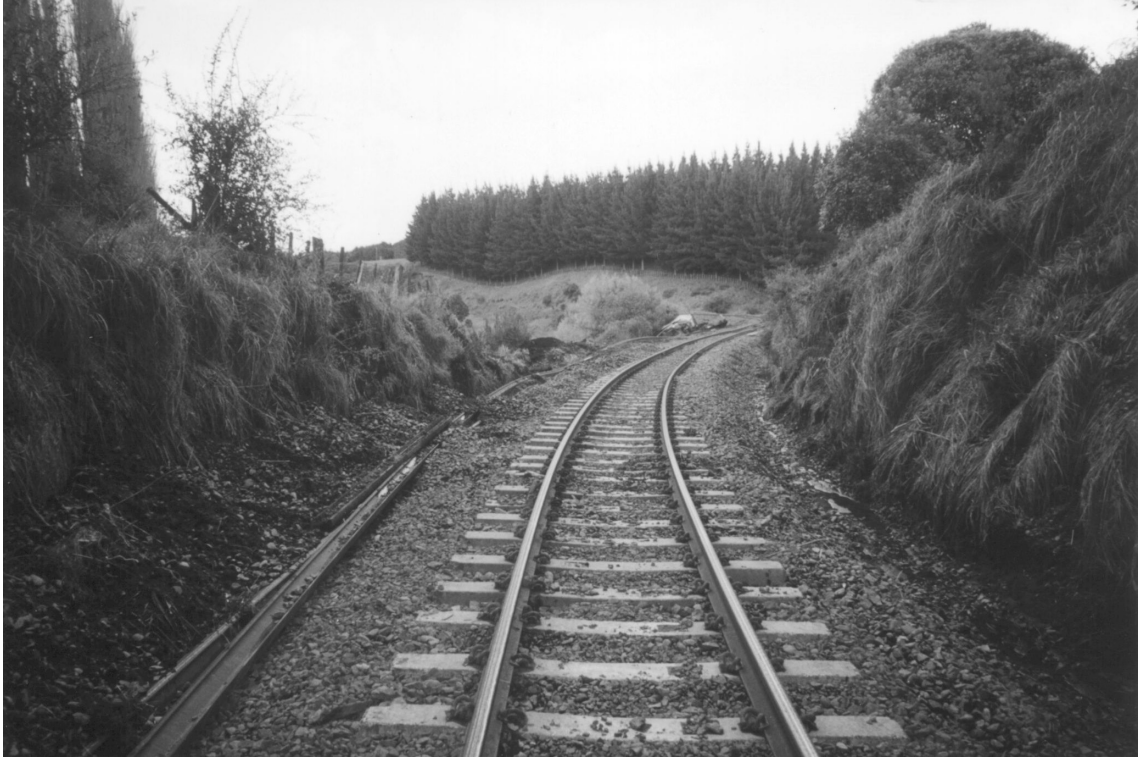
- 1.1.8 The 2 locomotives and the 5 leading wagons derailed and came to rest at various positions on the left side of the track or straddling the track. The 3 trailing wagons remained on the rails just beyond the POD.

Figure 1
Looking south from the POD at the derailed locomotives in the background

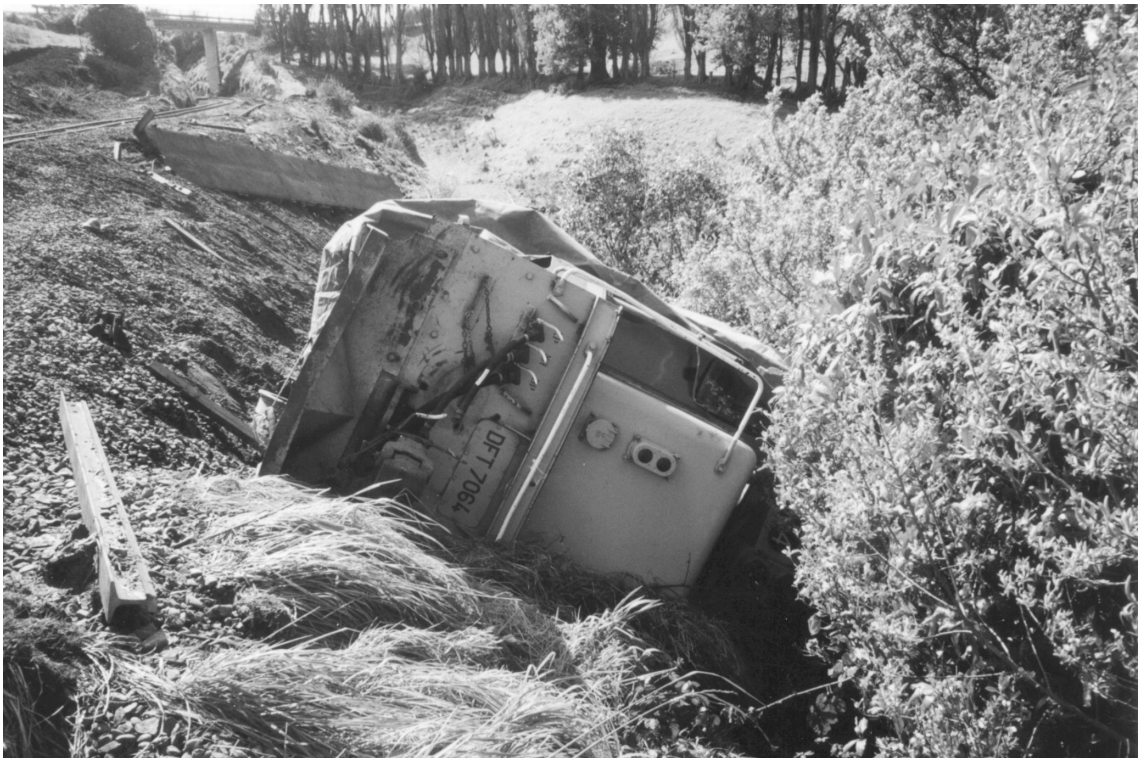
Figure 2
The cab of DFT 7064 (looking north towards the POD)

2.6.1 Despite the speed and severity of the derailment and related damage to the cab of DFT 7064, the cab provided sufficient protection for the LE to avoid serious injury.

- 2.6.4 All resilient cab mounts, including any retaining brackets used in Tranz Rail diesel locomotives will ultimately rupture or separate if subjected to high enough forces. What was most relevant in this case was that the cab had a weaker mount type and it impacted the ground in a manner for which protection was not designed.

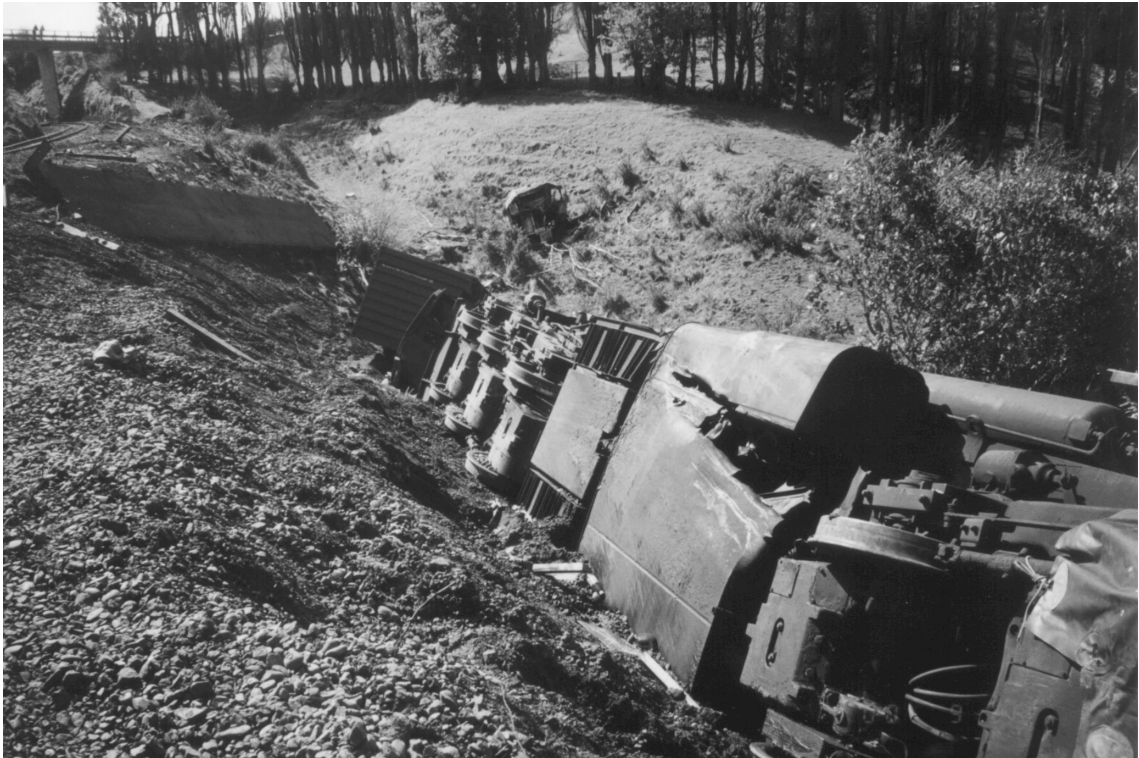
- 1.2.3 A full track geometry measure-up was carried out, based on 48.394 km as the POD.
- 1.2.4 DFT 7064, the leading locomotive, came to rest on its side about 110 m from the POD on the left side and some 5 m from track centre (see Figure 2). DC 4006 was still attached, also on its side. The cab of DC 4006 was separated from the locomotive and came to rest about 50 m from the POD on the left side and some 30 m from track centre (see Figure 3).

Figure 3
Looking north from the cab of DFT 7064 at coupled DC 4006 and the DC cab in
the background

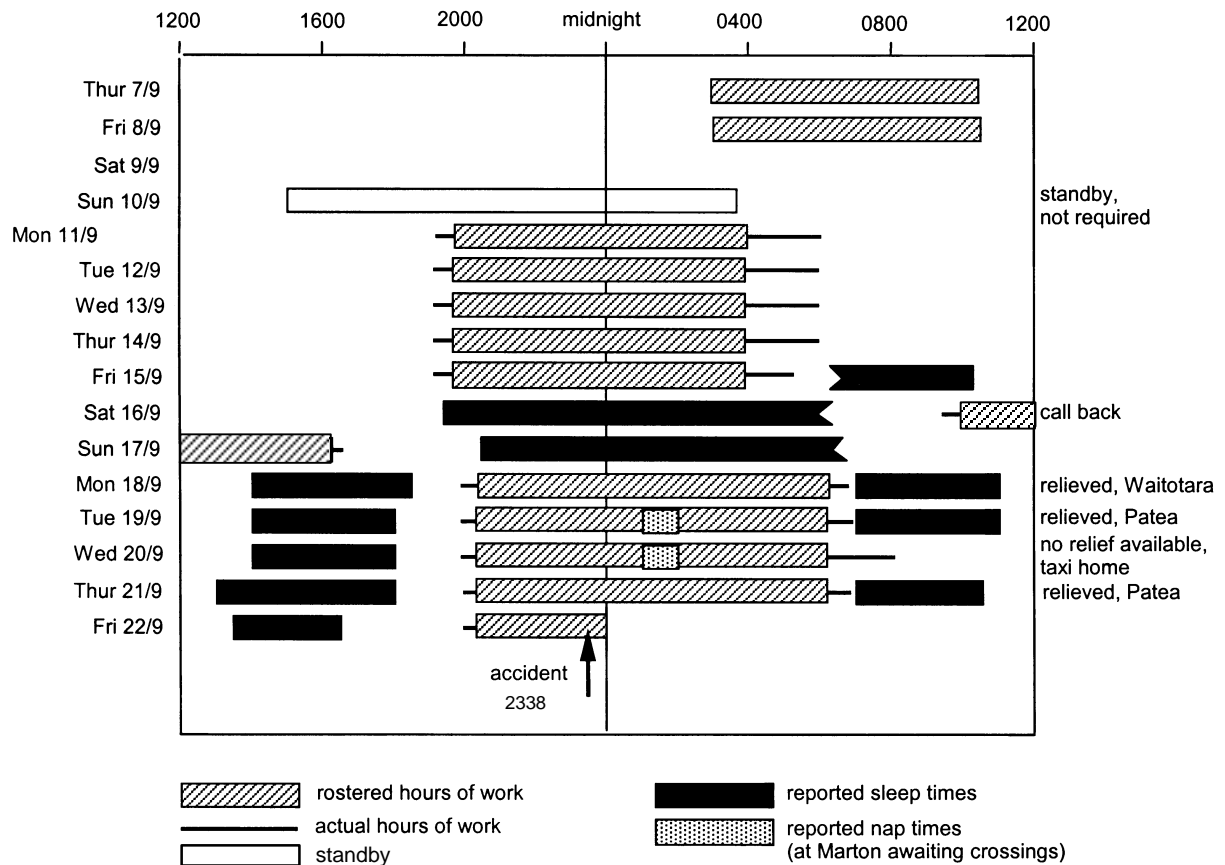
Figure 4
Sleep/Wake pattern
