## **Report 00-116**

### **hi-rail vehicle and express freight Train 225**

### **occupying the same section of track**

### **near Te Kauwhata**

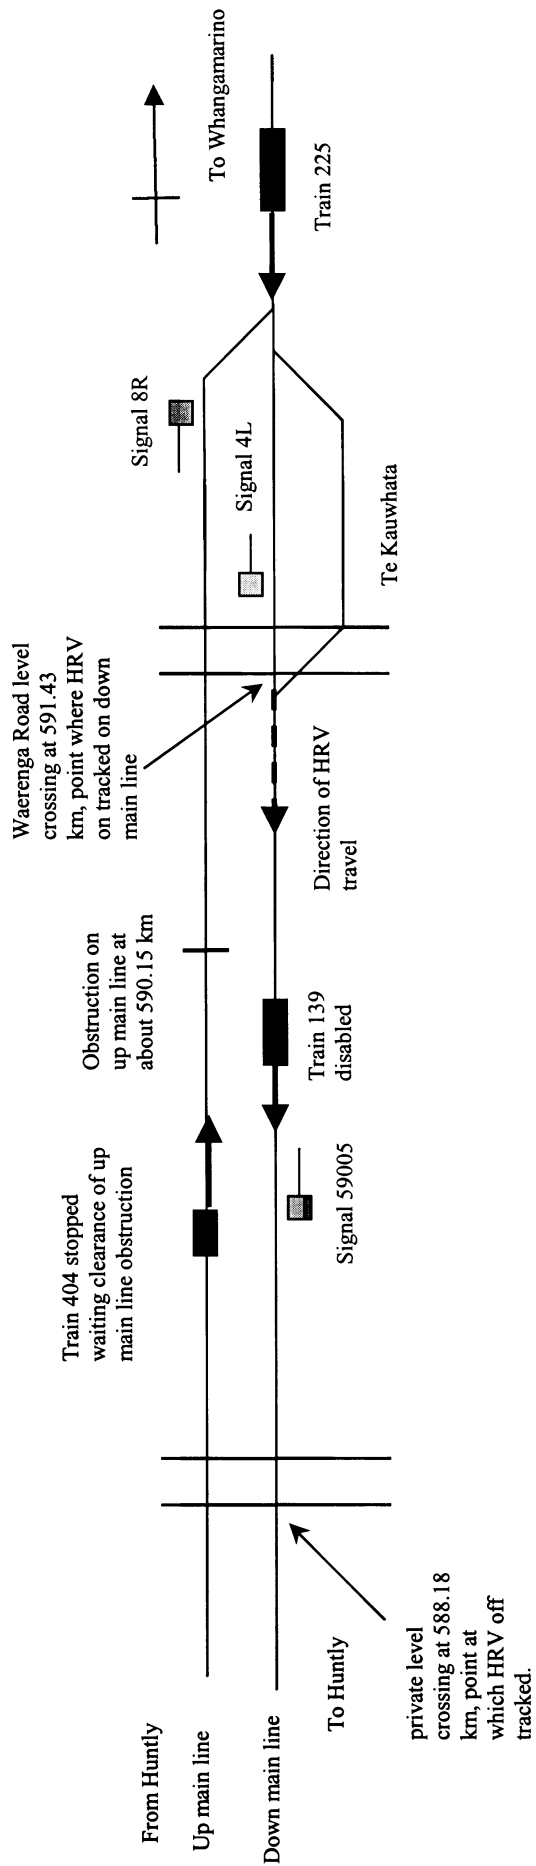
**Figure 1**  
**Track layout Te Kauwhata**  
 (not to scale)

- 1.1.5 The TC said he had not used the signal blocking command facility (refer paragraph 1.7.1), to tag Signal 4L at Te Kauwhata (refer Figure 1) to protect the HRV movement. His reason for not doing so was that he had planned to hold Train 225 at Whangamarino, a crossing loop about 5.3 km north of Te Kauwhata, to cross Train 404 and when he took the track call from the ganger he knew that a Whangamarino crossing allowed an additional 25 minutes for the gang to complete its work and be clear for the passage of Train 225. The pencil lines plotting this crossing were visible on the train control diagram.

- 1.1.13 While Train 139 occupied the section between Signal 4L and Signal 59005 (refer Figure 1) the TC could not clear Signal 4L to allow another train to enter the section. Signal 59005 was about 200 m from where Train 139 had been disabled. The distance between Signals 4L and 59005 was 1375 m.
