Report 00-117
express freight Train 540
derailment
near Kai Iwi
26 November 2000

Abstract

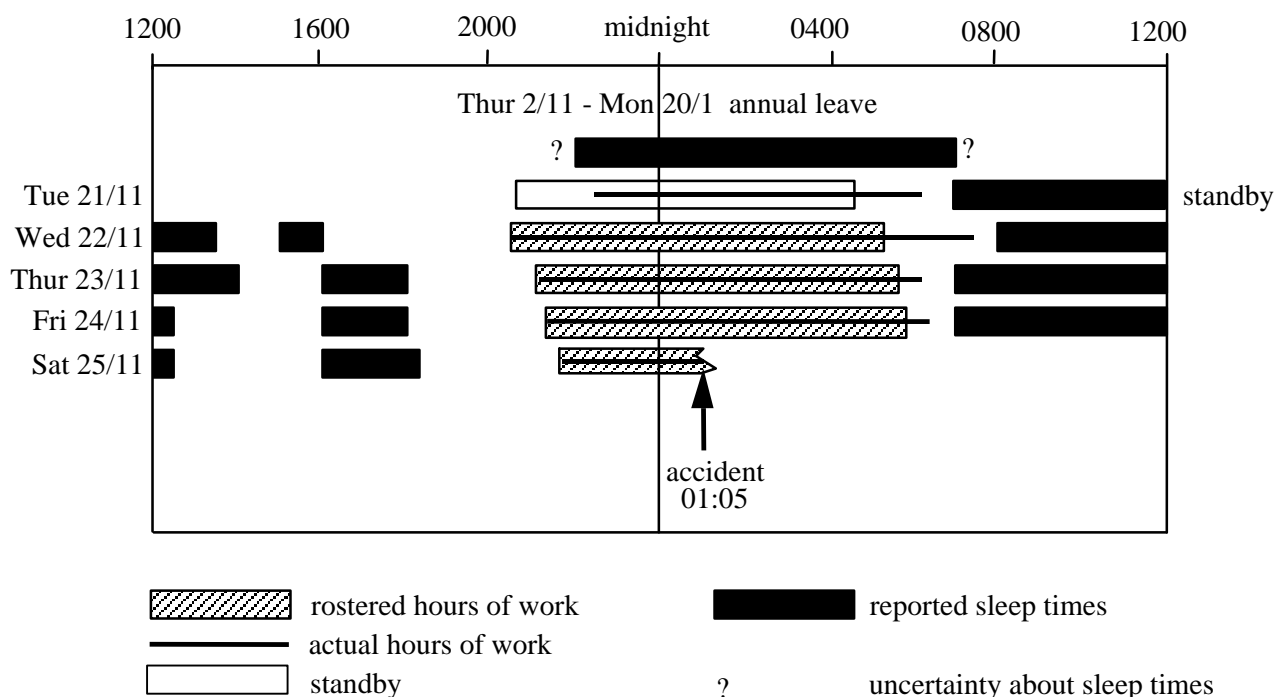
Figure 1
Sleep/wake pattern

1.8.7 Figure 1 shows the sleep/wake pattern for the LE based on sleep information available from 20 November and work patterns leading up to the derailment shift. The derailment occurred on his 5th consecutive night shift after a period of annual leave. All 4 preceding shifts ran longer than rostered because of late running of trains. Across the 4 rostered shifts prior to the derailment shift, the LE had worked 3 hr 45 minutes longer than was rostered. When questioned about the late running he commented, “We are used to it; we rarely get home on time.”

2.3.6 Figure 1 shows the LE had a pattern of sleeping as soon as he got home in the morning, and then taking a further nap in the afternoon before going back to work. This "split sleep" pattern is common among night workers. There is considerable scientific evidence indicating that the sleep period prior to night duty is effective in improving alertness and performance across the night shift. The derailment occurred about 6 hr and 40 minutes after the end of the LE's last reported sleep period. Thus, extended wakefulness would not have contributed to his biological sleepiness at the time of the derailment.
