Report 00-118

express freight Train 520, Te Wera, 5 December 2000
express freight Train 920, Pareora, 6 December 2000
express freight Train 922, Shag Point, 6 December 2000
express passenger Train 601, Opapa, 8 December 2000
express freight Train 729, Ward, 14 February 2001
express freight Train 234, Te Kawa, 2 March 2001

derailments or near-derailments due to heat buckles 2000/2001

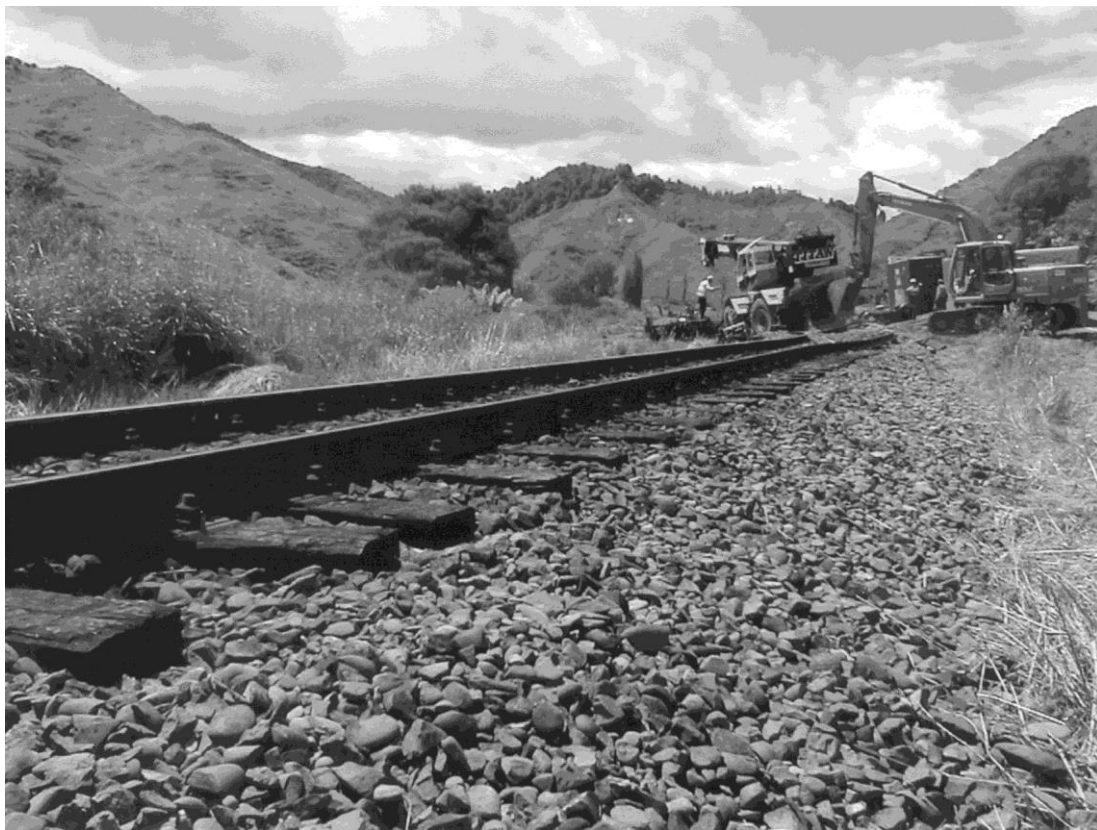
Figure 1
Typical ballast profile at 47.35 km SOL

- 2.1.6 The CWR track consisted of 1962, 91 lb/yd rail on 1977 treated pinus radiata (TPR) sleepers and rail anchored every fourth sleeper. All fastenings were tight. The ballast section was of clean crushed metal with a depth of approximately 250 mm below the sleepers. The ballast shoulders on both sides of the track in the area of the derailment extended up to about half the depth of the sleeper as shown in Figure 1. Evidence in the ballast section indicated that the sleepers had moved approximately 100 mm to the right at the point of derailment (POD) at 47.35 km SOL and 250 mm to the right at 4 m after the POD.

- 2.1.7 The minimum new ballast section for CWR track, as stipulated in Tranz Rail's Code supplement CSP/55, for curves under 400 m radius was for the ballast shoulder to be heaped up 100 mm above the sleeper top for 450 mm outside the end of the sleeper and a minimum depth of 225 mm below the sleeper. Tranz Rail advised that the ballast profile, as distinct from the ballast depth, was also a minimum standard for maintaining existing track.

- 2.2.1 The likely cause of this buckle was the passage of the train triggering lateral movement due to the substandard ballast profile providing insufficient lateral resistance.

- 2.2.3 There were no proactive measures in place to ensure CWR code requirements were maintained. Local staff believed it was appropriate to respond to any track misalignment which occurred. The area should have been reported as a weakness and been protected by a heat speed restriction until the appropriate ballast section was reinstated.
