**Report 00-201
stern trawler *Seafresh 1*
engine-room fire
north of Chatham Islands
9 March 2000**

**foundering
Hanson Bay, Chatham Islands
17 March 2000**

Abstract

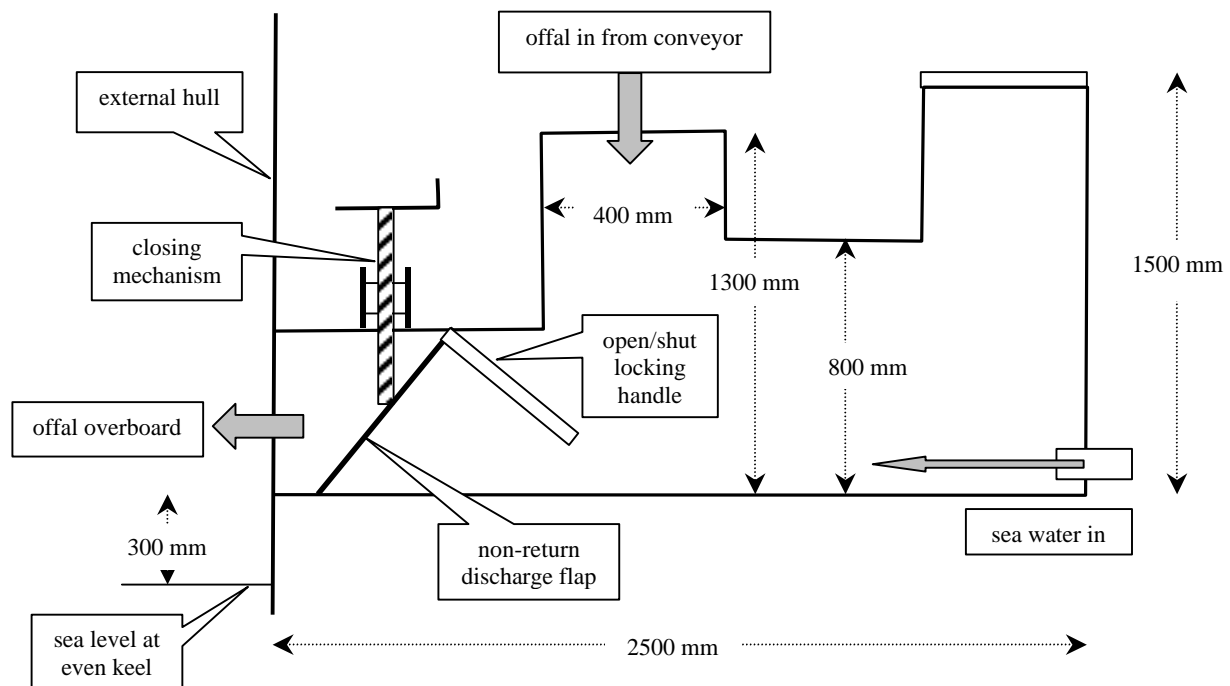
Figure 2
Side elevation of offal overboard discharge with approximate dimensions
(not to scale)

- 1.1.14 The engineers suspected that the offal overboard chute was the point of ingress and tried to close the non-return flap. The spindle actuator turned freely but was not closing the flap because the threaded block through which the spindle passed had broken free of its mounting and was turning with the spindle (see Figure 2).

- 1.1.15 The engineers saw some ingress of water through the spindle gland and packed around the area to reduce it. The non-return flap had an operating handle that allowed it to be locked in either the open or shut position. However, the handle had sheared off and the flap could be heard banging against its stop when the vessel rolled.
- 1.1.16 The mate had closed the overboard discharges for the factory deck bilge pumps and he told the chief engineer that the handle on the port aft one had broken. They found that a considerable amount of water was upwelling through the bilge after each roll to port.

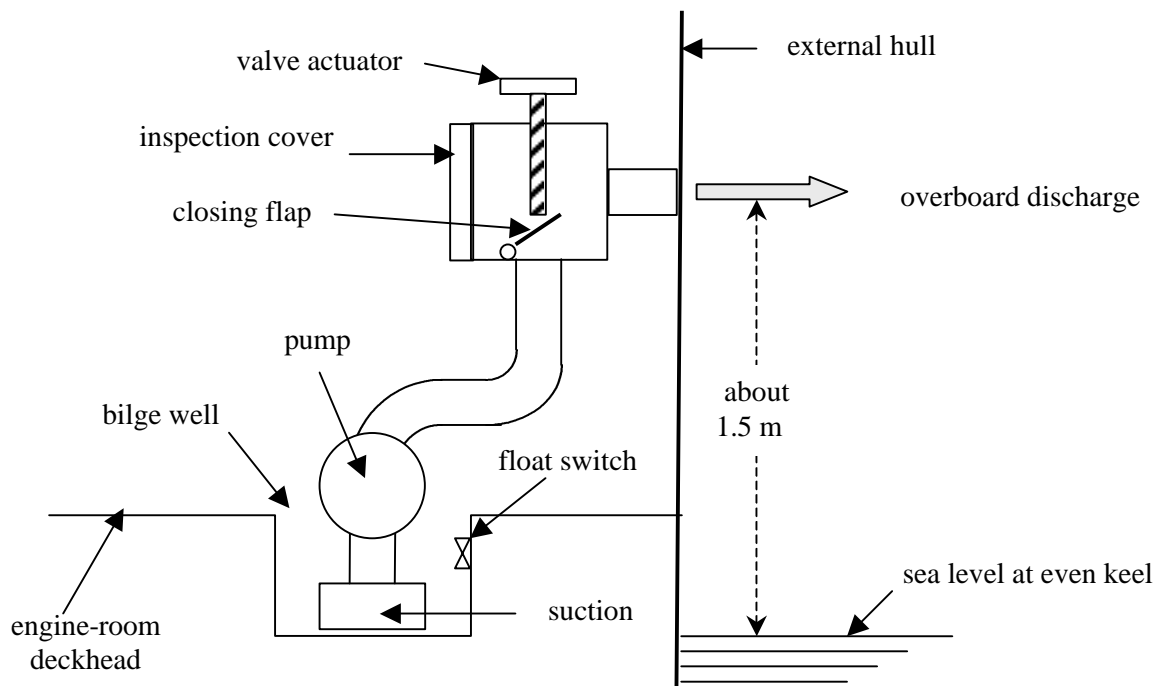
Figure 3
Diagram of factory deck bilge discharge
 (not to scale)

- 1.1.20 Meanwhile they used an oxy-acetylene torch to remove the nuts on the inspection cover of the port aft factory deck bilge and discovered that the closing flap had fractured from its spindle. They packed the inspection box and bilge uptake with plastic and rags and clamped the cover back in position. By about 0100 it appeared that the ingress of water had reduced and as the crew continued to bail the level of water on the factory deck lowered (see Figure 3).

- 2.2.2 The 3 bilge pump overboard discharges had been closed. The pump discharges on the starboard side of the factory deck remained watertight but the closing valve on the port side pump discharge was fractured, allowing water to back-flow through the discharge onto the factory deck.

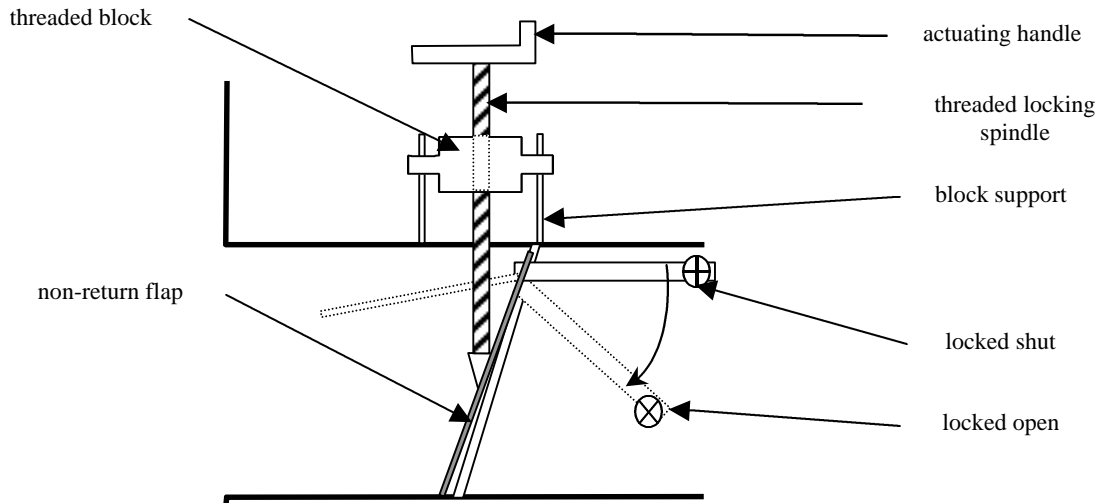
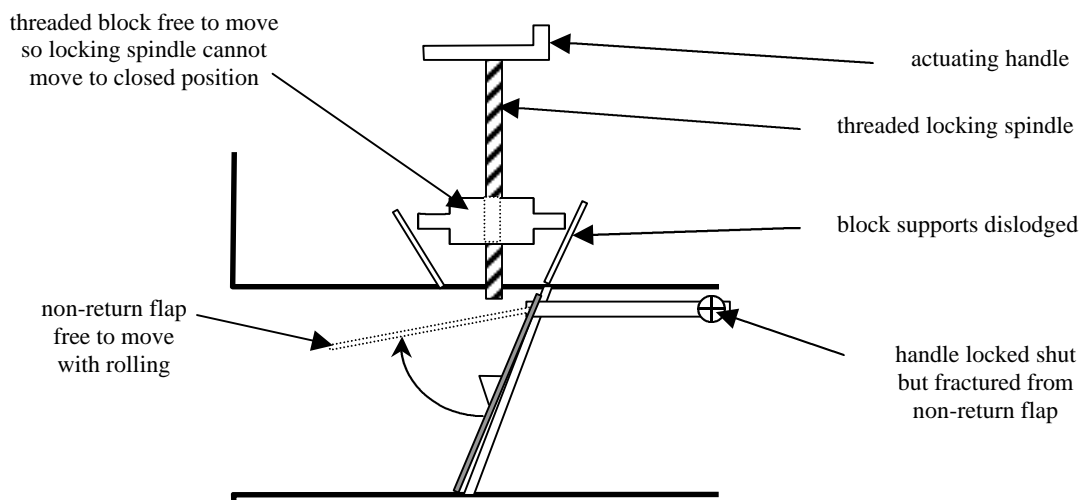
- 1.4.7 On the soundtrack of the recording a loud rhythmic banging could be heard. The banging was identified as the non-return flap in the offal overboard discharge swinging freely in time with the rolling of the vessel and banging back against its inboard stop. The recording showed that the locking handle was not moving, indicating that it was no longer attached to the flap (see Figures 6 and 7).

1.4.8 An underwater video recording taken by divers after *Seafresh 1* foundered, showed the engine-room, factory deck and part of the accommodation. At the offal overboard discharge, the recording showed the closing device. The packing around the gland was still loosely in place and the threaded block though which the spindle travelled was dislodged from its supports.

- 2.2.15 The starboard list would significantly increase the draft on that side, causing the offal overboard chute discharge to become deeply immersed with its non-return flap open most of the time.
- 2.2.16 Once this condition was reached, the ingress of water through the offal discharge would be almost continuous and of substantial volume. The stern trim and starboard list would significantly increase, further advancing the flooding.
- 2.2.17 With several open doors leading off the factory deck the flooding would continue through to other spaces until the vessel eventually foundered.

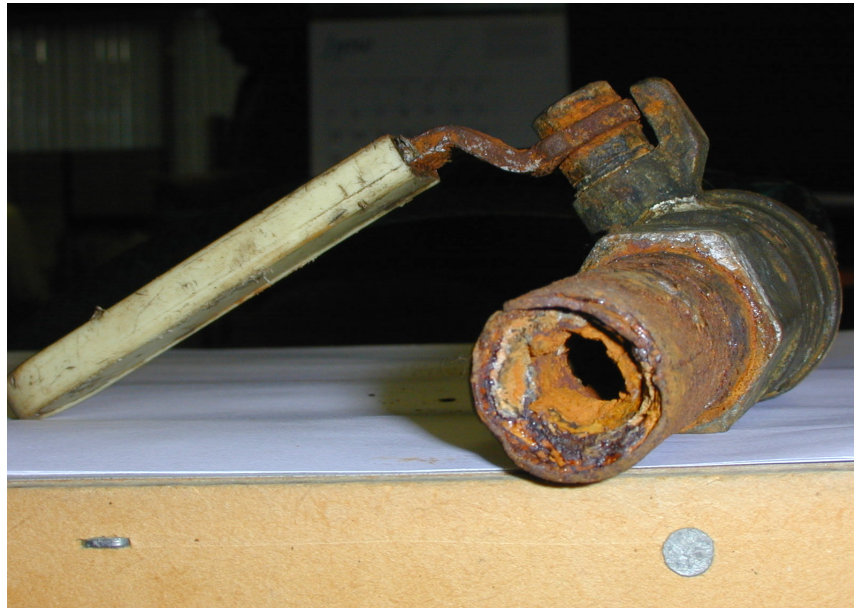
Figure 8
Internal corrosion in fractured pipe

- 1.4.10 Divers retrieved the fractured bilge pump priming pipe and Figure 8 shows the amount of internal corrosion at the fracture in the threaded socket.

- 3.4 The priming line fracture probably resulted from internal corrosion.
- 3.5 Had an effective fire detection system been installed in the engine-room, the crew would probably have been alerted to the fire in time to save part of the switchboard.

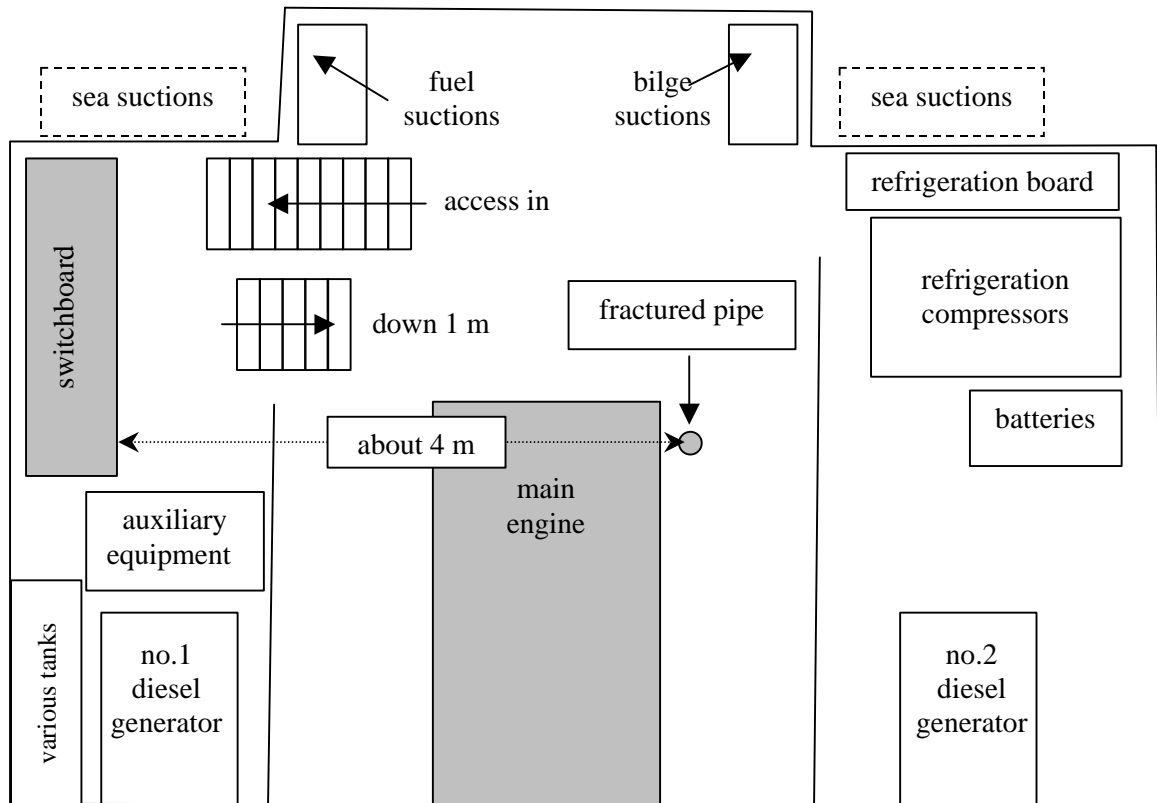
Figure 9
Simplified diagram of forward end of engine-room layout
(not to scale)

- 2.1.3 The main engine was cooled by a sea water system and the pump circulated water at a pressure of 2.2 bar. The bilge pump priming line that was fed off the top of the main sea water cooling line was corroded internally and fractured, probably shortly after the chief engineer left the engine-room. The remaining pipe stub had an internal diameter of about 15 mm. The resulting jet of sea water would have easily risen to the engine-room deckhead where it was probably deflected in most directions (see Figure 9).

- 2.1.4 The fractured pipe was on the starboard forward side of the engine and although the switchboard was positioned on the port side of the engine about 4 m away horizontally, the force of the jet of water, even after being deflected at the deckhead, would have been sufficient for a significant amount of sea water to have sprayed onto the switchboard.

- 2.1.5 Further, sea water may have run along cable trays, pipes and the vessel's structure and dropped onto the switchboard.
- 2.1.6 The switchboard was not intended to be watertight and sea water probably penetrated the circuit breakers. Salt water is a conductor and probably bridged out the live terminals within the circuit breakers. The temperature rise from the resulting excessive short circuit current would have been sufficient to cause the plastic circuit breaker insulation material and cable insulation to smoulder. The number 1 generator probably continued to feed the hot spot until it shut down or was automatically isolated by its supply circuit breaker, but by this time the combustible materials within the switchboard had sufficient heat to have caused the fire.

- 3.3 The fire in the switchboard was probably caused by sea water from a fractured bilge pump priming line spraying onto the circuit breakers, causing them to short circuit.

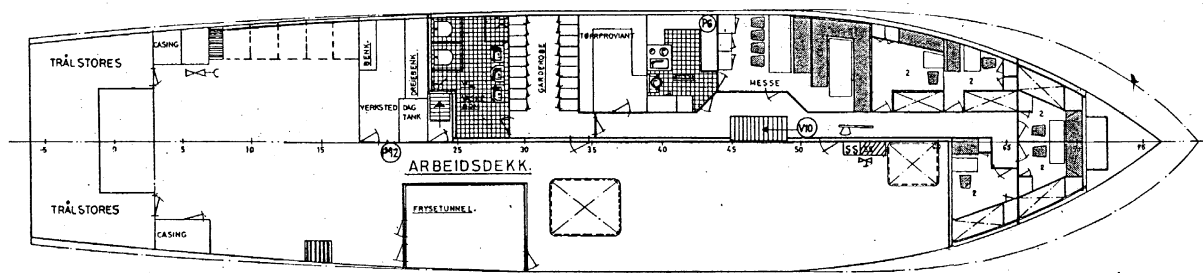
Figure 10
Plan of the factory deck on *Seafresh 1*

- 2.2.14 As the area covered by the water increased, the free surface effect of the water would have progressively reduced the stability of the vessel. When contained in the aft end of the factory deck the flooding would have been symmetrical, but once the water flooded forward of the workshop the flooding would have been asymmetrical and the vessel would start to list to starboard (see Figure 10).
