**Report 00-202**

**Restricted limits passenger vessel *Sweet Georgia***

**engine room fire and grounding**

**10 March 2000**

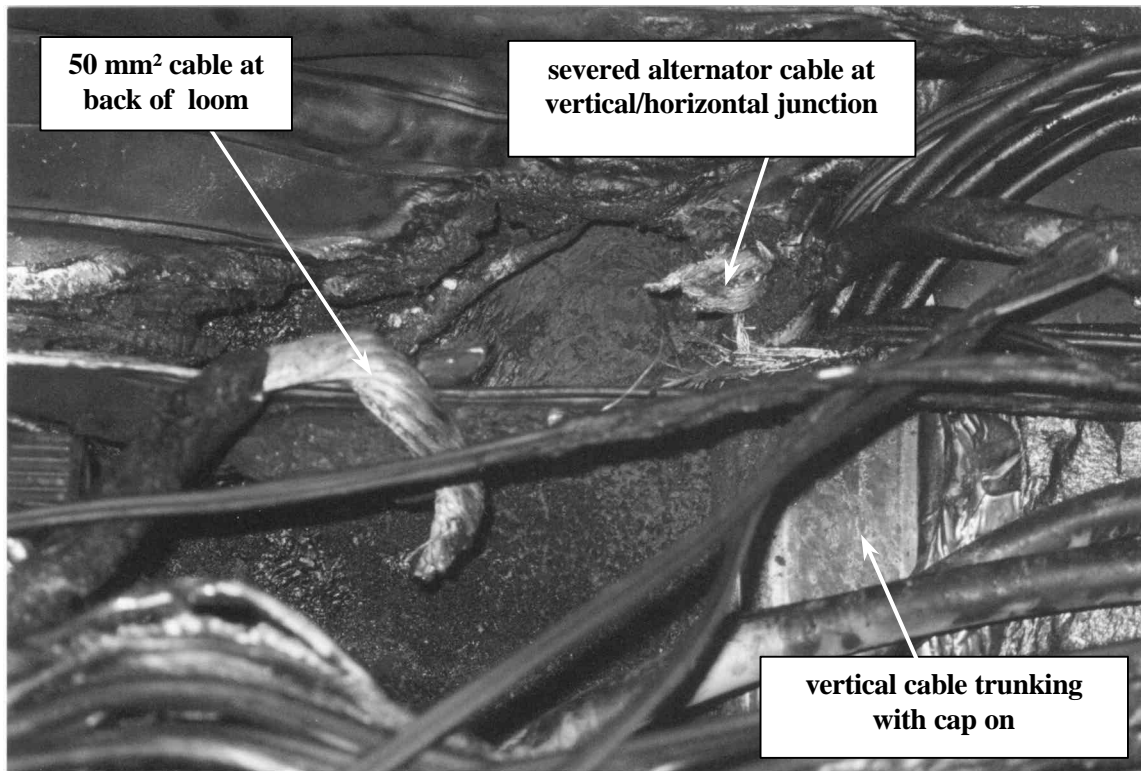
**Figure 3**  
**Photograph showing severed 50 mm² DC submain cable**

- 1.7.1 The fire damage to the cable trunking was concentrated in the area where the horizontal and vertical trunking intersected. It initially appeared to be caused mainly by the external application of heat. On closer inspection a severed end of a 50 mm<sup>2</sup> DC submain to the distribution board was protruding out of the bottom of the horizontal trunking, and its mating end was hanging free just to starboard. This cable appeared to have been severed by an electrical fault, which was evident by the molten copper at the broken ends. (See Figure 3)

- 2.4.3 The heat from the short circuit travelled along the copper conductor of the house alternator cable and damaged the 50 mm<sup>2</sup> cable insulation of the battery submain to the DC distribution board. Eventually the battery cables in the horizontal cable trunking were short circuited by a section of hot alternator cable and the explosive cable separations occurred. This was probably the source of the bang the passenger recalled hearing. The energy stored in the battery would have continued to discharge into the short circuit until the battery was flat, manually isolated, or the exposed conductors had blown apart and removed the short circuit. The fire had started sometime during this sequence. A fuse at the house battery could have safely disconnected the battery under this scenario and possibly avoided the fire.

- 2.4.4 Cable damage indicated that the maximum possible unprotected fault current from the house battery had been conducted through short circuits in this area. The magnitude of the fault current and resulting magnetic forces had separated the 50 mm<sup>2</sup> battery cables with an explosive force that severed the cables and thrust the molten ends out of the cable trunking. Without a protective device to limit the battery fault current, it appears that a section of the smaller 16 mm<sup>2</sup> alternator cable within the cable trunking may have acted as a fuse.

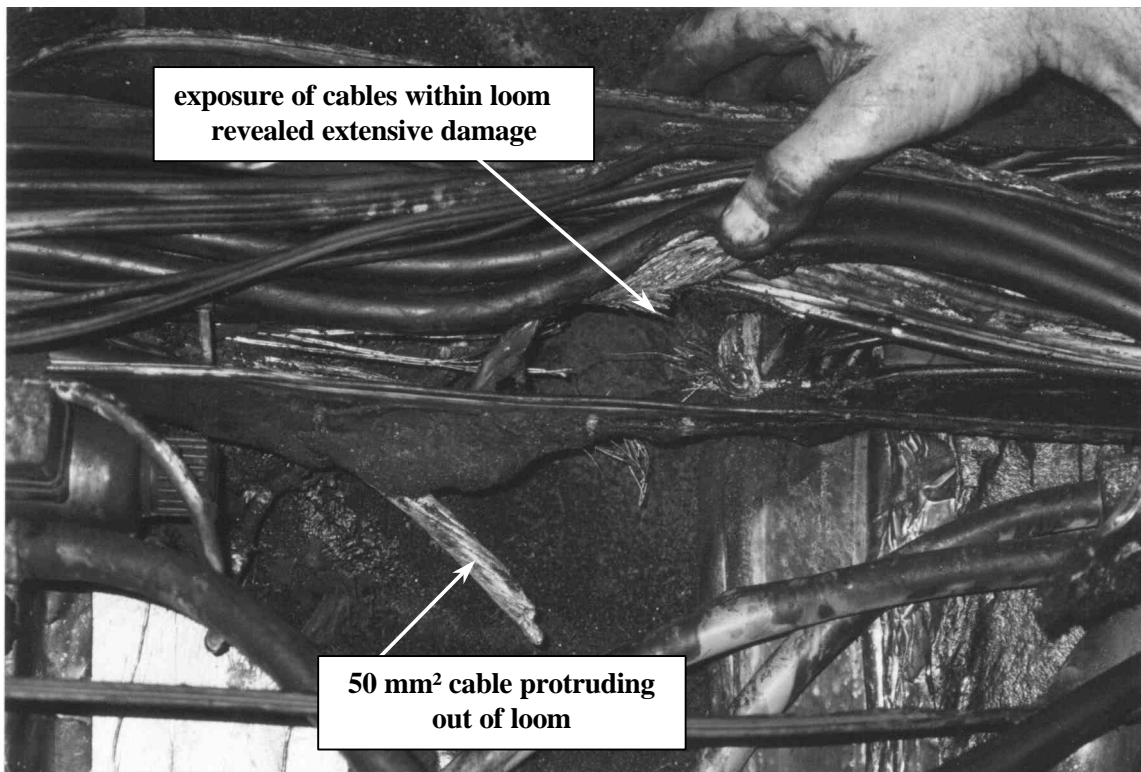
**Figure 4**  
**Photograph showing damaged cables in horizontal cable trunking**

- 1.7.2 When the cable loom within the horizontal trunking was further separated and pulled further apart, signs of insulation failure were more obvious. Severe charring was discovered within the loom and several bare copper conductors were visible. The cables at the back of the loom were bonded to the trunking and adjacent cables by the molten insulation. Another 50 mm<sup>2</sup> submain cable, at the back of the loom, to the DC distribution board was discovered to have been severed by an electrical fault. (See Figure 4)

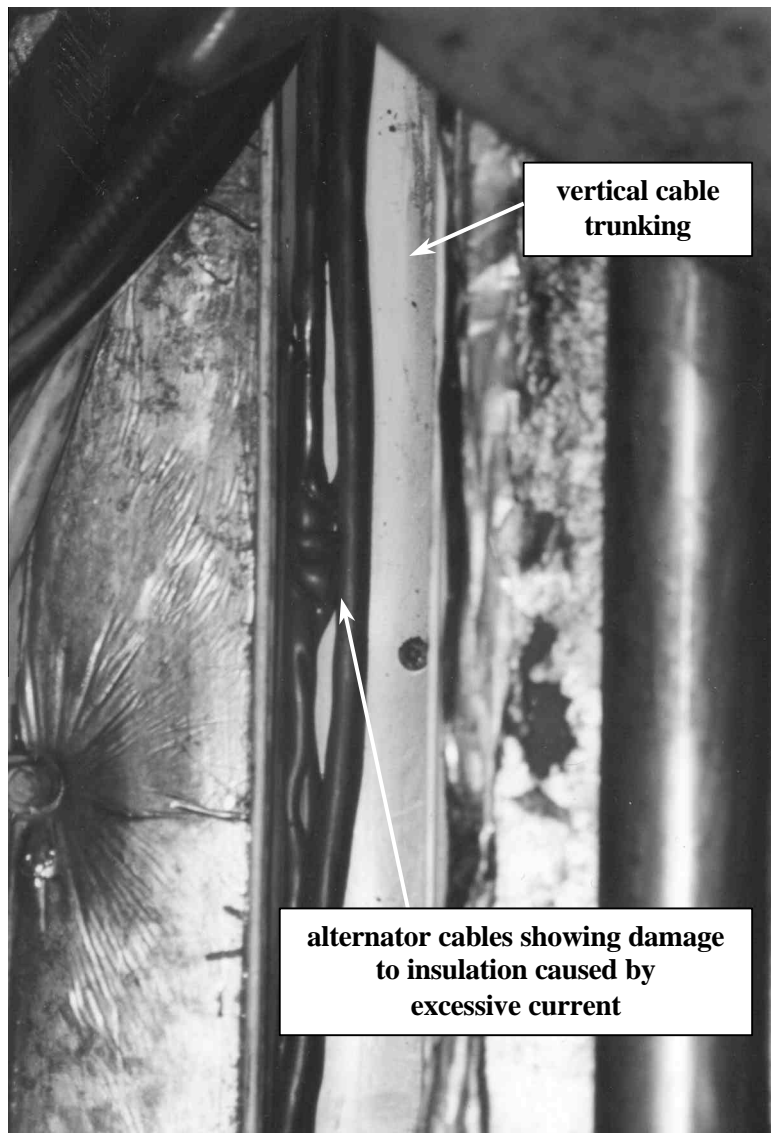
**Figure 5**  
**Photograph showing heat damage to alternator cables**

- 1.7.3 The two 16 mm<sup>2</sup> cables connecting the house alternator to the house batteries rose vertically from below the horizontal cable trunking. They were then bent at right angles to enter the trunking and ran to the shunt box on the port side. Both of these cables were severed at the bend by an electrical fault. A section about 300 mm long towards the shunt box was completely missing from each cable. It appeared, from the coppery and blue copper sulphate coloured deposits within the loom and on the cable trunking, that these missing sections of cable had been vaporised under severe electrical fault conditions.

- 1.7.5 The vertical cable trunking cap was removed and the cables examined. Insulation on the alternator cables within the cable trunking showed signs of extreme heat damage. The external surface of the cable trunking was relatively clear of soot with no signs of burning or heat damage. The heat damage to the cable had been caused by a sustained excess current flow within the cable. The only current that was able to flow along this section of cable would have been sourced from the alternator (see Figure 5).

3.4 The fire started at the right angle bend in the house battery alternator cables due to the overheating and subsequent failure of the insulation.

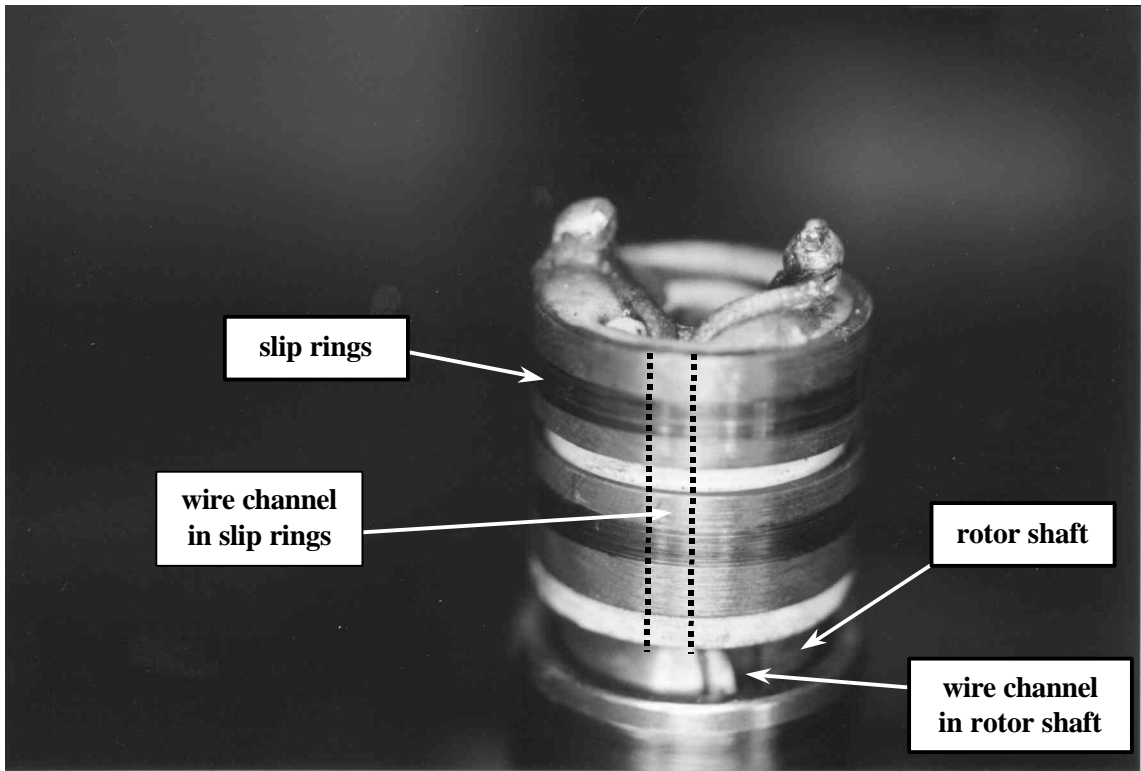
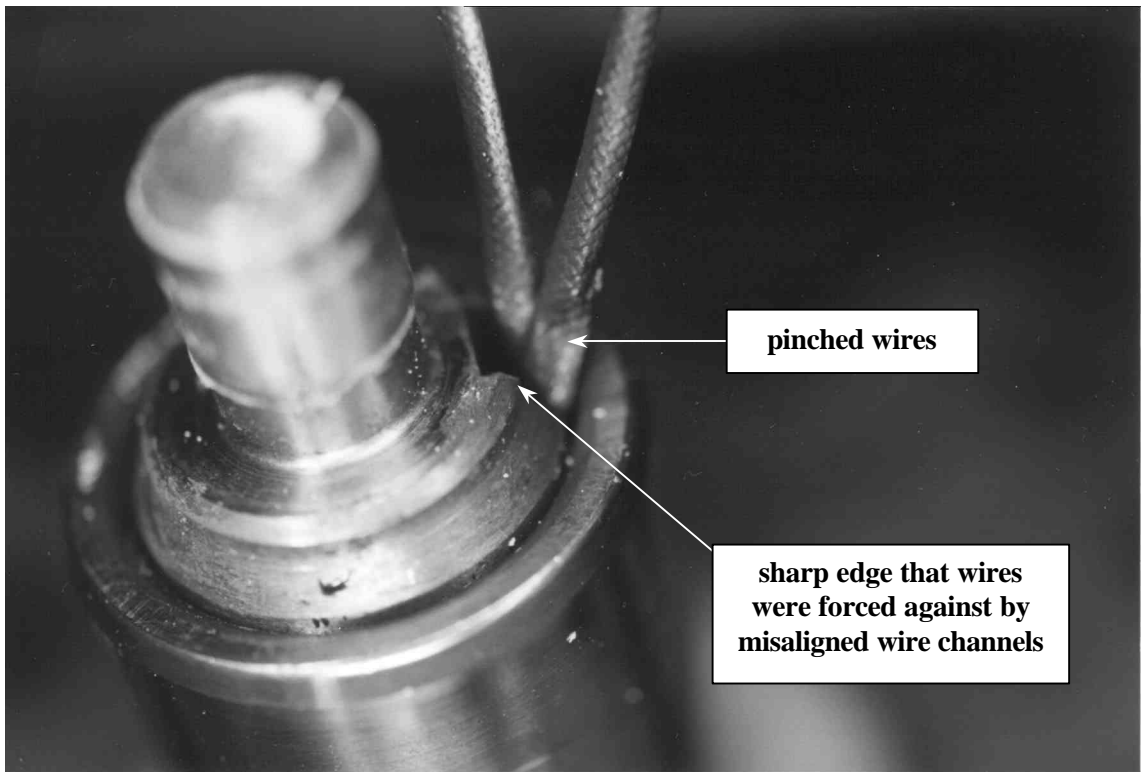
- 1.9.9 The disassembly of the alternator revealed that the wires from the rotor coil to the slip ring were being forced against the sharp edges of the wire channel within the rotor shaft. The wires had been pinched and flattened, damaging the insulation. This had been caused by the slight misalignment of the slip ring when assembling the alternator after it had been serviced just before the fire (see Figure 6 and Figure 7).

**Figure 6**  
**Photograph showing misaligned wire channels**

**Figure 7**  
**Photograph showing pinched wires with slip rings removed**

- 1.9.10 The damaged insulation created a low resistance current path between the rotor coil and the alternator case. Whenever current was able to flow through this low resistance path the regulator lost control of the output voltage. If no current flowed then the regulator worked normally. Current flow was completely dependent upon the existence of an external circuit path to one of the 2 isolated output terminals from the case. An earth loop through the HF radio created this path to the negative terminal of the alternator.

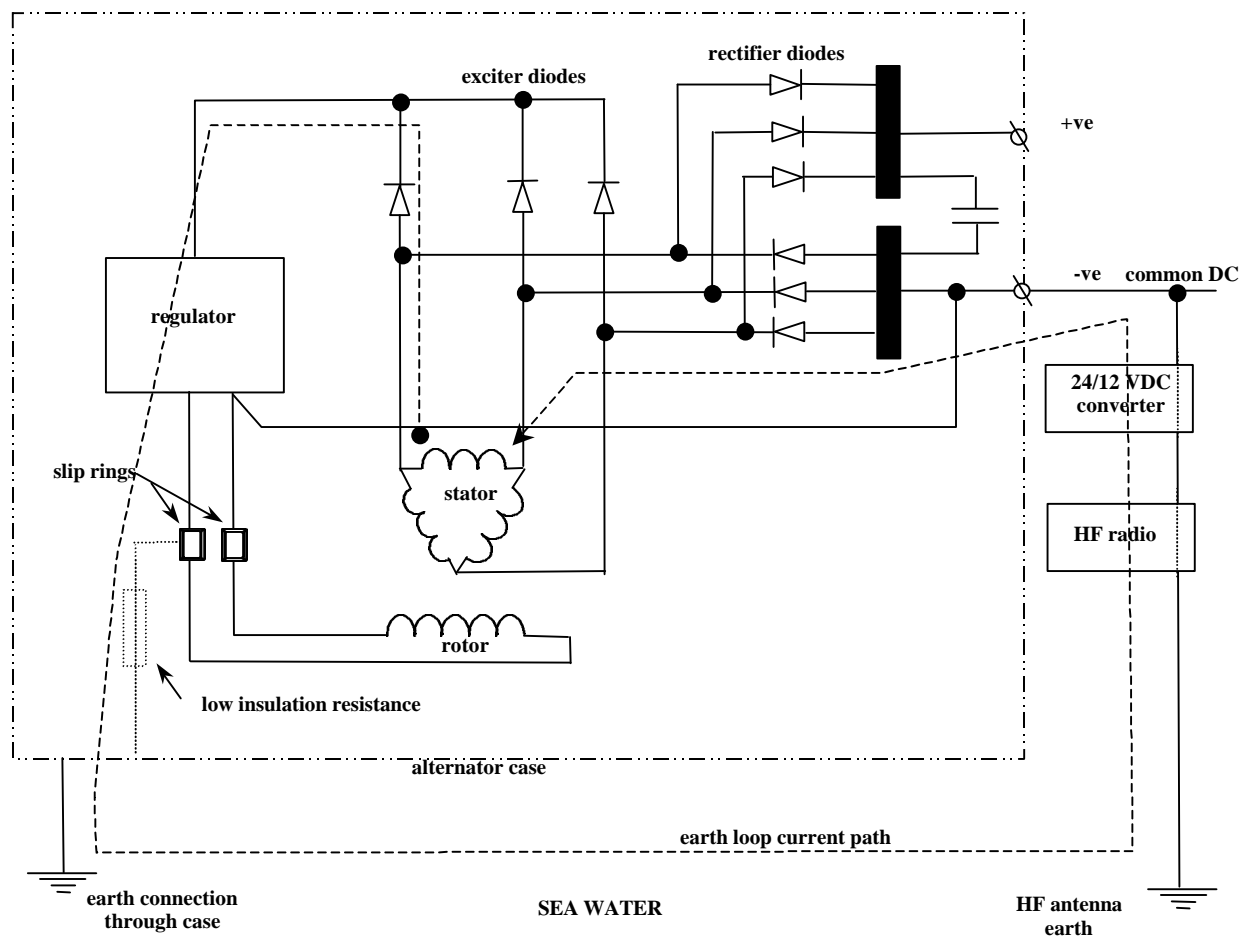
**Figure 8**  
**Earth loop current path**

- 1.9.4 Further tests on board the vessel revealed an alternative earth loop that was causing the regulator to lose voltage control of the alternator output. The earth loop was caused by the negative DC supply to the HF radio being directly connected to the HF radio antenna earth. The antenna earth consisted of a copper plate on the outside of the hull in contact with the sea water. The earth loop was completed through the sea water to the sacrificial anode and the engine block. When the earth plate connection cable from the HF radio was disconnected, the alternator worked correctly.

- 1.9.12 An earth loop DC current had been able to flow from the stator winding, through the exciter diodes, through the low resistance path to the alternator case and down through the engine mounting to the earth plate near the propeller shaft. From there the current passed via the sea water to the HF radio via its earth plate and then back to the stator windings via the negative DC battery cables. This current had adversely affected the alternator's voltage regulation (see Figure 8).
