Report 00-203

passenger charter launch *Kiwi Cruiser*

grounding and sinking

Tapeka Point, Bay of Islands

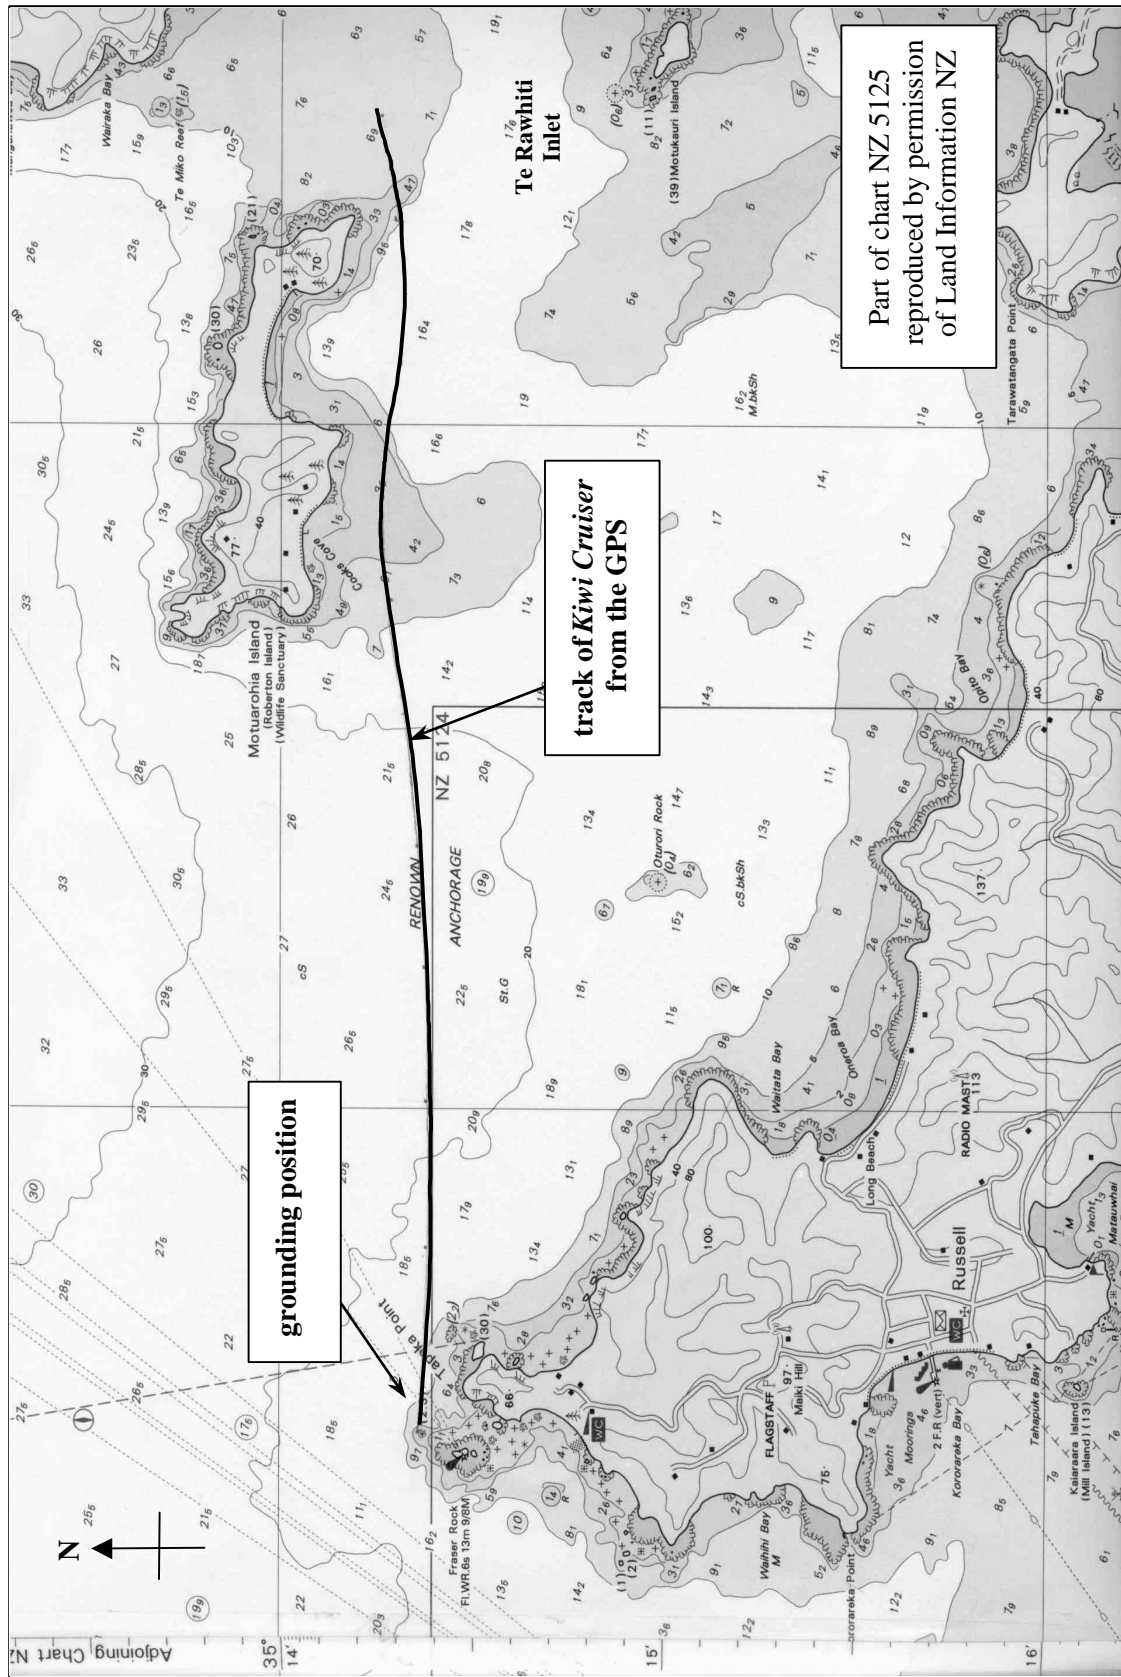
Figure 1
Part of Chart NZ 5125 showing area of accident and track from GPS

- 1.1.22 During the dive the skipper recovered personal equipment and, at the request of the Commission, the GPS receiver. The track of the *Kiwi Cruiser* was later downloaded from the GPS. The track shown on Figure 1 was derived from the downloaded data.

- 2.19 The GPS-derived track shown in Figure 1 was typical of the track expected when navigating by eye alone. The initial track headed straight for or slightly to starboard of the light. As the vessel closed on Tapeka Point the vertical angle of the light would have increased, raising the trainee's awareness of how close to it he was. He appears to have responded by altering course away from the light but not far enough to avoid the rocks on which the vessel eventually grounded.
