Report 00-204

refrigerated cargo carrier *Caribic*

grounding

7 May 2000

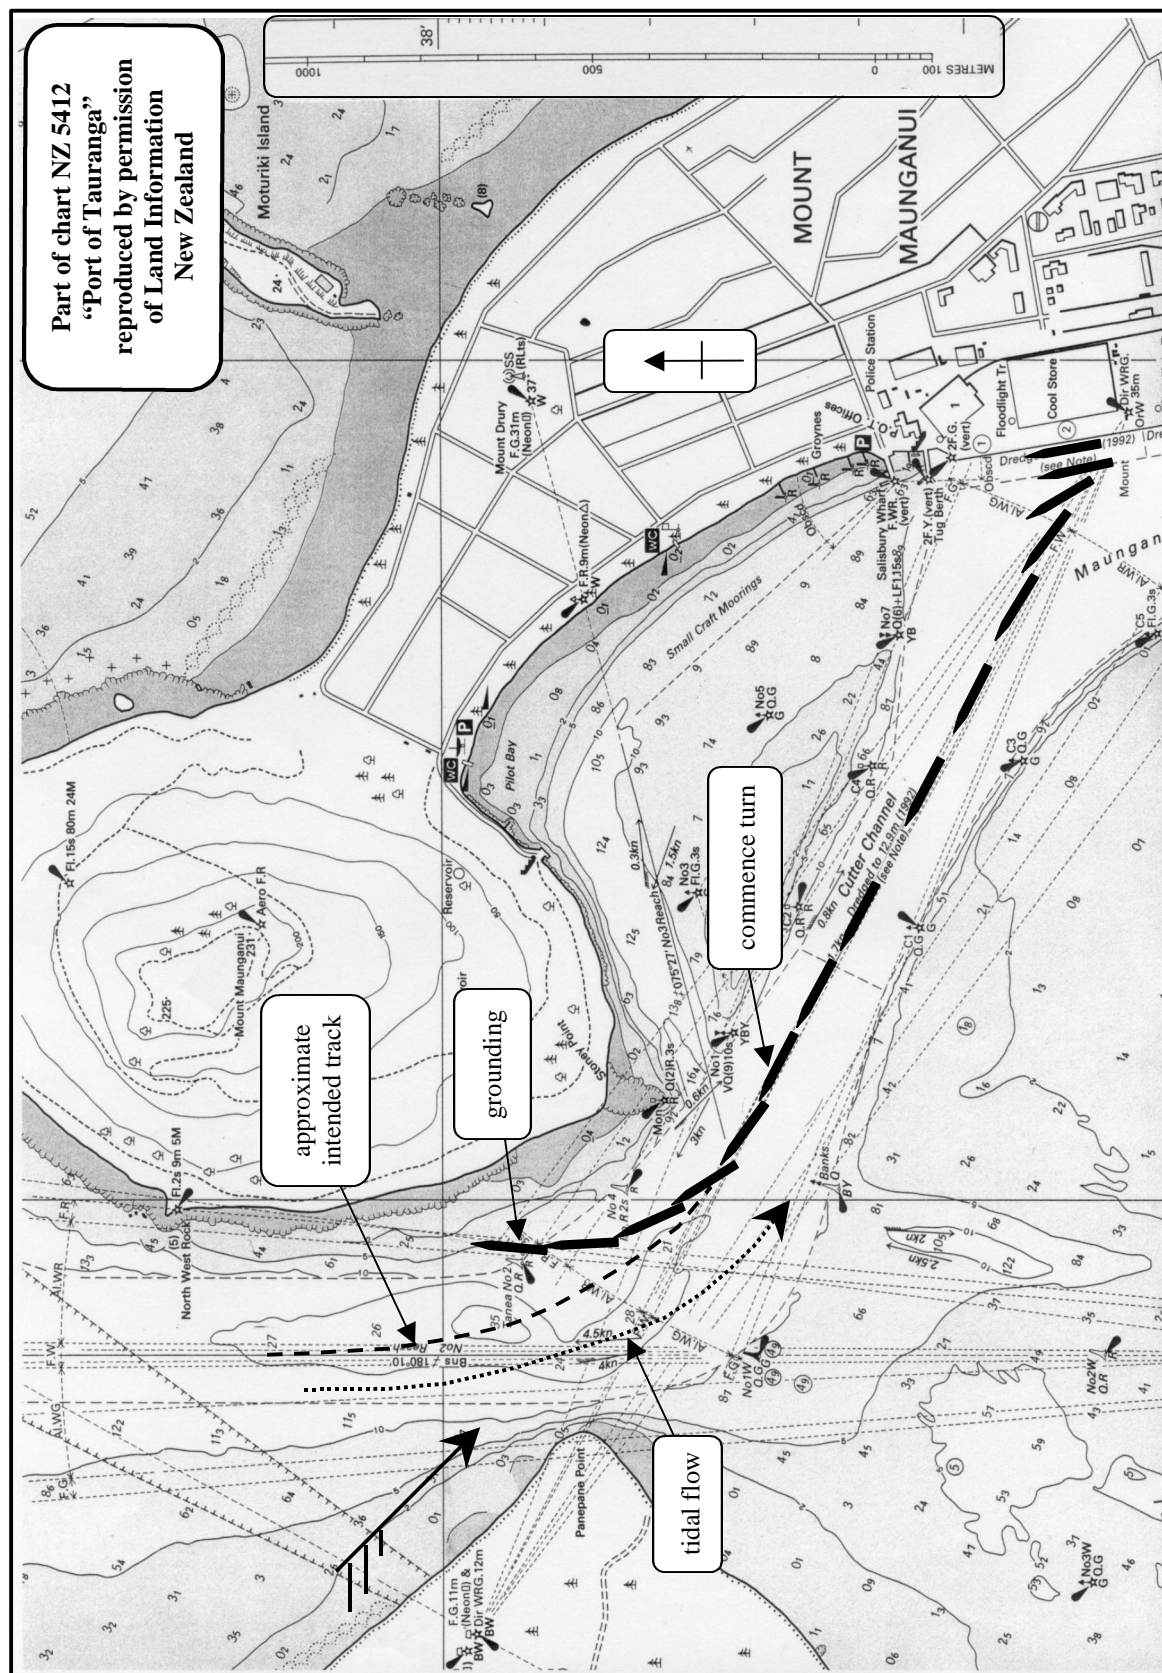
Figure 1
Part of chart NZ 5412 showing track to grounding

- 1.1.1 On Sunday 7 May 2000 at about 1245, the *Caribic* completed cargo operations at number 1 berth in the Port of Tauranga. In order that maintenance work could be completed before departure for Europe, the master requested a pilot for 2000 that night. For port operational reasons the vessel was shifted from number 1 berth to number 2 berth during the afternoon (see Figure 1).

- 1.1.13 Despite the actions taken by the master and pilot, the *Caribic* grounded at about 2020 with Tanea number 2 buoy close to port alongside the bridge. The propeller was put to zero pitch, the bow thruster stopped and the steering motors turned off. The vessel settled with a port list of 2 to 3 degrees.

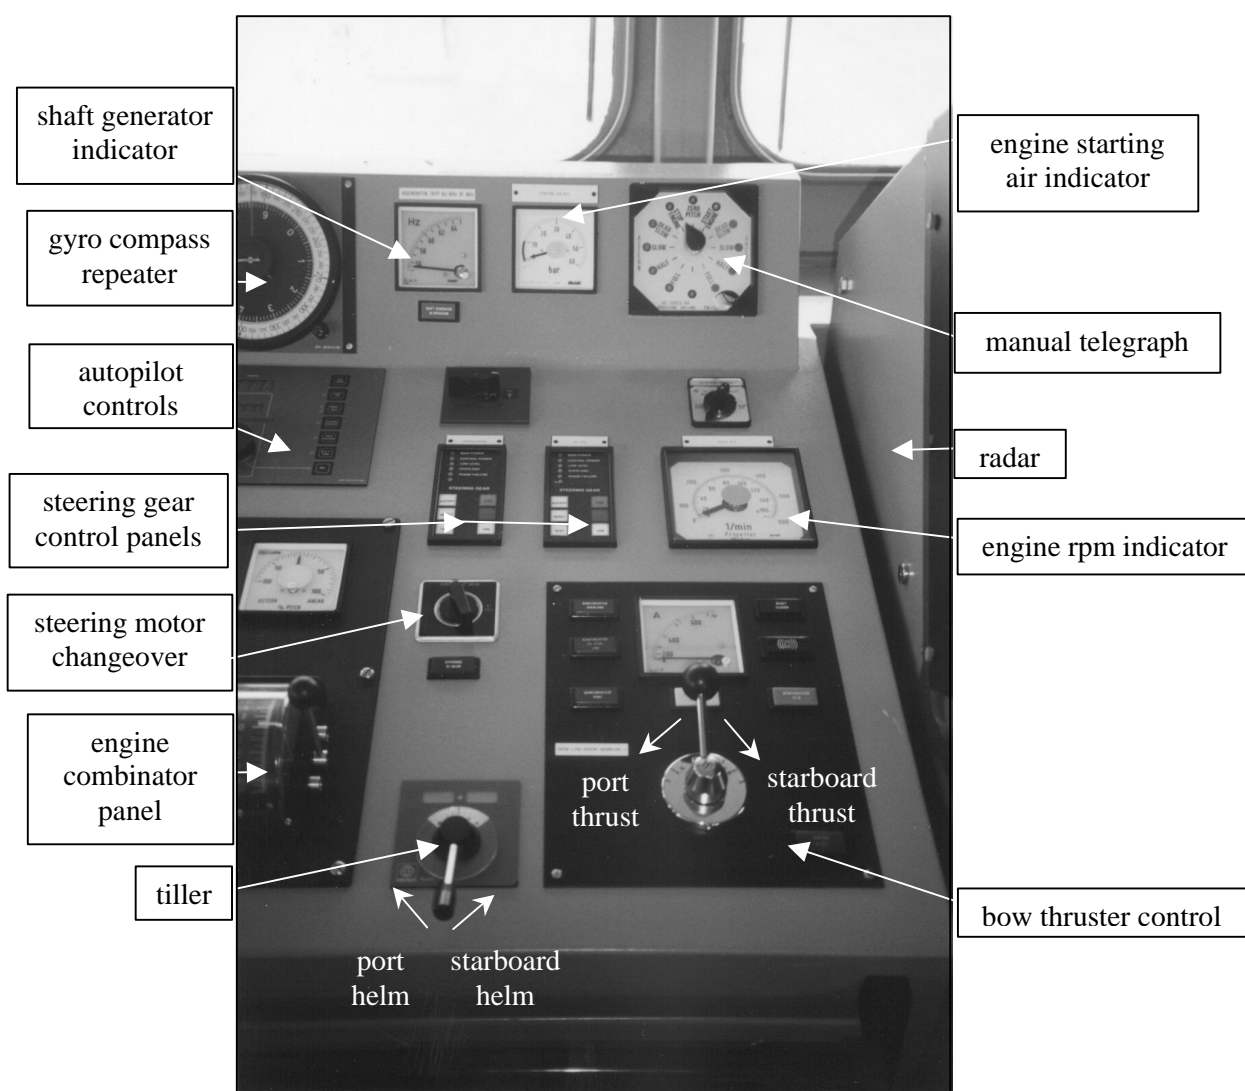
Figure 2
Controls and indicators at steering position

- 1.1.4 The master was steering the vessel using a small tiller. He was also operating the controls for the engine and bow thruster, and was monitoring the passage visually and by a radar that was situated immediately to his right (see Figure 2).

- 1.3.2 The bridge of the *Caribic* was fitted out for single watchkeeper operation and had the appropriate certification to that effect.
- 1.3.3 At the steering position, the controls for the engines, bow thruster, steering motors and internal communication system were within easy reach. The steering gyro compass repeater, autopilot controls, 2 radars and various gauges and indicators were set into the panel in front and either side of the steering position. The rudder indicator was set into the deckhead in front of the steering position and was multi-sided to enable it to be viewed from anywhere in the bridge. The VHF was set into the port side panel (see Figure 2).

- 1.3.4 There was no surface available at the steering position to place a navigational chart within sight and reach of the person steering and operating the other controls.
