Report 00-205

passenger ferries *Quickcat* and *Quickcat II*

collision

31 May 2000

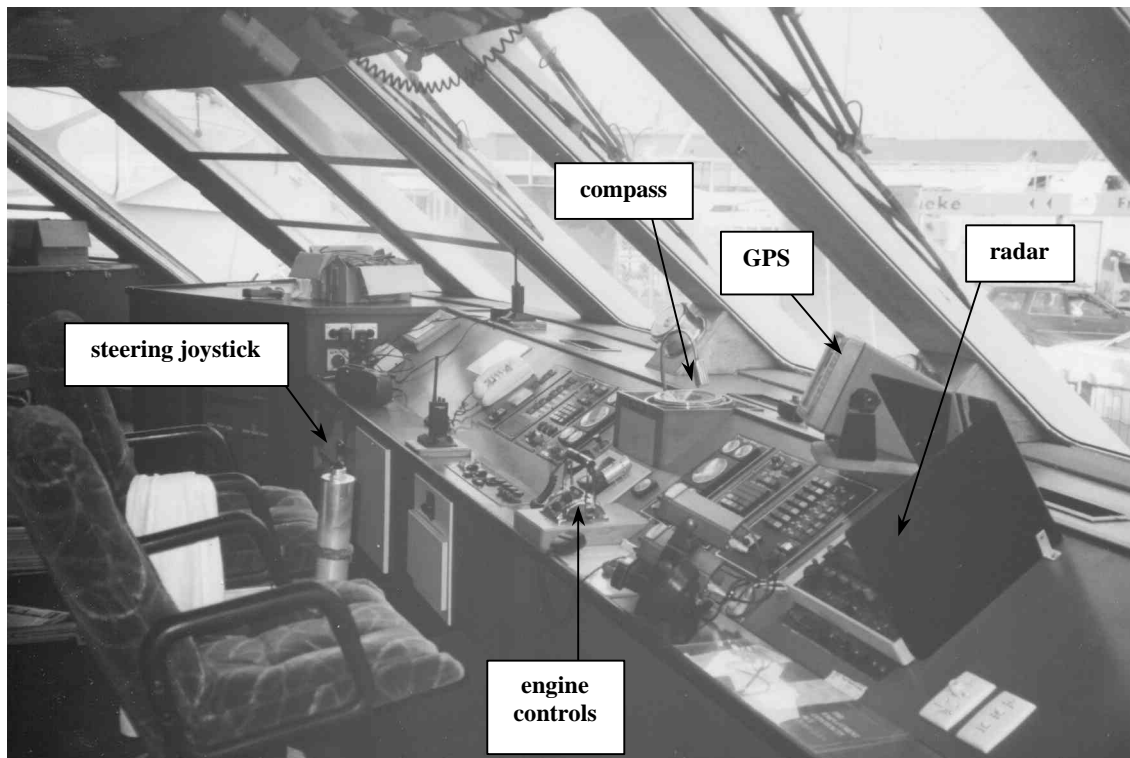
Figure 2
Quickcat wheelhouse

- 1.5.4 When seated the skipper could see the compass and reach the steering joystick, engine controls and radio. To adjust the radar settings he had to let go the steering joystick and stand up, as the radar was situated on the opposite side of the chair (see Figure 2).

- 1.6.8 From the conning position on both vessels there was a clear view directly forward, but the mullions between each window across the front of the wheelhouse on both vessels created a series of blind sectors to either side.

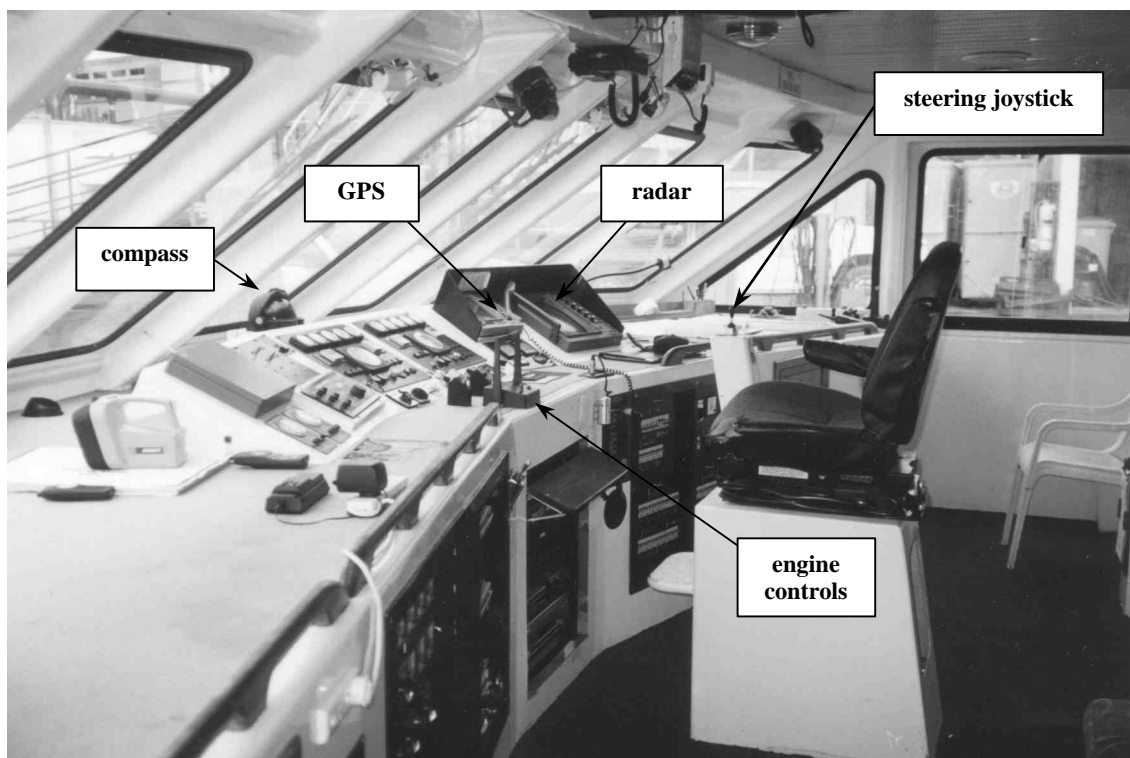
Figure 3
Quickcat II wheelhouse

1.6.3 The position of the wheelhouse and its layout was similar to the *Quickcat*. The steering joystick and radar were situated on the starboard side of the seat so the skipper could reach all the navigation and control equipment from a standing position. In order to adjust the radar settings the skipper had to let go the joystick (see Figure 3).

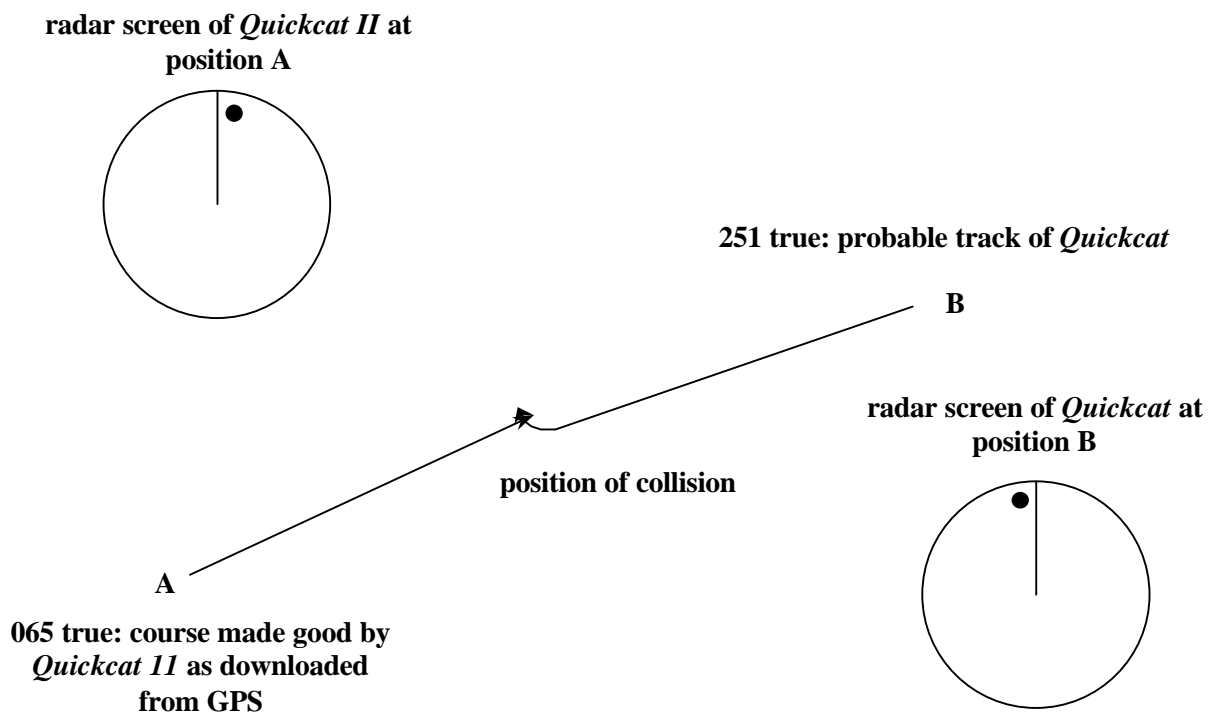
Figure 4
Diagram showing aspect of *Quickcat* and *Quickcat II*
(not to scale)

- 2.2 The track downloaded from the GPS of the *Quickcat II* was its true course made good prior to the collision. The skipper of the *Quickcat* had the tracking facility switched off on his GPS so the reconstruction of events is based on his account of the action that he took. The actual distance of closest approach if they had maintained their courses is unknown (see Figure 4).

- 2.3 The skipper of the *Quickcat* saw the radar echo of the *Quickcat II* fine to port of his heading marker, so he instinctively wanted to alter course to starboard and pass “red to red”. The skipper of the *Quickcat II* saw the *Quickcat* fine to starboard of his heading marker and elected to offer to pass “green to green”, which appeared to the skipper of the *Quickcat* to involve him altering course to port. Neither skipper, however, fully appreciated the situation. Neither knew what the course, speed or aspect of the other vessel was. The only prudent course of action to allow time to properly assess the situation in this case would have been to reduce speed to the minimum steerage speed or stop.
