Report 00-207

commercial jet boat *Discovery*

collision with rock face

Shotover River, Queenstown

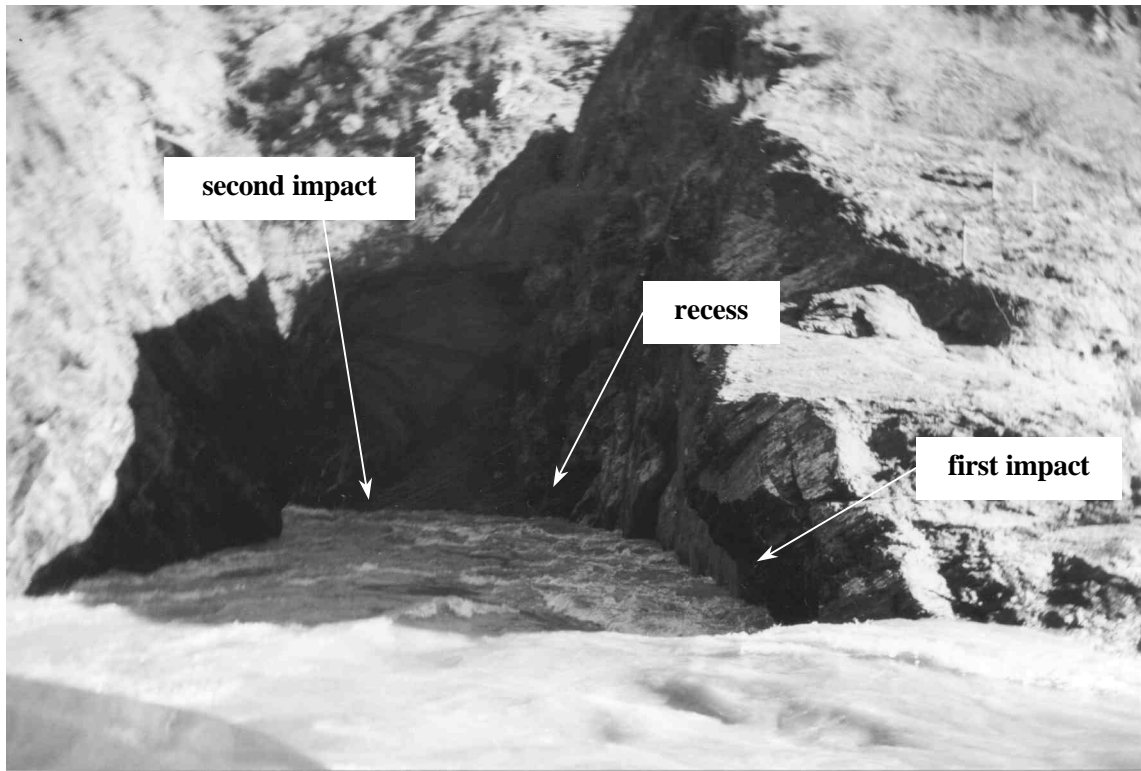
Figure 2
Entrance to Tyrees Cut

- 1.1.7 With a jet boat, the rate of a turn is governed by a combination of steering nozzle deflection and jet unit thrust. Because the driver of the *Discovery* was not able to achieve the level of thrust he wanted, the boat drifted to the right of his intended track, causing the starboard aft side to strike the rock face at the entrance to the cut. The impact caused the boat to sheer towards a recess in the true right canyon wall about 15 m downstream. To minimise the impact and avoid the boat becoming wedged in the recess the driver immediately put the helm to port, adjusted the position of his foot and applied power (see Figure 2).

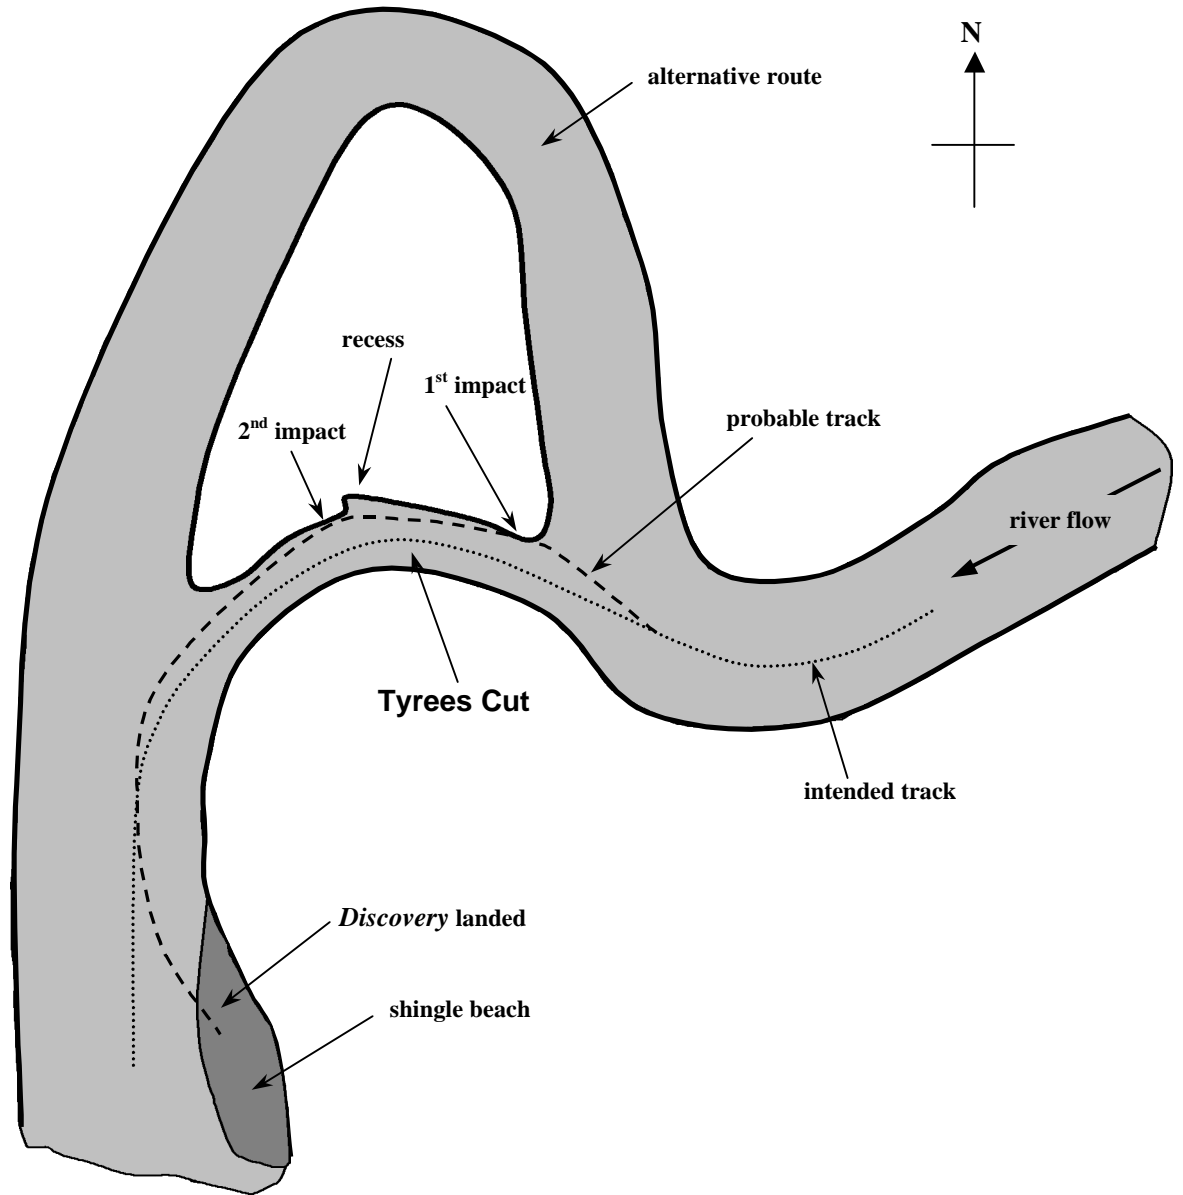
Figure 3
Path of the *Discovery* through Tyrees Cut, and the alternative route

- 1.1.10 With the aid of the paddles the driver and some of the passengers were able to manoeuvre the boat out of the fast water and beach it on an area of shingle about 100 m downstream of the cut (see Figure 3).

- 4.1 Immediately after the accident the operator's general manager:
- banned drivers from wearing Sorells while driving the boats or the 4-wheel drive vehicles
 - diverted the trip through the alternative route around Tyrees Cut if the river height was above 1300 mm.
- 4.2 When repairing the boat the following modifications were made:
- the gunwales were padded on the *Discovery* and the other boats in the fleet used for jet boat trips
 - the front seat passenger's foot rests were extended
 - the gunwale around the driver's seat was padded.

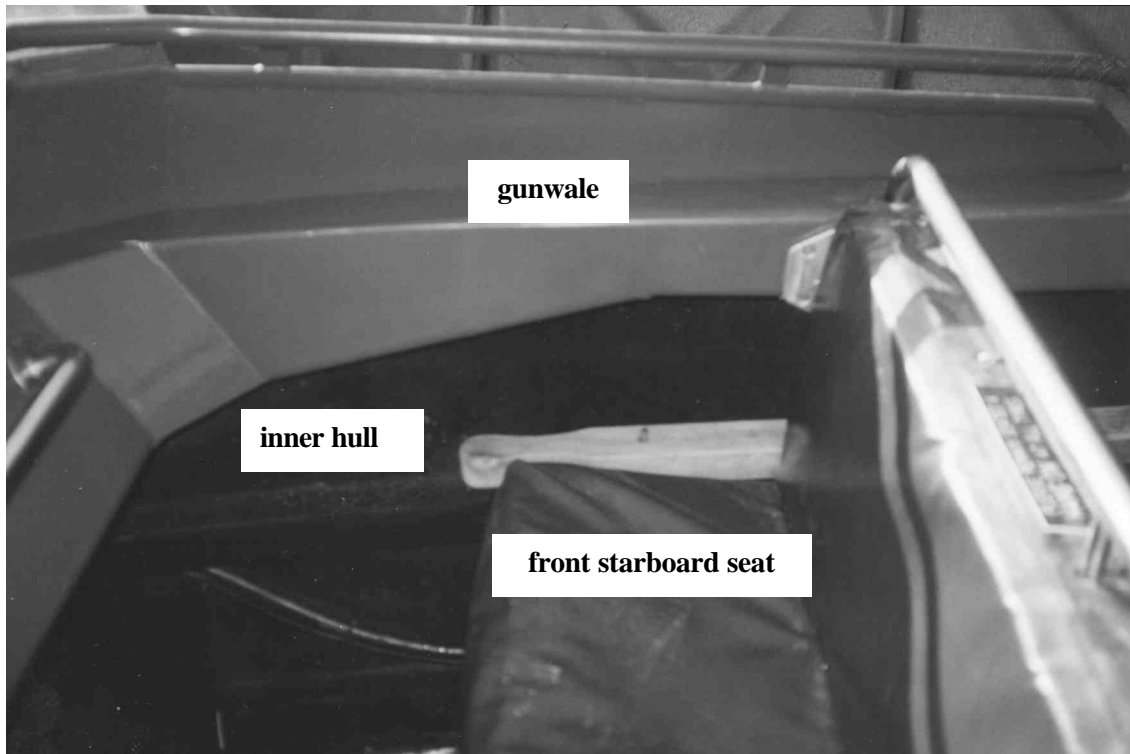
Figure 4
Gunwale on the starboard side of the front seat

- 1.1.12 On the starboard side of the boat the gunwale extended down into the boat, stopping about 25 cm short of the base of the seats. The space under the gunwale was used for running steering and electrical cables. When the *Discovery* struck the rock face the second time, the weight of the other passengers sliding across the seat forced the hip region of the 2 outside passengers in the front 2 rows of seats into this space. The deceleration of the collision resulted in one receiving a broken hip and the other severe bruising. The driver had a cut above his right eye which he thought had been caused by the frame of the glasses he was wearing.

- 5.3 On 15 January 2001 the Commission recommended to the general manager of Skippers Grand Canyon Limited that he:
- 5.3.1 remove or alter the extended plate to the left of the accelerator to prevent the driver's forefoot from catching on it (131/00)
 - 5.3.2 modify either the gunwale or the passenger seats to prevent passengers sliding into the gap under the gunwale. (132/00)

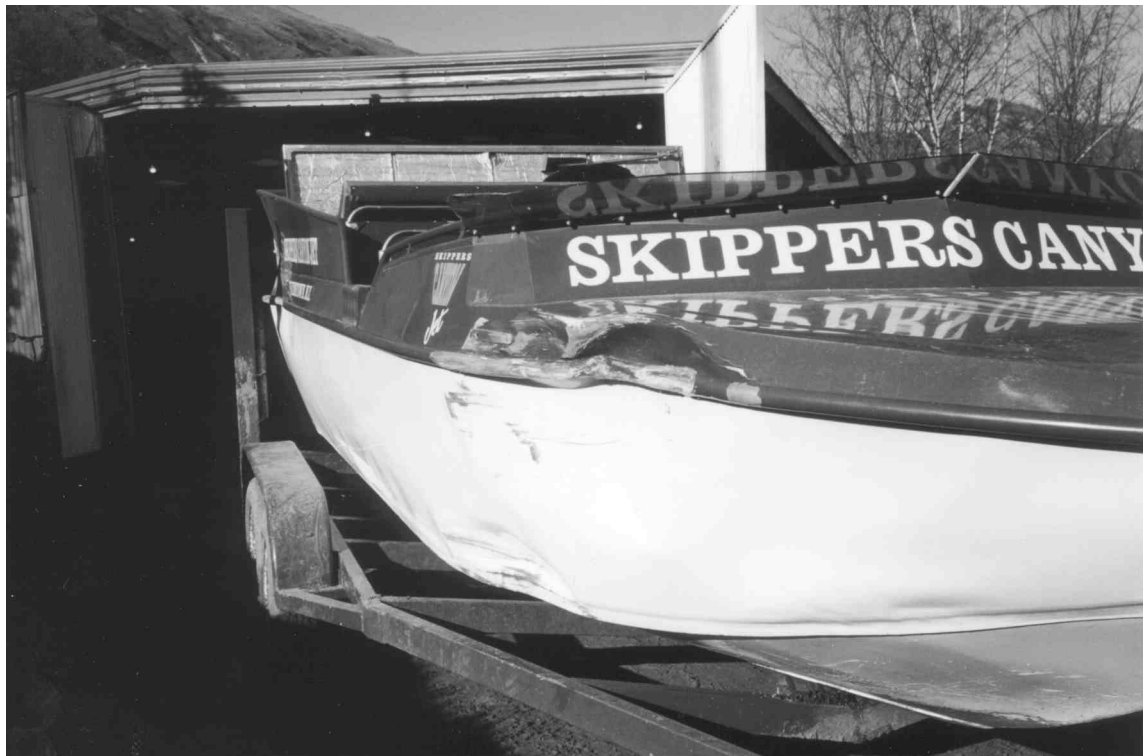
Figure 5
Damage to the starboard side of the *Discovery*

- 1.2.1 In the first collision with the rock face the *Discovery* suffered scrapes and minor indenting to the starboard aft side of the boat. There were also scrapes on the bottom in an area about one metre from the stern across to the trim tab under the jet nozzle, which was bent slightly upwards.
- 1.2.2 The second collision with the rock face caused heavy indentations to the starboard bow, just forward of the windshield, and to the hull directly below this point. These indentations continued back to the stern but were not as deep as those in the forward section. There was no apparent damage to the engine or steering system.

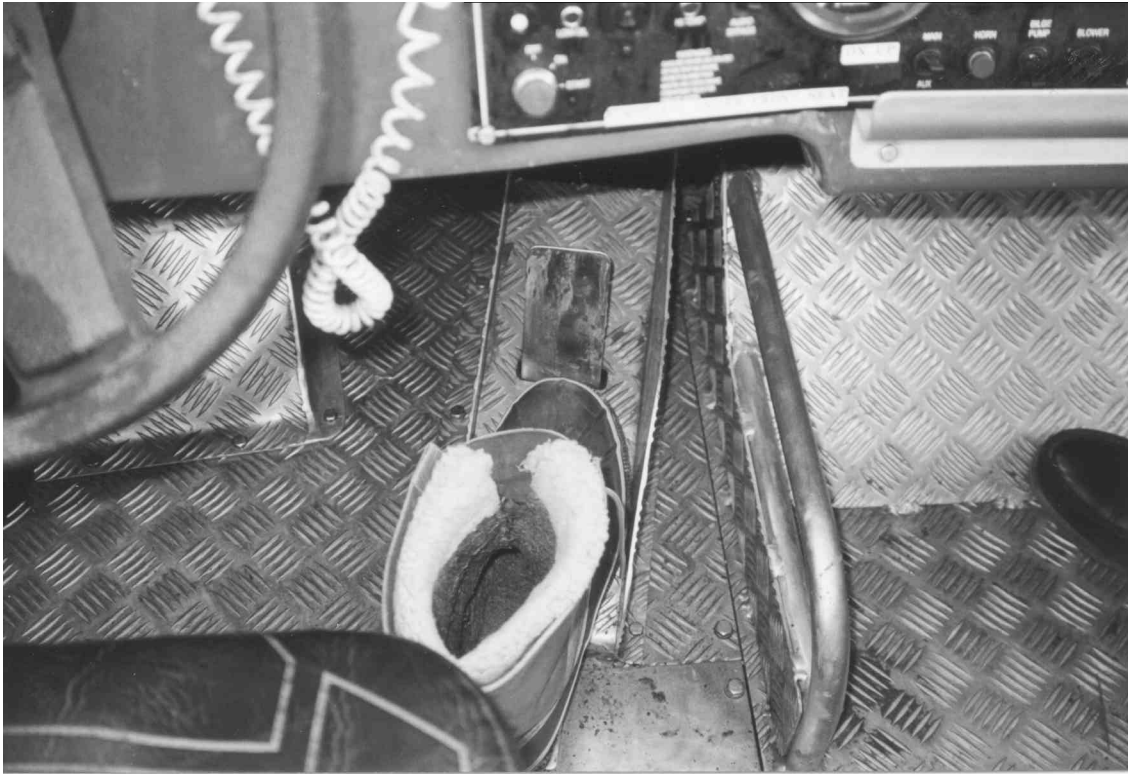
Figure 6
Accelerator arrangement and a Sorell boot

- 1.4.4 At the stern of the boat under the jet unit was a trim tab which doubled as protection for the jet unit.
- 1.4.5 The accelerator pedal was a smooth aluminium plate about 130 mm long and 70 mm wide situated to the right of the driving position and angled slightly towards the driver. It was cut into a 430 mm long and 145 mm wide chequer-plate footrest with a 40 mm extended plate on the left side and an 80 mm extended plate on the right. A 25 mm diameter alloy pipe guard was fitted to the right of the accelerator arrangement to prevent the feet of the passenger sitting next to the driver from interfering with the accelerator operation (see Figures 6 and 7).

2.5 The lining in the driver's Sorells was worn so they did not fit as tightly as when new. This would have inhibited the driver's "feel" on the accelerator and caused a delay from the time the driver moved his foot to the time the boot moved.

2.6 The extra width of the Sorell compared to a normal boot reduced the available distance between the extended plates either side of the accelerator, thus increasing the chances of the boot becoming caught on them.

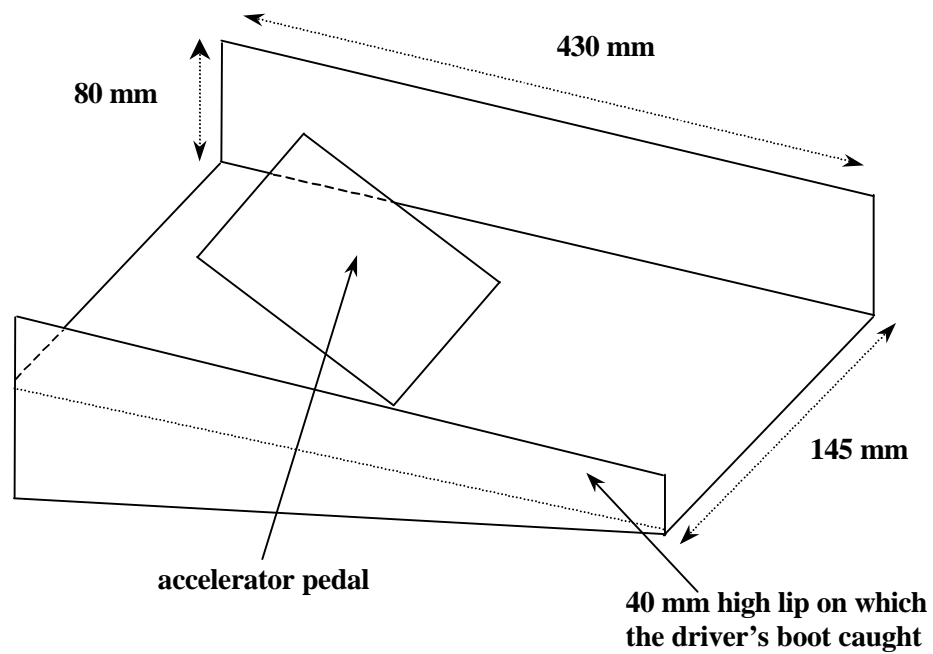
Figure 7
Dimensions of accelerator surround

2.7 The accelerator surround was designed to prevent the driver's foot from slipping or losing contact with the accelerator. When driving, the heel of the driver's right foot was in constant contact with the foot plate, while the toe of the boot was moving up and down to work the accelerator. If the extended plate on the left-hand side of the accelerator tapered off below the base of the accelerator the heel of the driver's foot would still be contained but the possibility of the forefoot becoming caught would be removed. The extended plate on the right of the accelerator was high enough not to be a problem and provided a useful guide for the driver's foot.
