## **Report 00-208**

**tug *Mahia***

**near capsized, parted towline and manoverboard**

**5 July 2000**

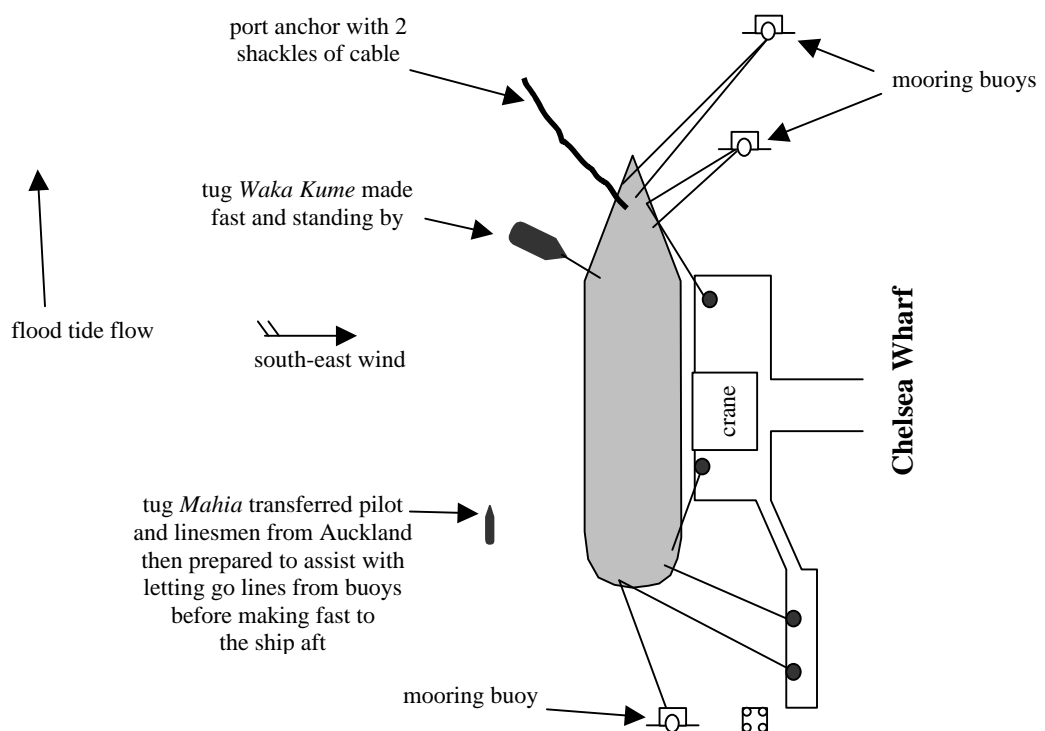
**Figure 2**  
**Mooring arrangement of the *Dorthe Oldendorff* at Chelsea Wharf**

- 1.1.12 The pilot told the skipper of *Mahia* to let go the stern line that was made fast onto the mooring buoy. Once that was done he told the skipper to go forward and let go the 2 long lines to the far mooring buoy. As the *Mahia* was moving forward, the pilot told the master to single up aft to one stern line and a spring line (see Figure 2).

- 1.1.13 When the pilot next looked aft, he saw that both stern lines to the wharf had been slackened off and let go, leaving only the spring line made fast.

- 1.1.14 When the *Mahia* had reached the distant forward mooring buoy, the pilot told the master to have the 2 lines slackened off for letting go. The master passed the instruction to forward but the crew slackened all the headlines, including those to the closer mooring buoy.

- 1.1.15 Seeing all the headlines slack, the pilot decided to let them all go although the release of the lines to the closer mooring buoy was sooner than he had planned. Once the headlines were let go, only the forward and aft spring lines to the wharf remained fast.

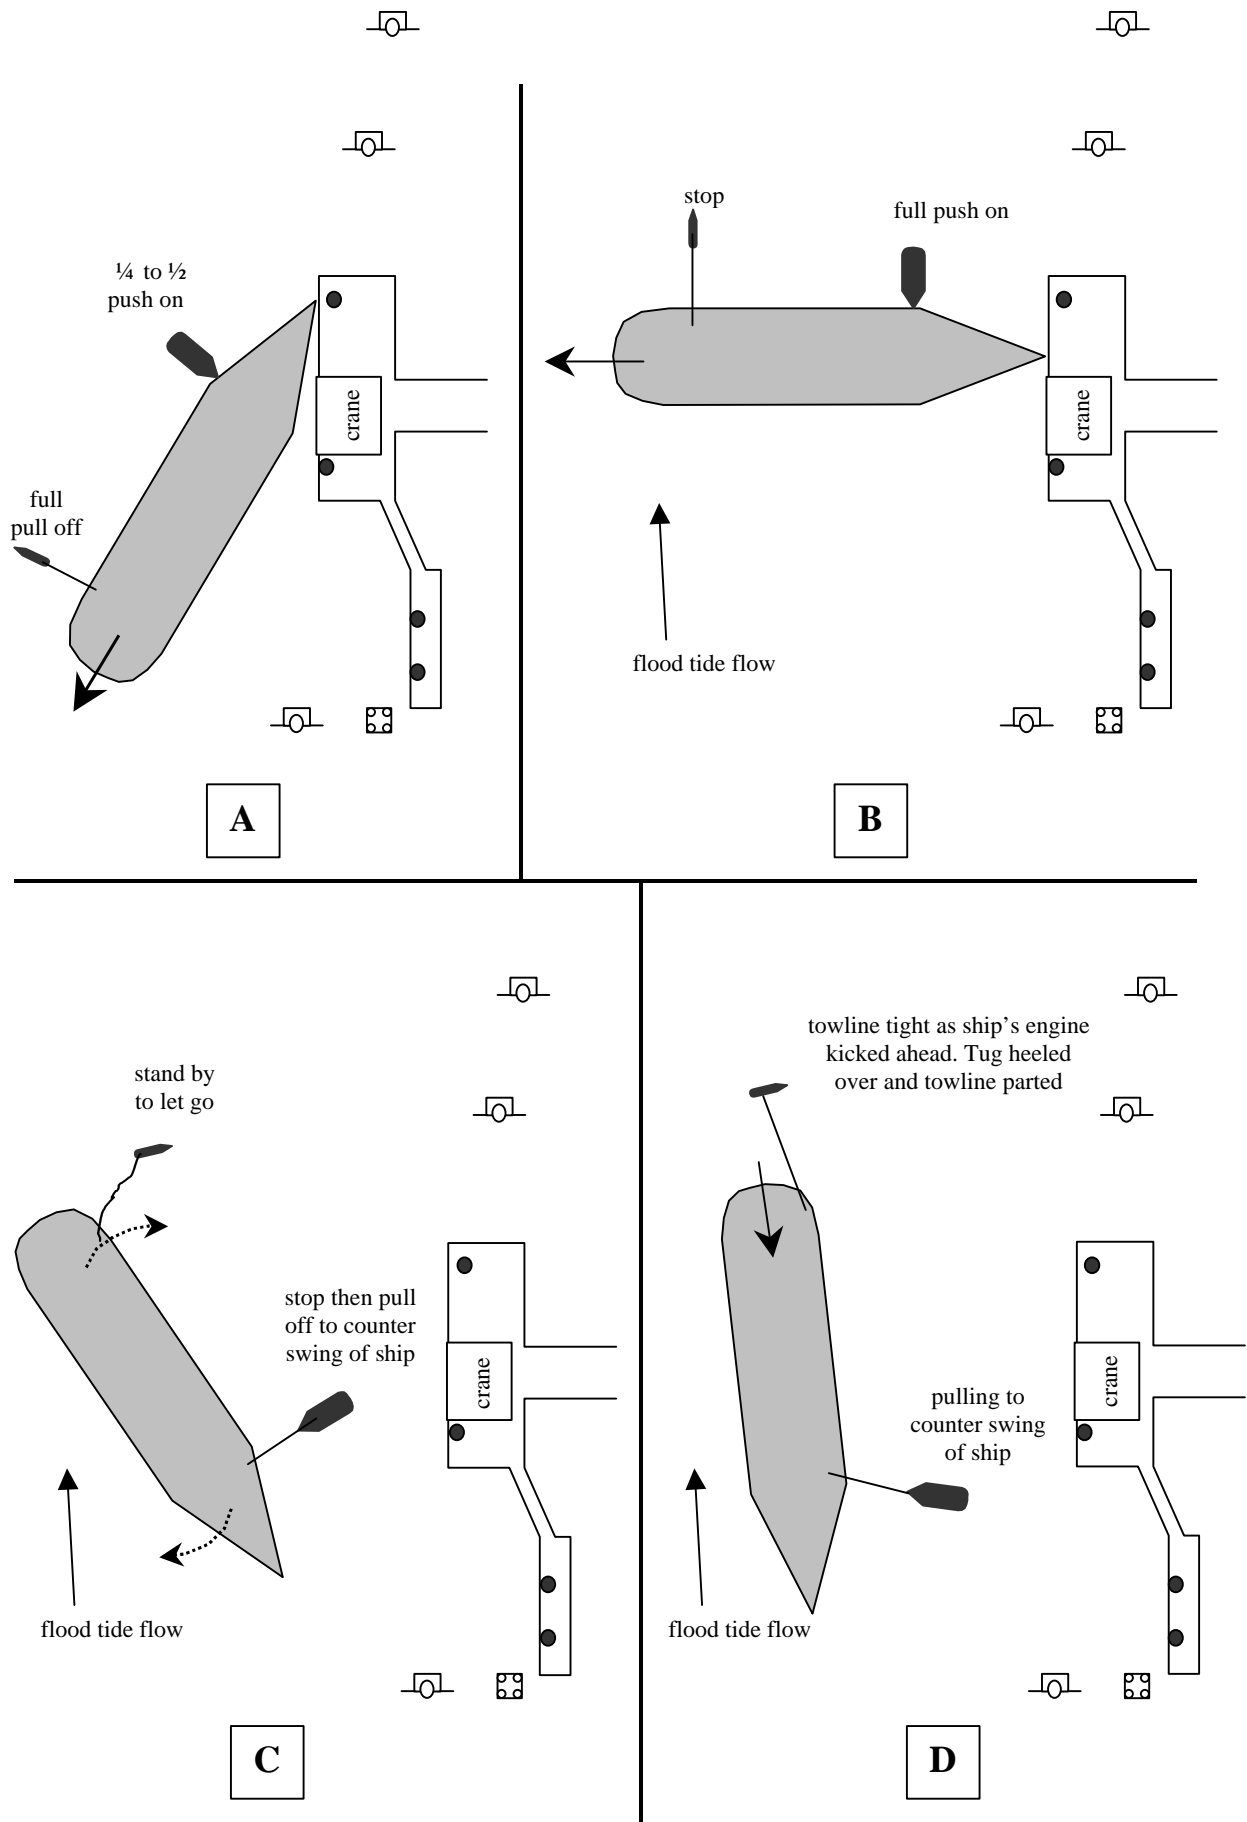
**Figure 3**  
**Stages of unberthing and turning of the *Dorthe Oldendorff* from Chelsea Wharf**

- 1.1.17 The pilot ordered the *Mahia* to pull off at right angles to the ship. He issued orders to the *Waka Kume* to push on the bow at power settings varying from a quarter to a half. As the ship began to move astern he ordered slow astern on the engine. The time of this engine movement was recorded in the ship's bridge movement book as 0857. This time and the times of subsequent engine movements were recorded to the nearest minute.

- 1.1.18 As the *Dorthe Oldendorff* moved aft, the forward spring line became slack and was let go. With the *Mahia* pulling off aft, the ship swung into the stream stern first and the pilot used the *Waka Kume* to control the bow, keeping it clear of the wharf knuckle and crane. He increased the engine power to half astern at 0858.

- 1.1.19 When the ship was clear of the wharf and at right angles to it, the pilot ordered the *Mahia* to stop pulling but maintain position, and the *Waka Kume* to push on at full power to complete the turn. By this time the stern of the ship was in the flood tide flow and being pushed by it. The pilot and master had been on the starboard wing of the bridge while manoeuvring the ship off the wharf, and at this stage moved into the wheelhouse.

- 1.1.20 When the ship was swinging towards the line of the channel, the pilot ordered the ship's engine stopped at 0859 and instructed the skipper of the *Waka Kume* to stop pushing and then pull off to control the swing, which had become greater than he expected.

- 1.1.21 The pilot told the skipper of the *Mahia* to stop and stand by to let go, and that he was going to kick the engine ahead to arrest the sternway of the ship before letting go the towline. The skipper of the *Mahia* told the pilot that there was no ship's crew aft to let his line go so the pilot requested the master to instruct the aft crew to stand by to let the tug go. At 0900 the pilot ordered half ahead on the engine.

- 1.1.22 The skipper of the *Mahia* had stopped his tug in readiness for letting go and the towline was slack. The stern of the *Dorthe Oldendorff* had swung past the tug's position so that the tug was astern of the ship and beam on to its propeller wash. The wash, which the skipper of the *Mahia* later described as "a sheet of water" from the stern of the *Dorthe Oldendorff*, pushed the *Mahia* astern and the towline became tight again and caused the tug to heel over to such an extent that its deck edge was substantially submerged.

- 1.1.23 At 0901 the pilot ordered the engine stopped and the *Mahia* to be let go. The master passed the instruction to aft. The aft crew arrived to let go the tug but meanwhile the propeller wash from the engine and a surge of water as the engine stopped caused the *Mahia* to heel further. The towline parted and the tug rapidly righted itself. The deckhand, who had been waiting on the tug's aft deck to retrieve the towline, was thrown overboard.
