## **Report 00-211**

### **harbour tug *Waka Kume***

### **loss of control**

**19 November 2000**

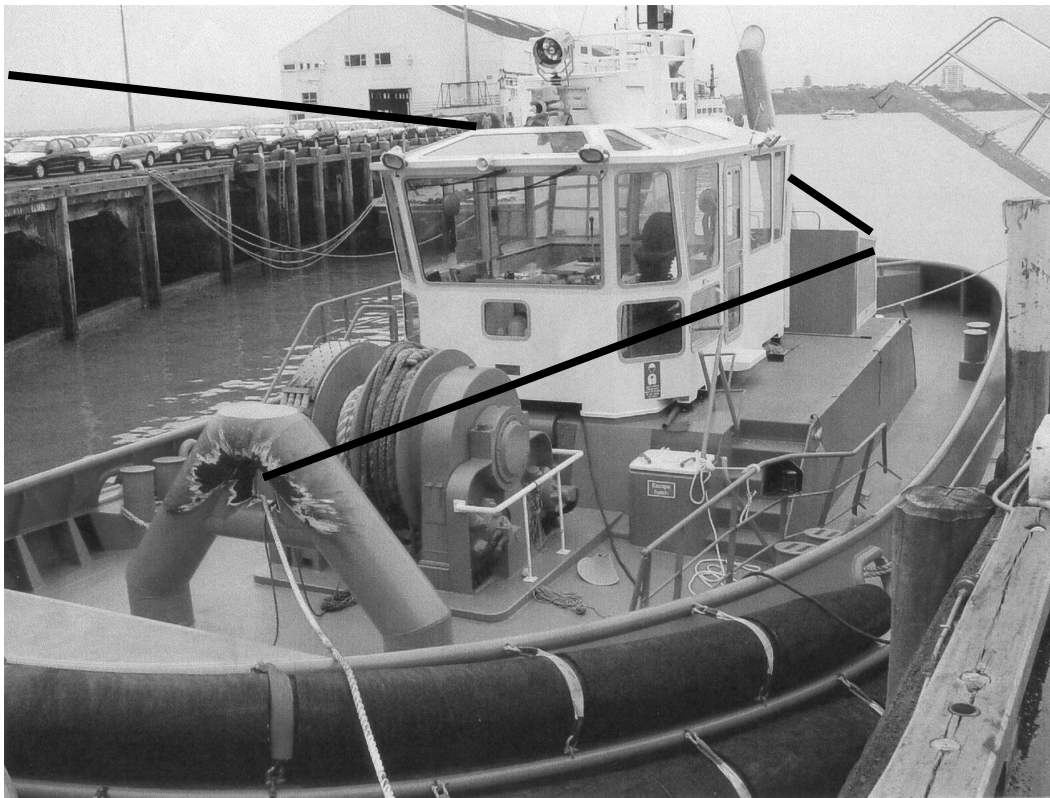
**Figure 2**  
***Waka Kume* showing direction of towline and damage to port side**

- 1.2.1 Damage sustained in the accident was caused by the towline contacting the tug's superstructure, starboard funnel and deck fittings and then coming under load.
- 1.2.2 The damage included the following:
- broken handrails on both sides of the steps from the starboard side of the fore deck to the wheelhouse
  - broken windows on both sides of the wheelhouse
  - broken whistle klaxon on monkey island
  - damage to the starboard stay bracket for the mast
  - damage to starboard forward and port aft deck spot lights
  - crush damage to the corner above the access to the CO<sub>2</sub> store
  - crush damage to the starboard engine room ventilator
  - crush damage to the starboard funnel
  - crush damage to the starboard after corner of the wheelhouse
  - damage to the towline.

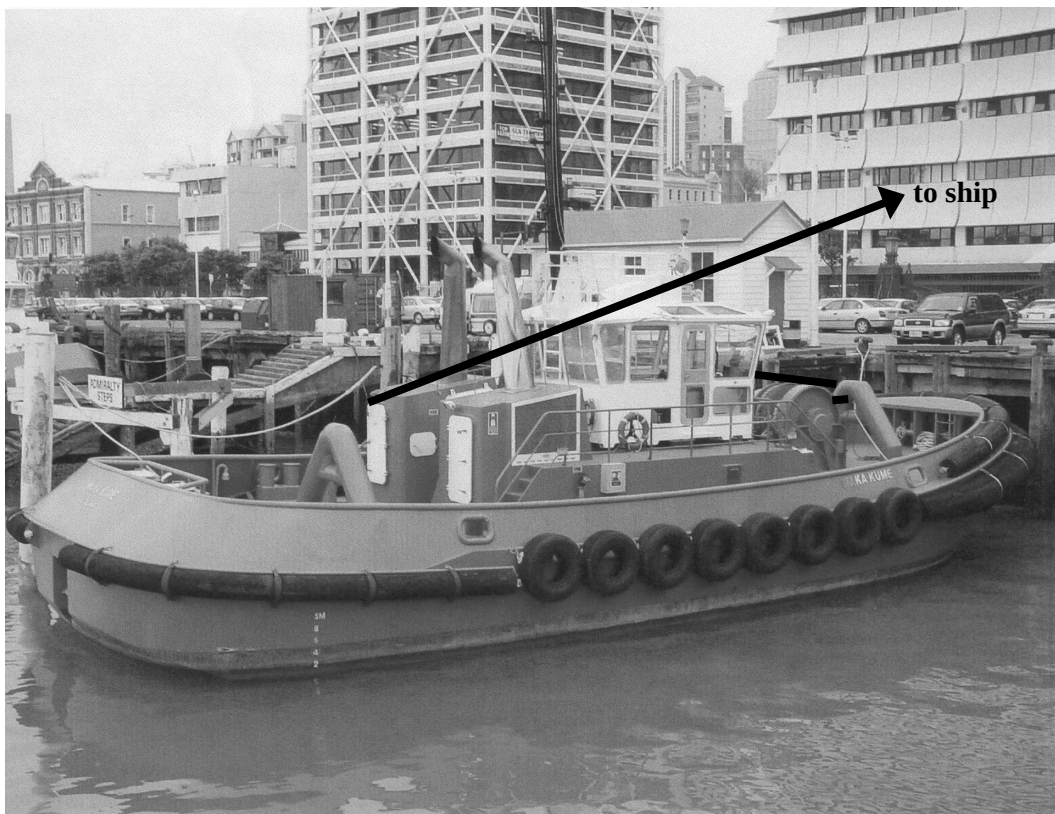
**Figure 3**  
***Waka Kume* showing direction of towline and damage aft end and starboard side**

- 1.1.14 The tug continued rotating to starboard, wrapping the towline around the port side of the wheelhouse, across the after end of the superstructure, up and around the back of the starboard funnel, and then forward along the starboard side of the wheelhouse, eventually riding up over the monkey island. The weight came on the towline causing damage to the superstructure, starboard funnel and deck fittings.
