Report 01-009

Bell 206B Jetranger

ZK-HWI

perceived engine power loss and heavy landing after take-off

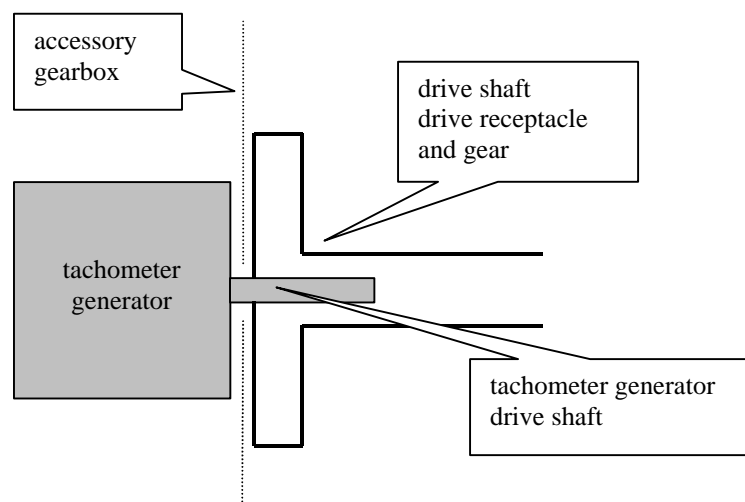
Figure 1. Tachometer generator and drive mechanism

- 1.5.6 The N_1 and N_2 tachometer generators were removed from the accessory gearbox. The tachometer generators had square-shaped drive shafts attached, which fitted into corresponding normally square-shaped drive receptacles on gears in the accessory gearbox. (See Figure 1) The drive receptacles normally rotated the generator drive shafts. The N_2 tachometer generator drive shaft receptacle had red coloured RTV inserted in it. This had been inserted on top of some brown aviation sealant. The RTV was not adhering to the N_2 tachometer generator drive shaft and it fell away from the shaft as it was removed from its receptacle. The drive shaft was polished on each of its 4 corners, indicating that its receptacle had been rotating around the shaft instead of driving it. The drive receptacle was rounded instead of square-shaped. The N_2 tachometer generator drive shaft was reinserted into its receptacle and the engine rotated. The receptacle rotated around the drive shaft and did not turn the shaft and drive the N_2 tachometer generator, as it should have. The N_2 tachometer generator was tested separately and operated normally.

- 2.6 The N₂ tachometer generator had been replaced during field maintenance 6 months before the accident, and RTV was placed in the drive receptacle to prevent any fretting and any further wear or slippage. The maintenance engineer said he intended to replace the drive 10 days later during the scheduled helicopter servicing. The drive receptacle replacement could not be accomplished in the field because of the complexity of the work. The engineer recorded the defect and the rectification action taken on the appropriate work record sheet but did not transfer this information to other appropriate records. Because the required subsequent action was not recorded in the maintenance work pack as additional maintenance due on the company maintenance advice form, nor in the helicopter technical log, and because there had been no further reports of erroneous N₂ gauge indications, the drive receptacle replacement was overlooked during subsequent servicings. Consequently, the RTV deteriorated over time and failed to prevent further wear, or failed to continue to assist in maintaining a positive drive, between the N₂ tachometer generator drive shaft and its receptacle, until slippage between them occurred. On the accident flight, the drive failed causing the N₂ gauge indication to decrease.

- 3.1 The N₂ tachometer generator drive failed shortly after take-off, which caused the N₂ gauge indication to decrease and infer a loss of engine power, or transmission drive problem.
- 3.2 The instructor pilot did not have sufficient time to confirm the failure, and took the appropriate and immediate action necessary in response to what he perceived to be an engine power loss, or transmission problem, during a critical phase of flight.
- 3.3 The follow-up action necessary after field maintenance to the N₂ tachometer generator drive was overlooked, and the drive remained in service until it deteriorated and failed.
- 3.4 The maintenance company and operator did not have a suitable system in place to make certain that any additional maintenance action required following field maintenance was recorded correctly and completed at the next available aircraft servicing.

- 2.8 The helicopter maintenance company and operator needed to establish a robust system that ensured any additional maintenance due was recorded correctly, so that any required follow-up action after field maintenance was brought to the attention of the responsible personnel for action. Had there been such a system in place ensuring correct maintenance recording, the N₂ tachometer generator drive receptacle probably would have been replaced and this accident prevented.

establish a system, in conjunction with any operators for whom Airwork provide maintenance services, that ensures any follow up maintenance action necessary after any maintenance, is correctly recorded and carried out at the appropriate time.
(013/02)
