## **Report 01-106**

### **express passenger Train 600 *Bay Express* and maintenance plant**

#### **collision**

#### **Muri**

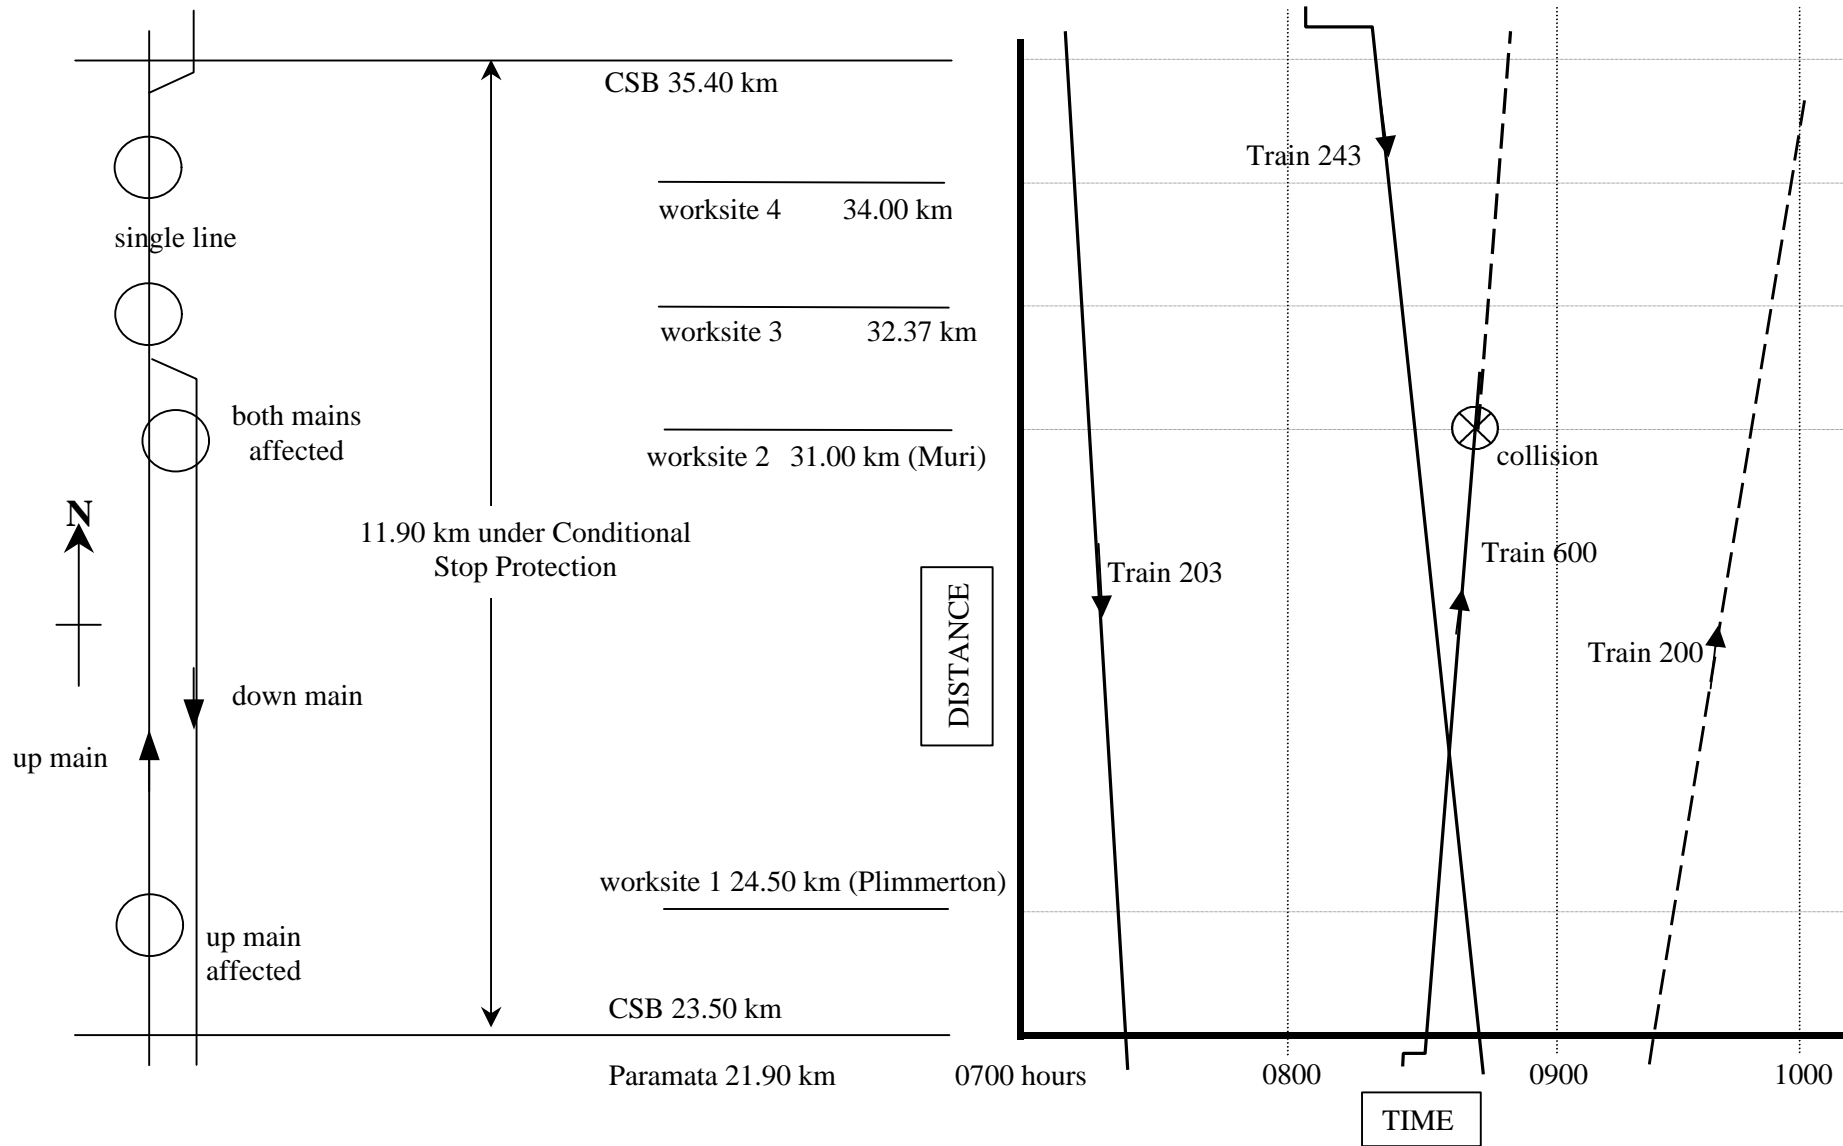
**Figure 1**  
**A time/distance plot of the worksites within the protection and the trains passed through**

- 1.1.3 The protected length, the worksites involved and the train movements through the protected length on 6 May are shown in Figure 1.
- 1.1.4 The Muri site (worksite 2) involved 2 Tranz Rail track staff and 2 contractors. The contractors were operating an excavator fitted with rail wheels which could be on-tracked when desired, and a rubber-tyred front end loader. The work involved using both machines to shift rails from the up main (west) side of the track to the down main (east) side ready for later re-railing work. The planned work obstructed both the up and down main lines and required the overhead power to be isolated for safety.

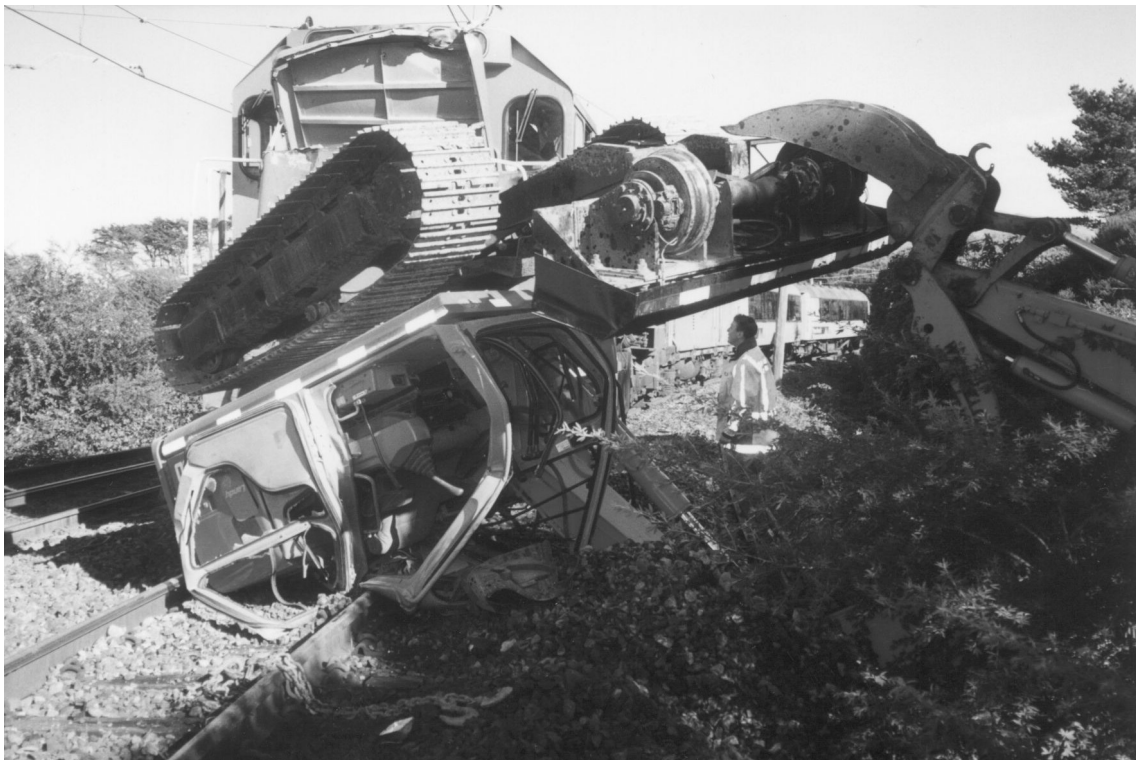
**Figure 2**  
**The collision scene**

- 1.1.12 At about 0835 work was in progress at the Muri site. The excavator was on-tracked on the up main, and the front end loader was straddling the up main some 15 m to the north. They were preparing to hook up to a rail on the up main side when the excavator driver noticed a hydraulic leak at the south end of his machine. He raised the rail wheels and settled the excavator down on the ground to allow a check of the hydraulic system. He had left the cab and was standing on the up main investigating the source of the leak when he became aware of Train 600 some 30 m away and jumped down the bank beside the track.

- 1.1.13 Train 600 was travelling at 34 km/h just south of Muri around a 200 m radius left-hand curve when the LE saw machinery on the line some 50 m ahead and applied emergency braking. The train slowed to 30 km/h before striking the boom of the excavator. The excavator overturned and was pushed ahead of the train for about 20m, where it struck the front end loader. The 2 vehicles were pushed ahead of the train for a further 12m before the train stopped. The front end loader driver had seen Train 600 approaching and tried to reverse his vehicle clear, but did not have time.

- 1.1.14 There were no injuries arising from the collision.
- 1.1.15 The excavator was extensively damaged and the front hood of the locomotive was peeled off by the impact. An overhead traction pole was jolted as a result of the collision. The overhead system sustained minor damage but remained intact.
