## RAILWAY OCCURRENCE REPORT

**01-111** Electric Multiple Unit Passenger Train 2621, door opening incident,  
Ava

15 August 2001

**TRANSPORT ACCIDENT INVESTIGATION COMMISSION  
NEW ZEALAND**

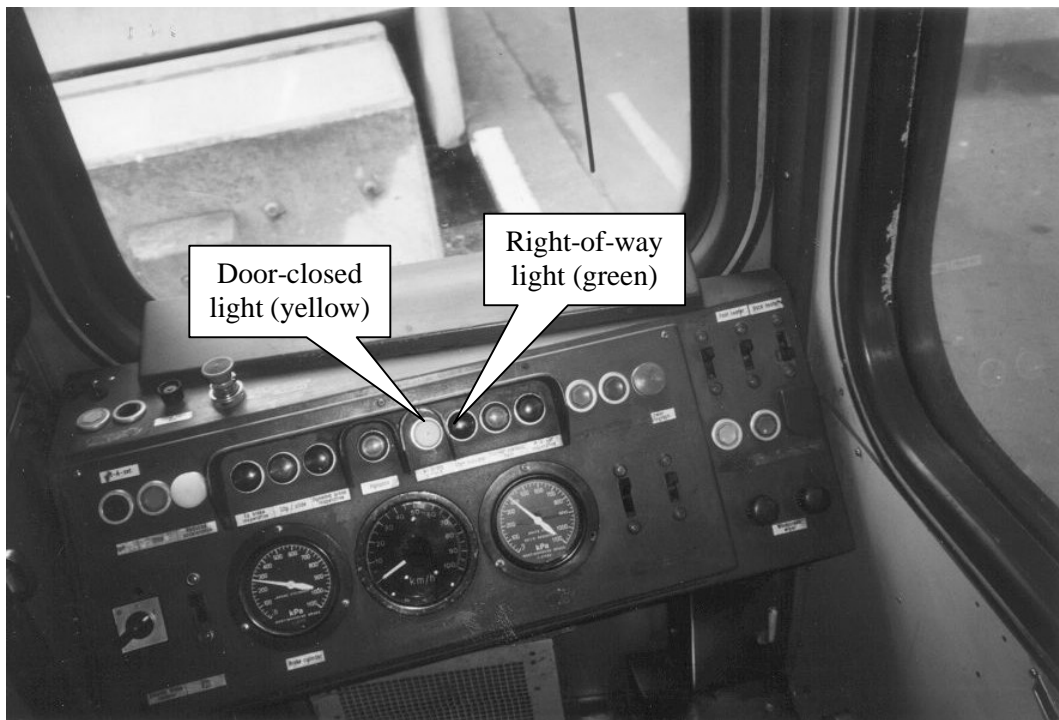
**Figure 1**  
**The console in the LE's cab**

- 1.1.3 Train 2621 stopped at all stations after departing from Upper Hutt. The driver said that after stopping at Ava he had received a doors closed light on the driving console in front of him (refer Figure 1) and a short blast on the right-of-way buzzer, so he departed. He was not sure how long the train had been stopped before he had received the right-of-way signal, nor how far he had travelled before he noticed that the door closed light had “gone out”, but he immediately stopped the train when he noticed the light had extinguished.

- 2.6 Tranz Rail's procedures for trains departing from passenger stations did not mention the doors-closed light on the console in the driver's cab, because a right-of-way signal could not, in theory, be sent or received until all the doors were closed. However, the light was a defence against the train departing without a right-of-way signal or, as in this case, when an unintentional right-of-way signal was received. Although there was no documented requirement for him to do so, had the driver referred to the doors-closed light on the console when starting the train he would have noticed that the light was not illuminated and probably would not have departed. A safety recommendation covering this issue is included in Section 5 of this report.

- 3.3 When Train 2621 departed Ava platform the driver had neither a right-of-way signal, nor a door-closed light illuminated on his console, but acted on the unintentional right-of-way signal received on arrival about 30 seconds earlier.

- 3.4 A procedure requiring the driver to check that the doors-closed light on his console is illuminated before departing from a platform, would be a useful defence against similar occurrences in the future.

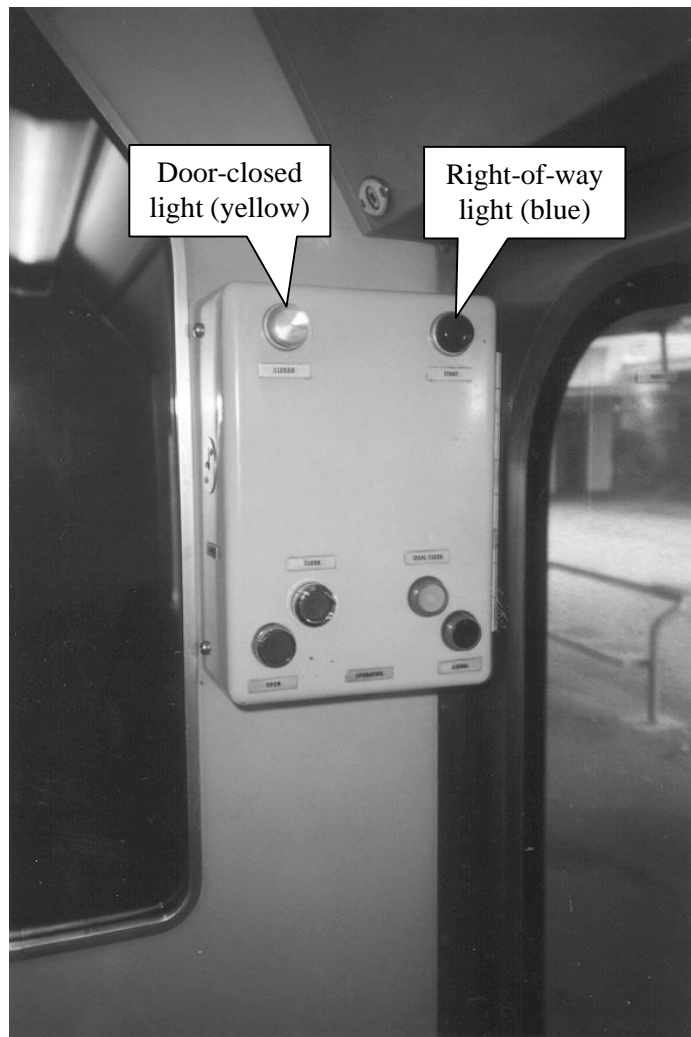
**Figure 2**  
**The door control box on an EMU**

driver to stop the train with 3 quick pushes of the right-of-way signal button<sup>1</sup> from the door control box at door 1, but found that the signal button was stuck in the depressed position. She tried to release it by banging it but was unsuccessful, so she tried again to signal the driver, this time by turning her key off and on<sup>2</sup> three times while it was still inserted in the door control box.

- 1.1.10 When the EMU arrived in Wellington it was inspected by mechanical staff who found no faults in the door-closed light in the driver's cab, but did find that the signal button in the door control box at door 1 of the second passenger car was faulty. This fault was fixed before the EMU was returned to service.

- 2.3 On arrival at Ava the guard had again inserted her key in the door control box at door 1. When she turned the key, the faulty signal button would have immediately sent a right-of-way signal to the driver until the doors were opened, effectively isolating the buzzer again. This unintentional right-of-way signal to the driver would have happened only seconds after the train had stopped at the platform.

- 3.1 A faulty signal button at the door control box for door 1 of the second carriage sent an unintentional right-of-way signal to the driver of Train 2621 within a few seconds of stopping at Ava platform. At the time of receiving the signal, the driver would have had a door-closed light illuminated on his driver console.

- 3.2 An audible signal to accompany the right-of-way signal at the door control box in the passenger cars would increase the awareness of guards to potential faults and would be a useful defence against similar occurrences in the future.

- all Ganz Mavag EMUs were being fitted with firmer springs on door control buttons to prevent sticking
- the colour of the “door closed” status light had been reviewed by staff but it was concluded that a change was not necessary
- The Rail Operation Code had been enhanced to confirm requirements for EMUs to be stopped when door status lights are extinguished

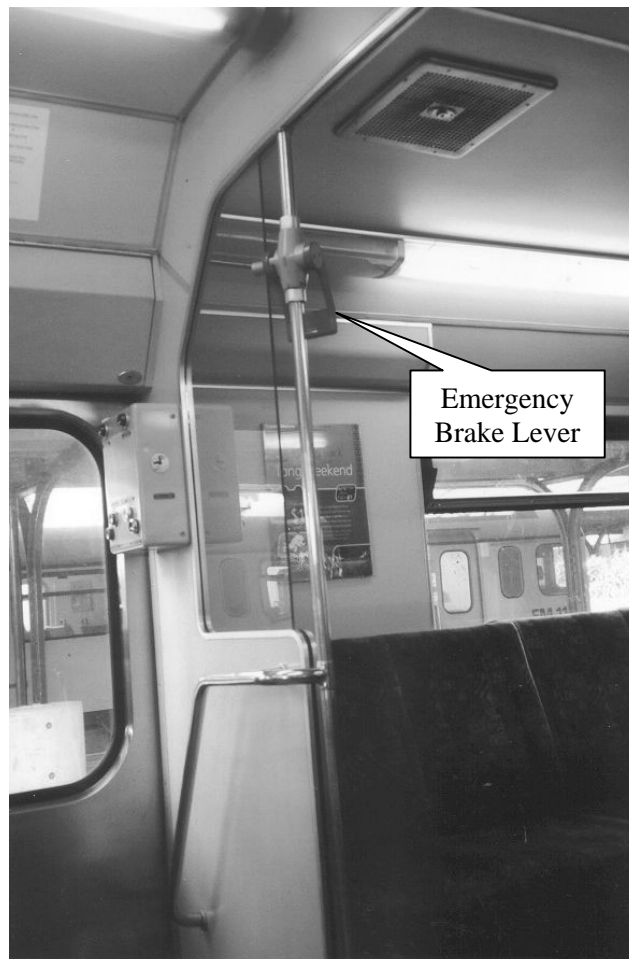
**Figure 3**  
**The passenger emergency brake lever in the normal or off position**

1.3.2 There was an emergency brake lever located about 1.5 m away from, and immediately opposite, the door control box at door 1 and a second emergency brake lever located adjacent to the door control box at door 2.

- 2.9 The guard's actions in running from door 1 to door 2, then to the driver's cab, indicated that the use of the passenger emergency brake was not considered in her response to the situation. The guard had completed her training only one week before this incident, so whatever she had been taught should have been fresh in her mind. It is not unusual for inexperienced operators in any mode of transport to forget their emergency training procedures in the heat of an emergency or unsafe situation, but in this case the guard's actions indicate that her training had, firstly, not resulted in her recognising the potential seriousness of the situation and secondly, fully appreciating when to use the emergency brake lever, and how effective it would be in bringing the train to a stop.
