Report 01-113

DC4185 light locomotive and private car collision

Egmont Tanneries private level crossing 164.14 km Marton - New Plymouth Line

19 September 2001

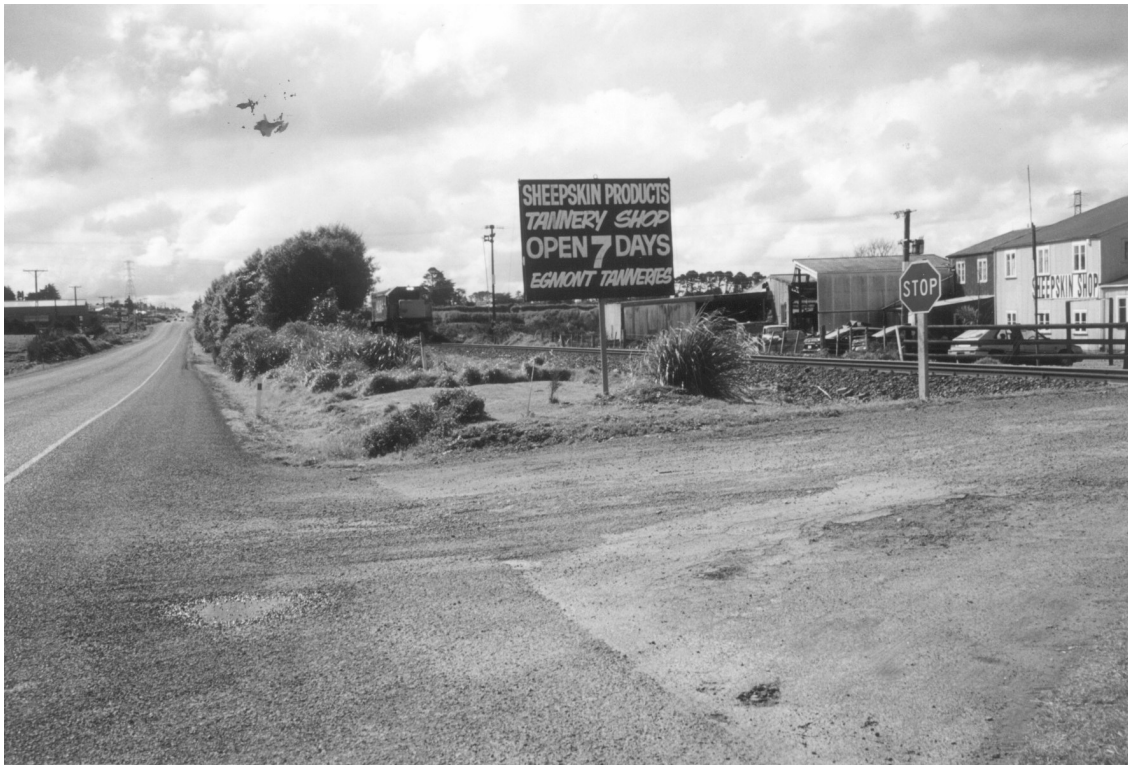
Figure 1
The view of the level crossing from where the car entered the right of way

For the photograph a locomotive was positioned at the end of the row of trees, 70 m from the level crossing. The compulsory Stop sign visible in the photograph was installed by Tranz Rail immediately after the collision.

- she was not expecting any trains
 - this was a regular driving habit developed during the years of using the level crossing.
3. The car driver's failure to see the approaching locomotive may have been that she was satisfied it was safe to turn from the northbound lane of the highway and had steered her car towards the nearest corner of the approach to the level crossing. As the car turned, her line of sight would have moved from straight ahead down the highway to focus on various points in the turn she intended to make, the first probably in line with the words "sheepskin shop" seen on the building in the background of Figure 1. The LE's report supported this.

- 3.1 Following the collision Tranz Rail arranged for the advertising sign to be removed and installed a compulsory Stop sign on the highway side of the level crossing.

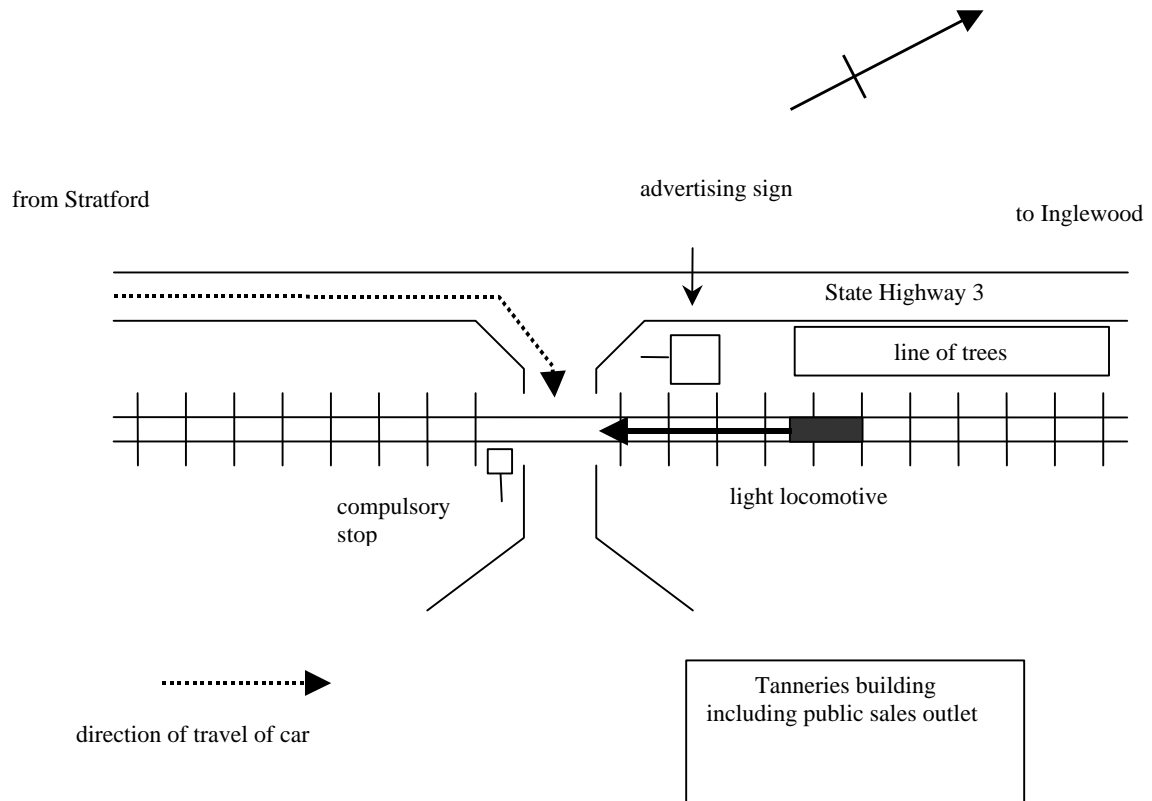
1.2.1 The general layout of the crossing is shown in Figure 2.

Figure 2
Site plan of Egmont Tanneries level crossing
(not to scale)

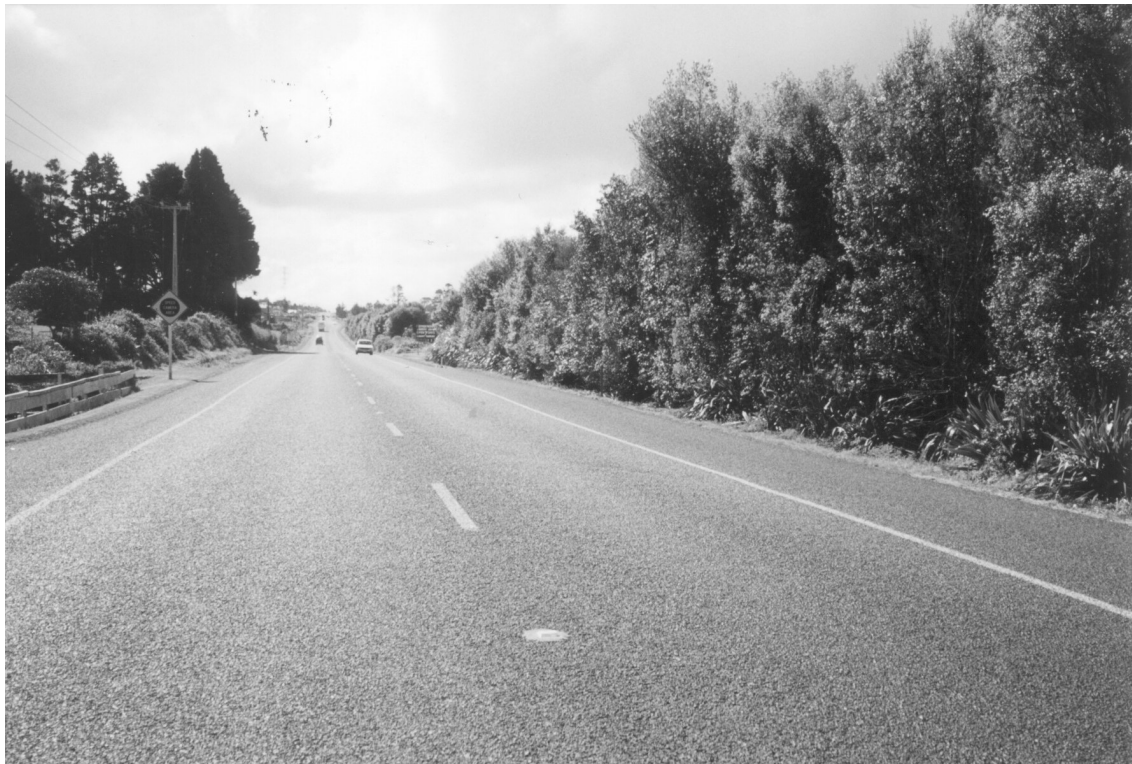
- 1.2.4 The approach to the level crossing from the highway allowed a stacking distance of about 14 m and consisted of mainly broken seal. The approach from the Tanneries was unsealed. There was no compulsory Stop or Give Way sign in place at the level crossing for traffic approaching from the highway, nor was there any signage advising motorists that they would encounter a level crossing immediately after turning off the highway.
- 1.2.5 There was a compulsory Stop sign and lockable gates on the Tanneries side of the level crossing for traffic leaving the Tanneries. These gates remained open during the hours of business.
- 1.2.6 A row of tall trees ran parallel to the railway line for about 500 m in each direction from the level crossing which obstructed the motorist's view of trains approaching the level crossing (refer Figure 3).

Figure 3
The right of way from 150 m away looking north in the direction of travel of the car

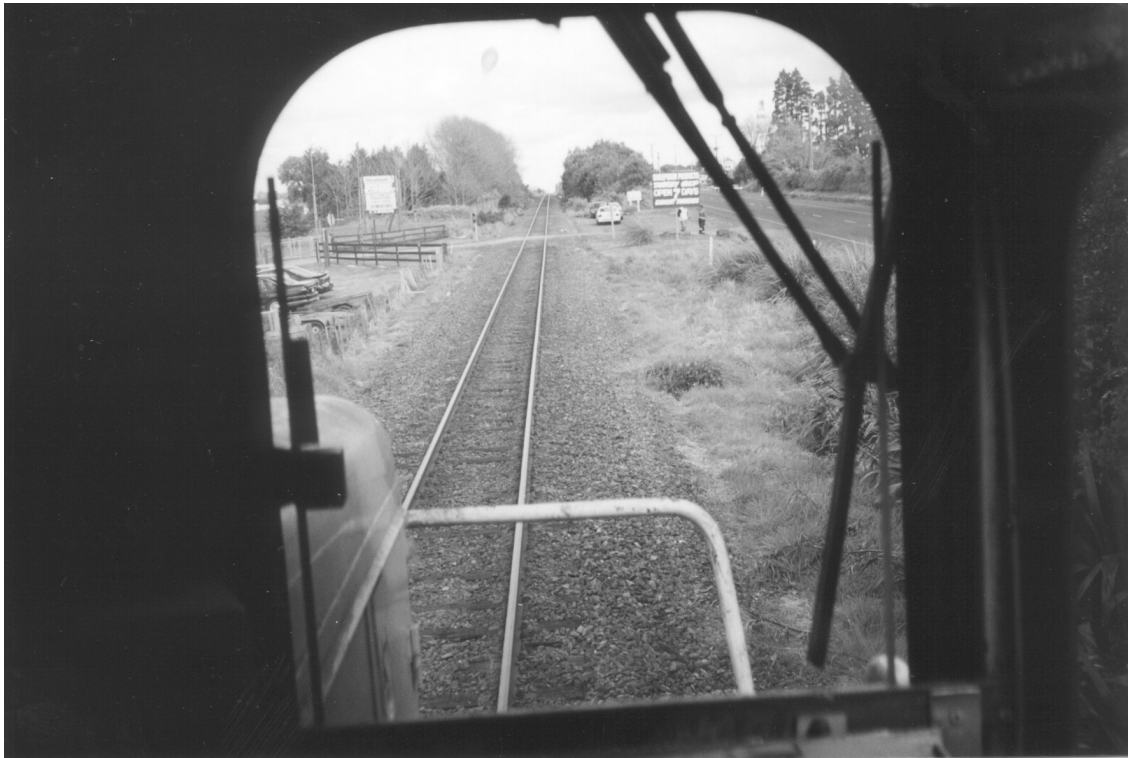
Figure 4
The LE's view from 70 m away from the level crossing

12. The LE's view of the level crossing and its approaches was not obviously obstructed by the sign (refer Figure 4).
13. Although the removal of the advertising sign took away a highly visible invitation for the public to cross the railway it would not have stopped all such traffic. The shop had been in existence for many years and its presence was widely known. There was also a large sign on the wall of one of the Tanneries buildings and visible from the highway which advertised the shop. It is considered that removing one of the 2 advertising signs did not change the fact that the public was still being invited to cross the railway line. A safety recommendation covering this issue was made to Tranz Rail and is included in Section 5 of this report.

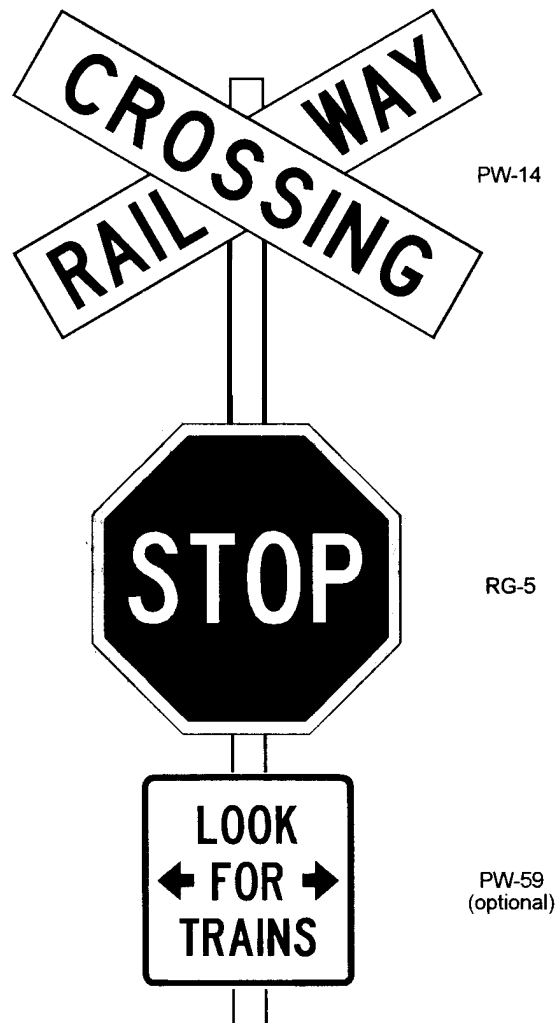
Figure 5

An RG-32 Railway Level Crossing Stop sign combination with a PW-59 sign attached

10. The minimum standard signage required at this crossing was an RG-32 RAILWAY LEVEL CROSSING STOP sign combination with a PW-59 LOOK FOR TRAINS sign attached in conjunction with PW-13.1 RAILWAY CROSSING ON SIDE ROAD signs positioned alongside the highway. The PW-59 LOOK FOR TRAINS sign is considered a particularly appropriate reminder to road traffic at level crossings in areas where there is light rail traffic.

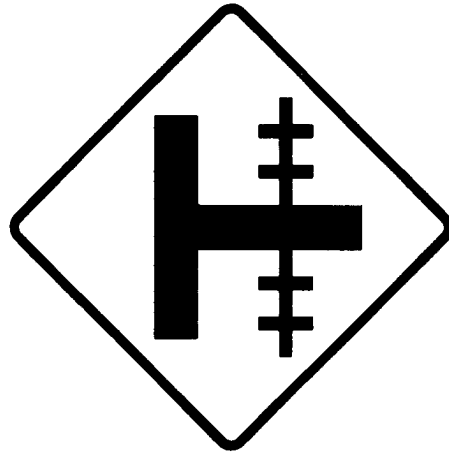
- 1.5.10 Clause PW-13.1 of the manual allowed for the provision of “Railway Crossing On Side Road” signs alongside the highway in either direction, about 160 m from the approach to the level crossing. These signs were to be erected where a railway level crossing was located on the side road immediately adjacent to the main road intersection (refer Figure 6). There were no such signs for this crossing.

Figure 6
A PW-13.1 Railway Crossing On Side Road sign
