Report 01-201

commercial jet boat

Huka Jet 3

rock strike and uncontrolled departure from river

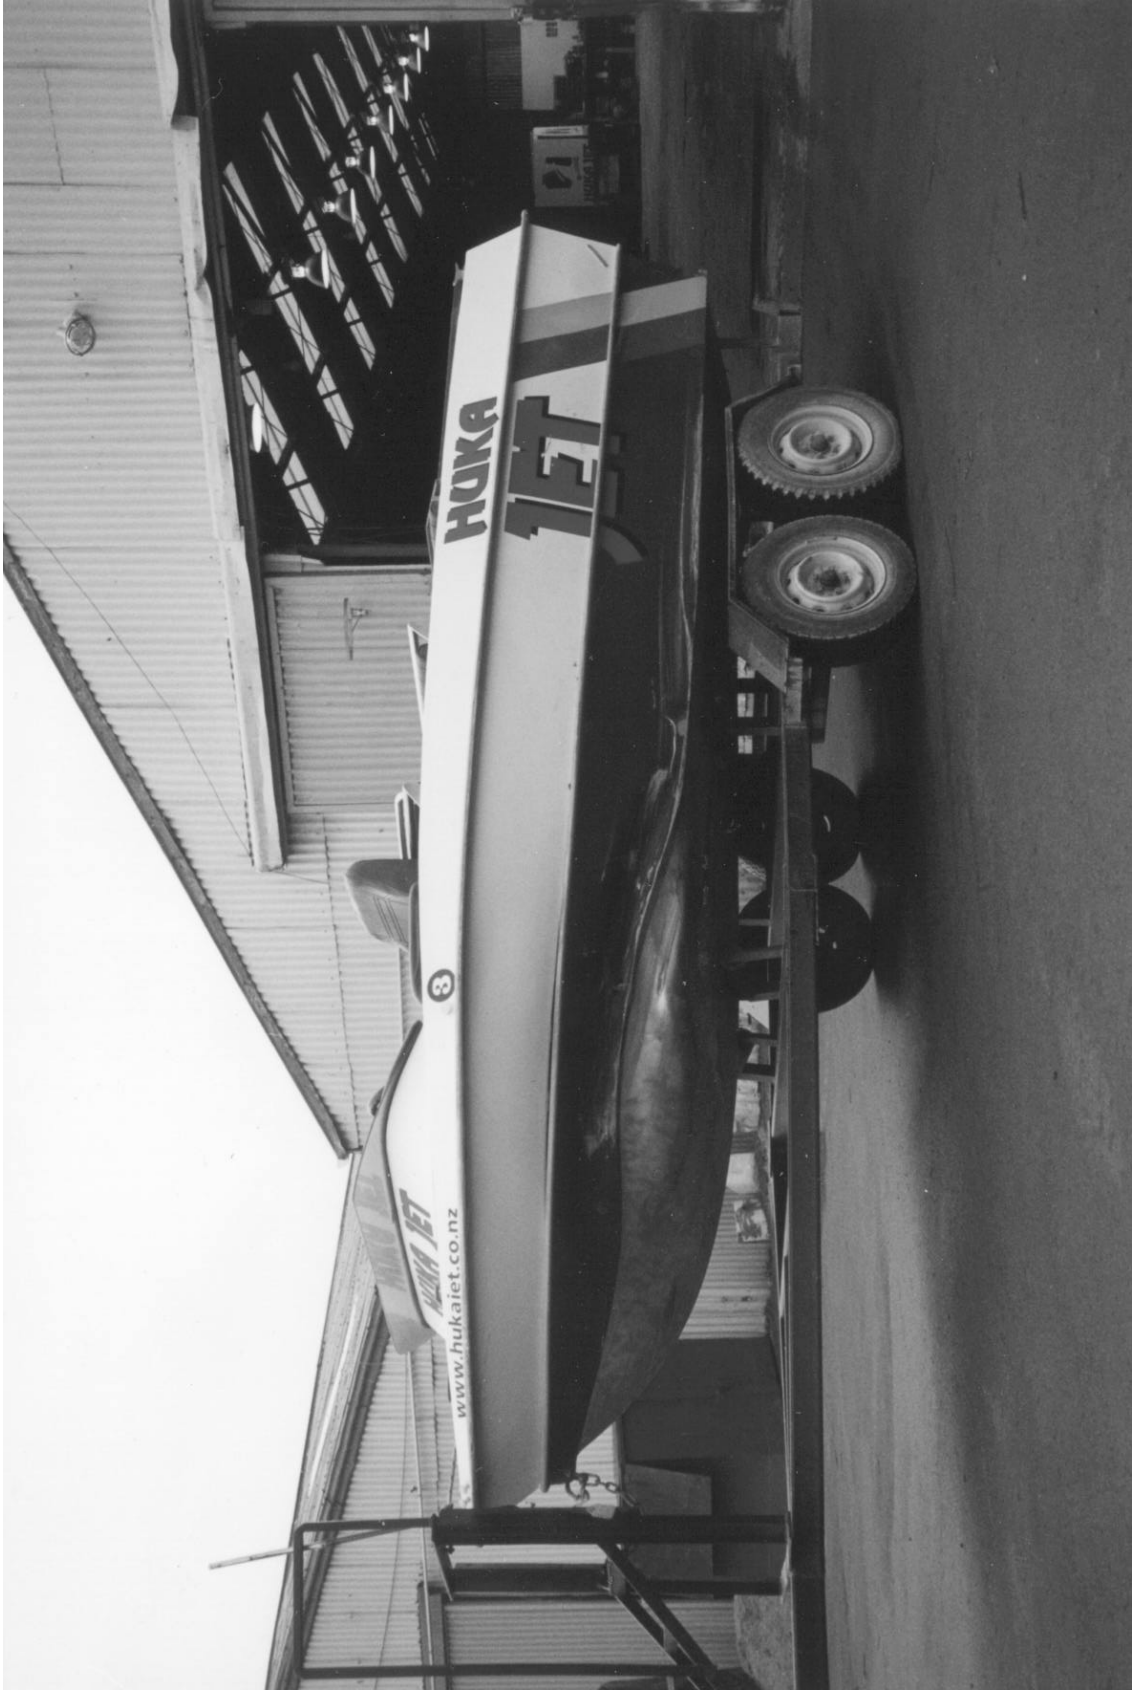
Huka Jet 3 after the accident

Nature of damage: substantial to hull at left front and right rear
driver's seat displaced and first passenger seat distorted

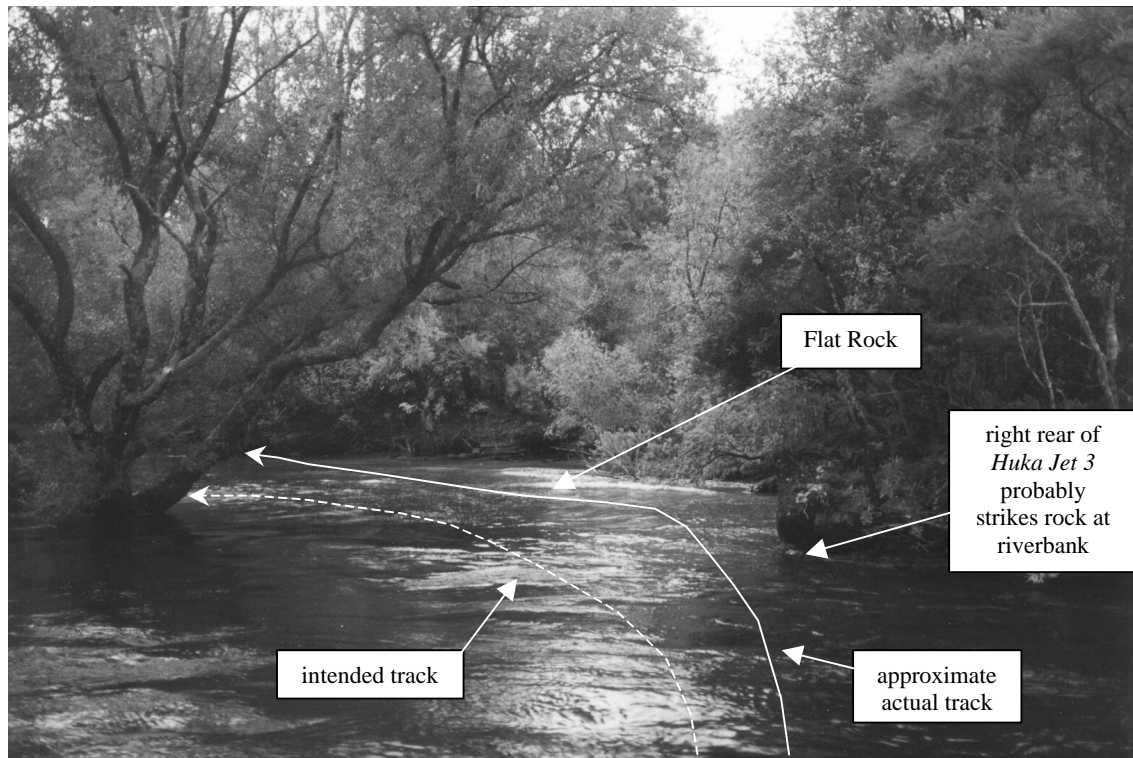
Figure 2
View of entrance to Second Tunnel

- 1.1.12 When approaching the entrance of the tunnel, the boat was travelling across the river flow and being set downstream with the current. The driver had initially headed towards the right-hand side of the entrance to counter the set.
- 1.1.13 The driver committed himself to transiting the tunnel and approached the entrance, increasing speed to make the relatively tight turn through the area (see Figure 2).

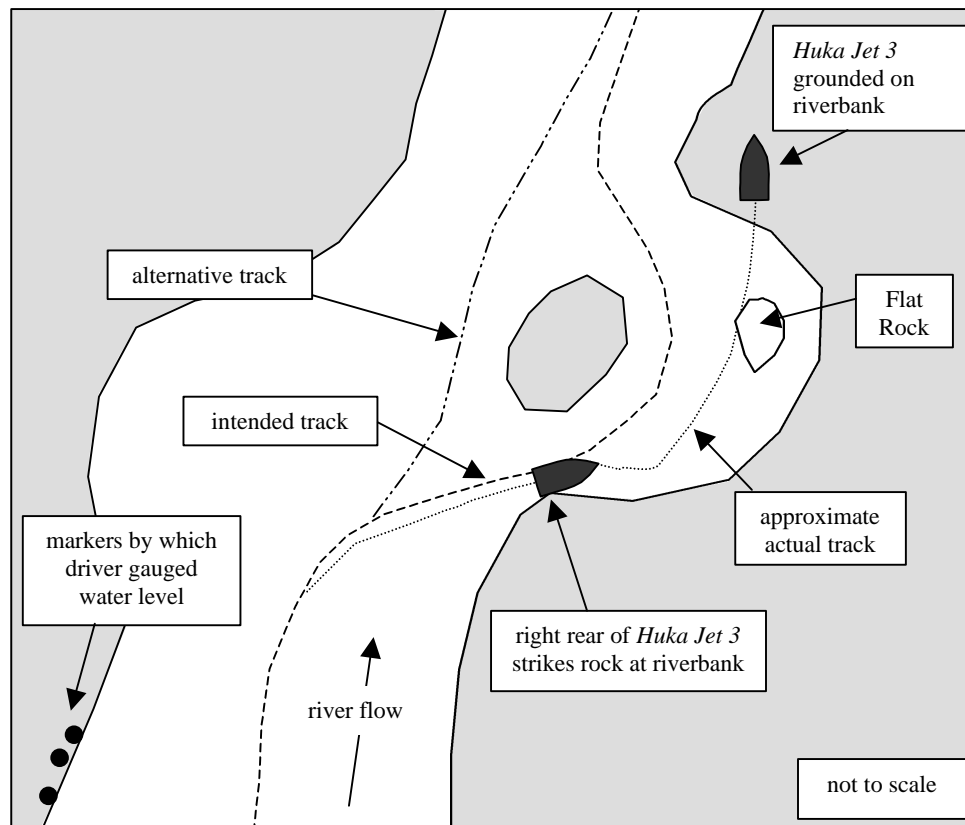
Figure 3
Second Tunnel showing intended and actual tracks

- 1.1.15 The boat slewed out of control and tracked further than normal to the right-hand side of the tunnel. The driver tried to steer the boat out of the tunnel but he was unable to regain control before the boat hit the riverbank. The boat climbed the bank and came to rest among the trees about 2 m in from the water’s edge (see Figure 3). The driver later recalled that he had tried to close the reverse bucket before the boat hit the bank.

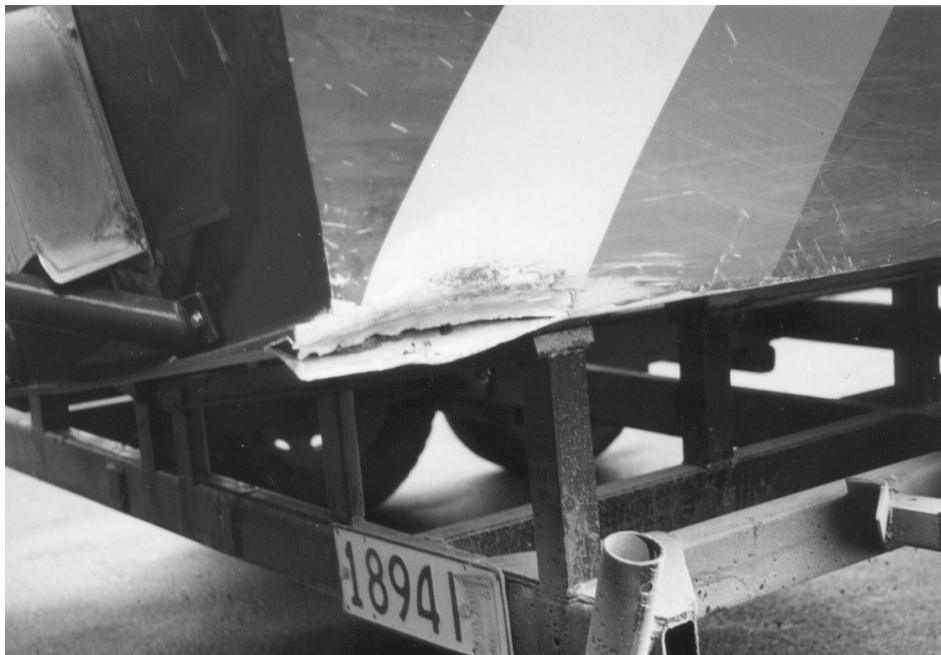
Figure 4
Damage to chine at right rear

- 1.2.1 *Huka Jet 3* was substantially damaged in the accident. On the left front, the hull was set in about 140 mm over a length of 1700 mm and a height of 600 mm. At the extreme right rear there was a tear on the chine about 300 mm long, 55 mm high and 30 mm deep (see Figure 4).

2.6 The damage to the hull of the boat, particularly that on the left front, could mostly be explained by the grounding on the riverbank and passing through the trees. The damage at the right rear of the boat was on the chine and was a tear in the aluminium rather than the depression damage at the front of the hull. It could not be determined with certainty whether the tear resulted from contact with the rock at the entrance to the tunnel or had happened at some other point in the accident sequence.

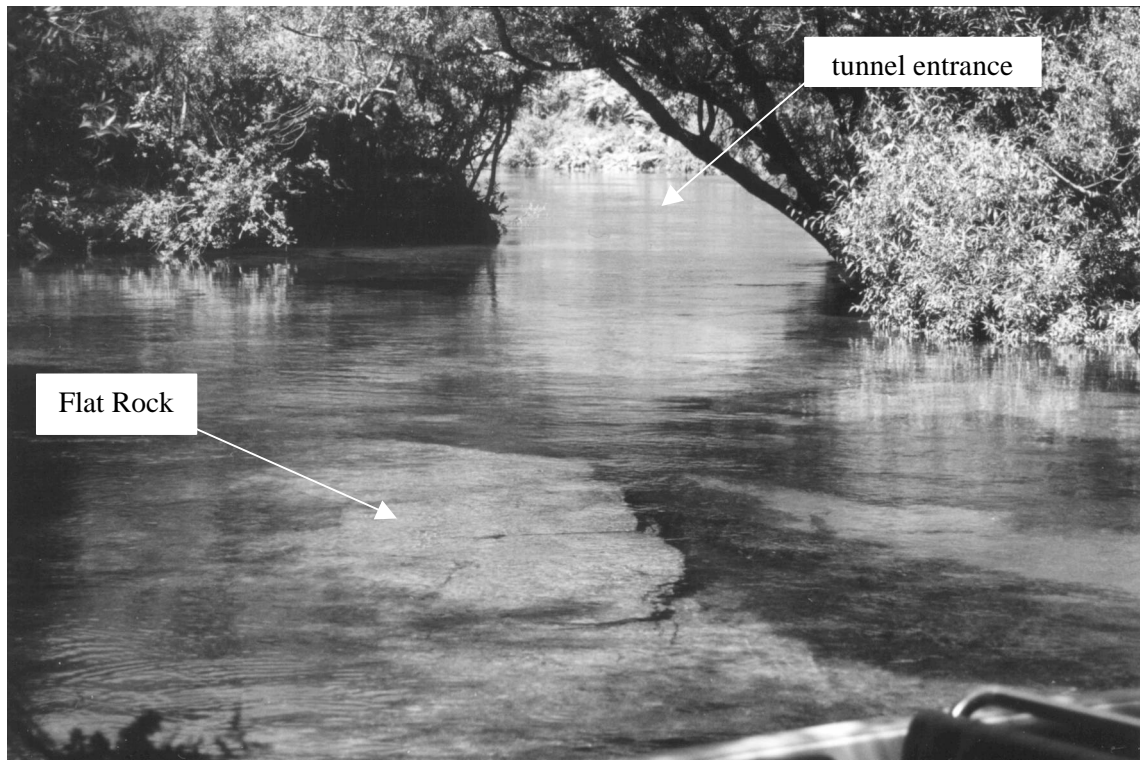
Figure 5
Second Tunnel entrance viewed from within tunnel

- 1.3.11 During the site inspection subsequent to the accident, the river conditions were reported as being similar to those on the day of the accident (see Figure 5). Flat Rock was submerged to an extent that a planing jet boat would have been able to pass over it, as a depth of only about 100 mm is required.
