Report 01-204

tug *Nautilus III*

capsize and sinking

9 March 2001

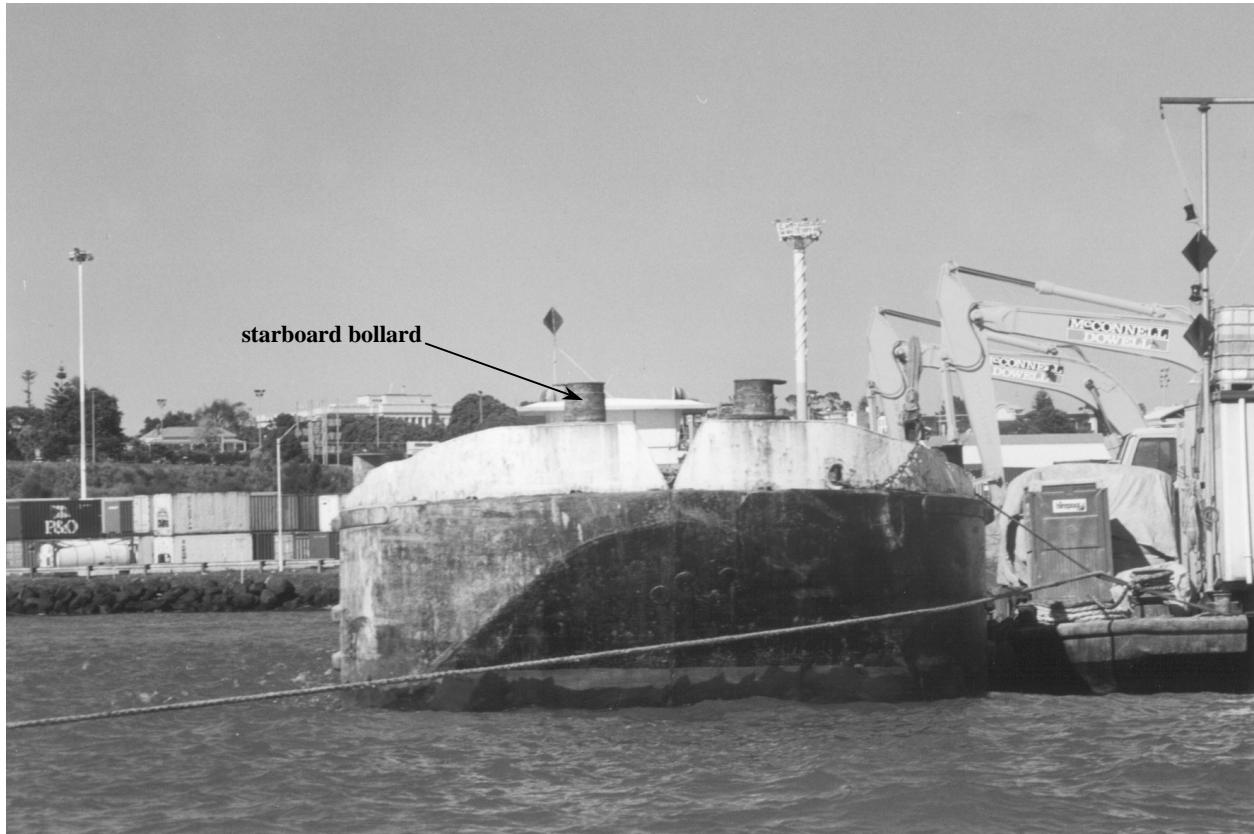
- 1.1.6 The towline they used was a 20 m length of 60 mm diameter polypropylene multiplait rope with a soft eye spliced in each end. One eye of the towline was looped over the H post on the tug. The skipper backed the *Nautilus III* up to the bow of *H7* and the deckhand transferred across and put the other eye over the starboard bollard on the bow of *H7* (see Figure 2).

Figure 2
Empty hopper barge *H7* alongside the mixing barge

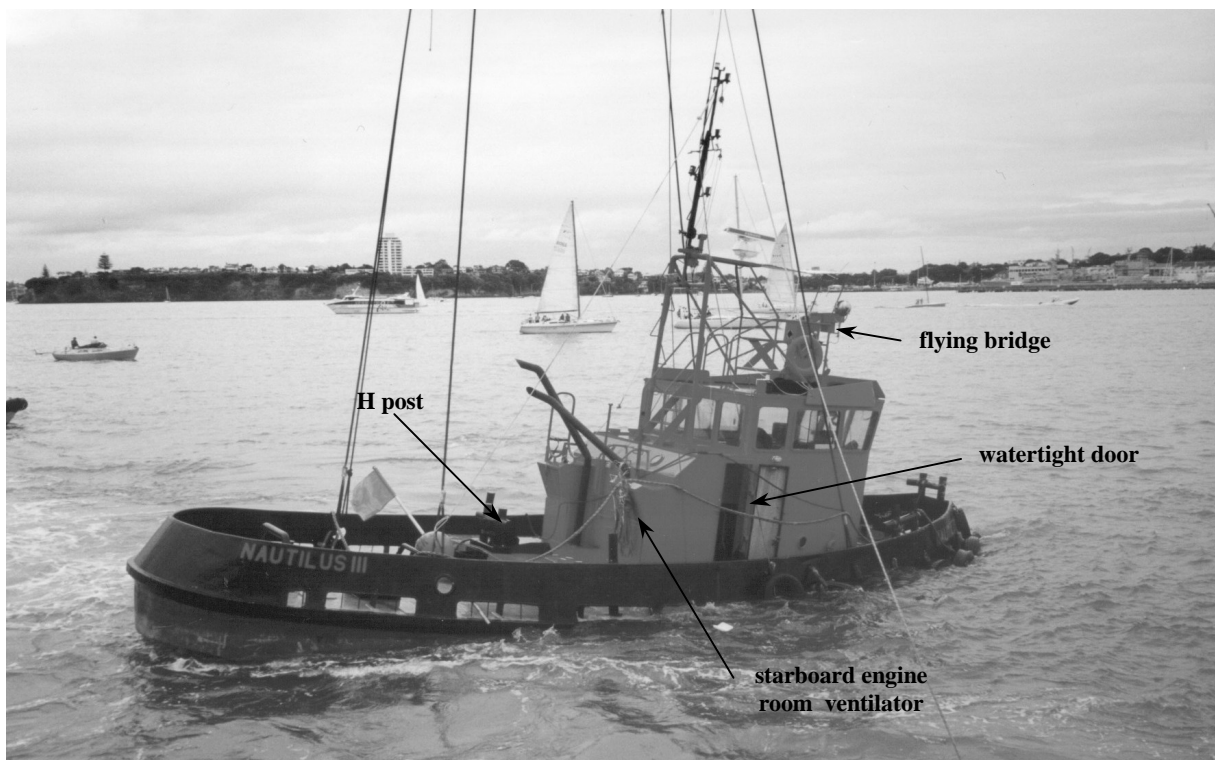
- 1.1.12 In an attempt to get the towline back over the stern of the tug, the skipper altered the course of the *Nautilus III* further to port until he recalled he was heading roughly north. *H7* did not respond and *Nautilus III* was girted with the towline leading close to abeam on the starboard side. The heel of the tug increased until the sill of the watertight door to the accommodation, which was open and hooked back to the bulkhead, was submerged and down flooding commenced (see Figure 3).

Figure 3
The *Nautilus III* during salvage; note open watertight door

- 2.12 The watertight door on the starboard side of the *Nautilus III* was left open. The decision to leave the door open decreased the angle of heel at which down flooding occurred by about 20 degrees. The size of the door opening significantly increased the rate of down flooding when it did occur.

- 2.13 Once the sill of the watertight door was immersed, at angle of heel of about 52 degrees, the resulting down flooding would have rapidly increased the heel until the starboard engine room ventilator also became immersed. It is possible that if the door had been shut the skipper may have had time to manoeuvre the tug out of trouble or the towline might have parted before significant down flooding occurred through the engine room ventilator.

- 3.7 The *Nautilus III* sank due to excessive down flooding through an open watertight door. The tug probably would not have sunk had the watertight door been closed.

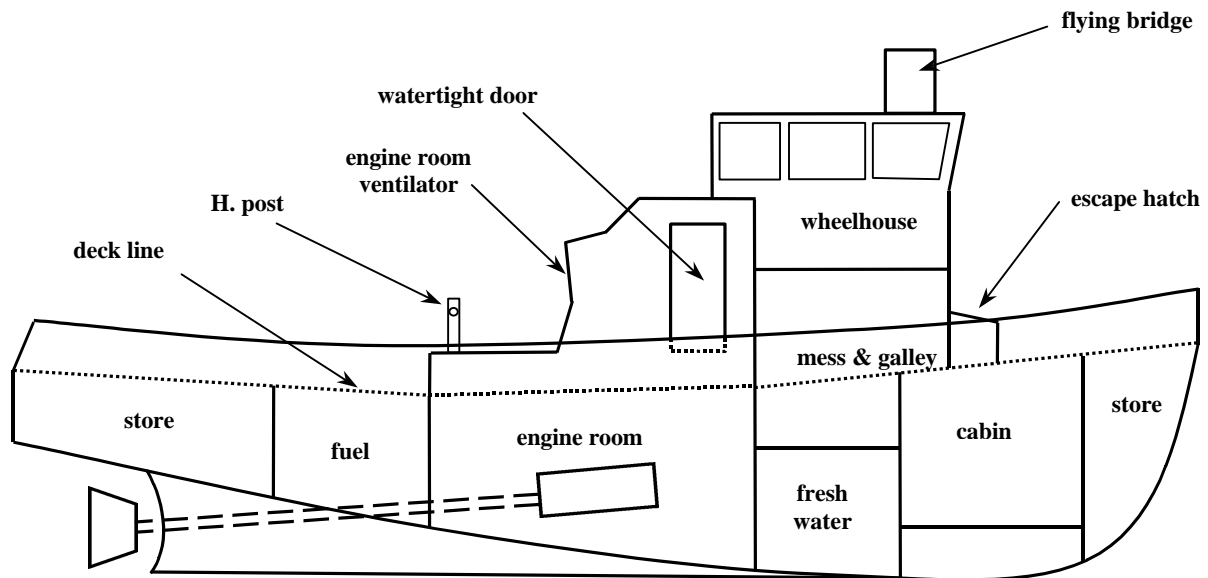
Figure 4
Profile of the *Nautilus III*
(not to scale)

- 1.3.2 The *Nautilus III* was constructed of steel and built in Australia in 1971. It had 4 watertight bulkheads. The engine room was amidships. The accommodation was forward of the engine room and was split into two levels; the upper was a galley and messing area and the lower a cabin. Access to the accommodation, wheelhouse and engine room was from an alleyway just inside a watertight door on the starboard side of the main deck (see Figures 3 and 4).
