## **Report 01-205**

***Spirit of Enterprise***

**sheer and contact with channel side**

**Otago Harbour**

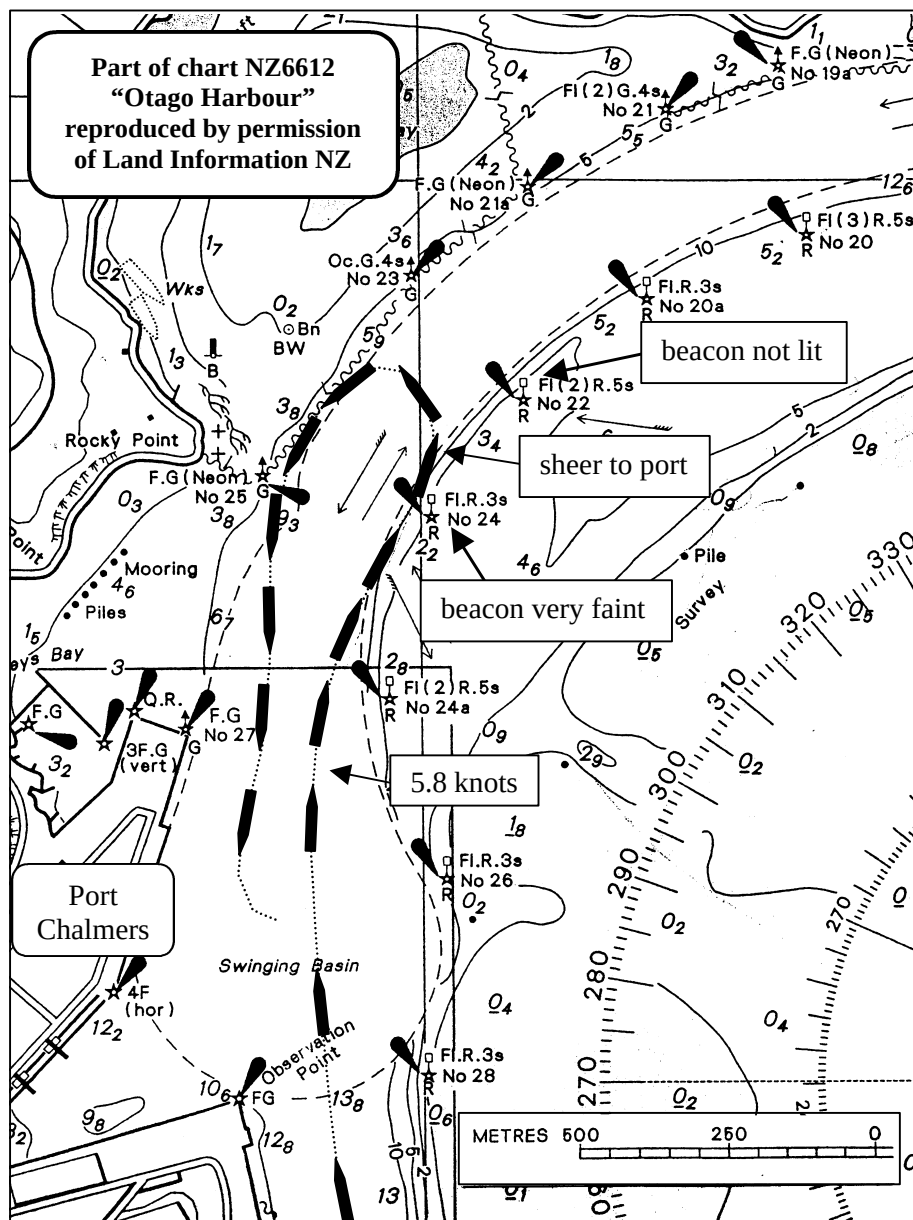
**Figure 2**  
Part of chart NZ 6612 showing approximate track during first sheer

1. The master had unknowingly altered to starboard early, causing the ship to close with the channel side. As the ship approached the bank by beacon 24, bank effect would have caused the bow to be cushioned off and the stern to be sucked into the bank. Thinking that his ship was in the middle of the channel, the master would not have expected bank effect and only small amounts of helm were being applied to make the turn. In order to control bank effect, a mariner would need to expect that it might happen. Once a ship has begun to sheer, it can be difficult to recover.

3. Not realising that his ship had been close to the bank, the master's initial thoughts of a steering failure were understandable, particularly as the helmsman had reported a loss of steering, and the master was aware that the ship had previously experienced a steering failure. However, given that the rudder reacted to the helm when correcting the sheer and tests revealed no faults, he should have been searching for some other cause of the sheer.

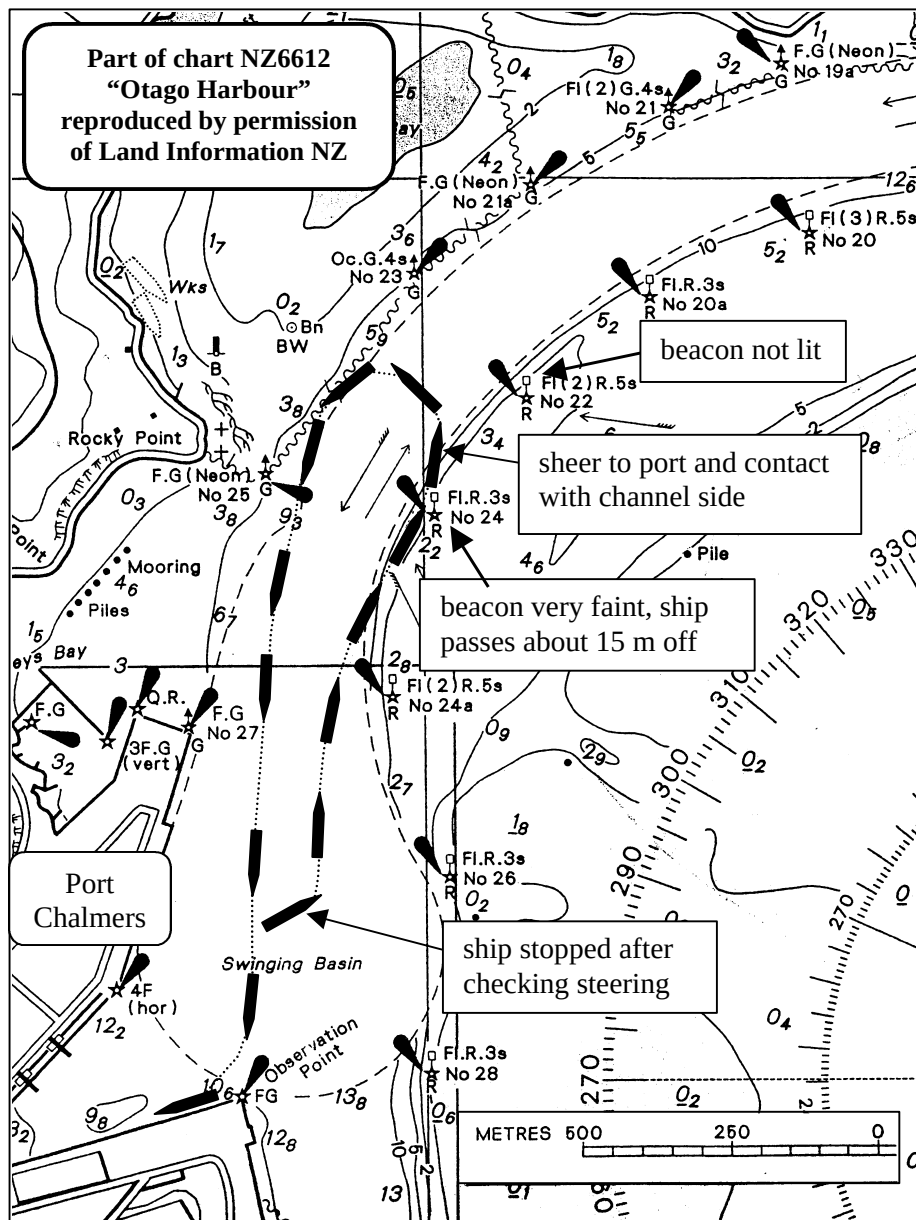
**Figure 4**  
**Part of chart NZ 6612 showing approximate track during second sheer**

- 1.1.28 As the ship passed beacon 24a, the master started the turn to starboard. Shortly after passing beacon 24a the ship again sheered to port despite the helm being put hard to starboard. The ship was not travelling as fast as previously and the sheer was not as violent as the first time. As the ship sheered it was felt to touch the channel side (see Figure 4).

- 1.1.29 Just as the sheer started, the second mate reported to the bridge that a beacon with a very weak light had just passed the starboard bow at an estimated distance of about 15 m. The master asked the chief mate to look for the beacon but he was unable to see it and had not seen it on the radar.

5. Bank effect again caused the ship to sheer rapidly to port and the sighting of beacon 24 by the second mate came too late to avoid the sheer. On this occasion the ship touched the channel side, probably because of the closer approach and possibly due to a slightly later reaction from the master or helmsman.

12. The lights on 2 beacons in the area of the sheers were subsequently found to have failed and were therefore not visible from the bridge of the *Spirit of Enterprise*. The master mistook the more distant red-lighted beacons for those that he could not see, causing him to adjust the course and manoeuvre his ship prematurely into the starboard turn.

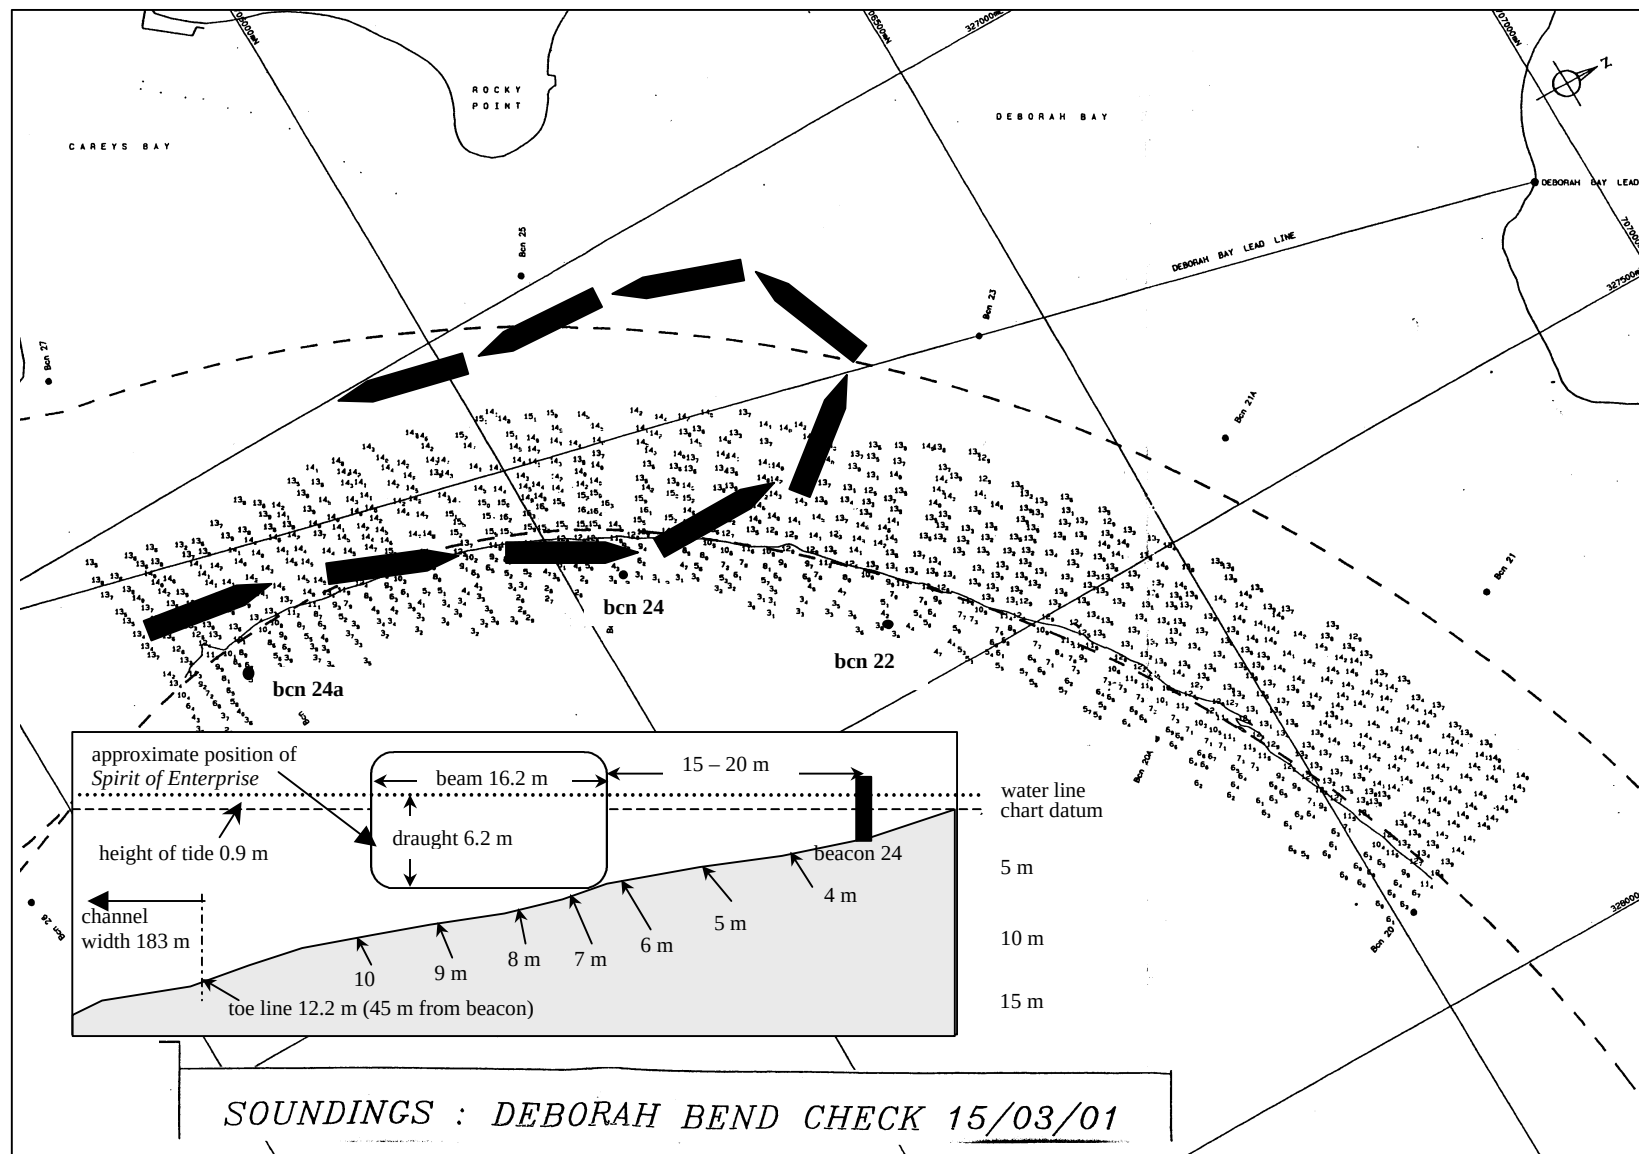
Figure 7  
Sounding chart showing probable track of the *Spirit of Enterprise* with channel profile insert

- 1.3.6 When the *Spirit of Enterprise* was berthed in Lyttelton later on 15 March, divers inspected the hull. No indentations were found but an area of bottom paint 6 m long and 2 m wide had been rubbed off on the starboard side aft of the shoulder.

- 1.7.5 Soundings for the full channel were carried out each year, with soundings taken of each section after dredging. The area of Deborah Bend was last dredged in February 2001. Soundings were taken in the area after the incident and no significant shoaling was found (see Figure 7).
