Report 01-206

liquefied petroleum gas (LPG) carrier

Boral Gas

grounding

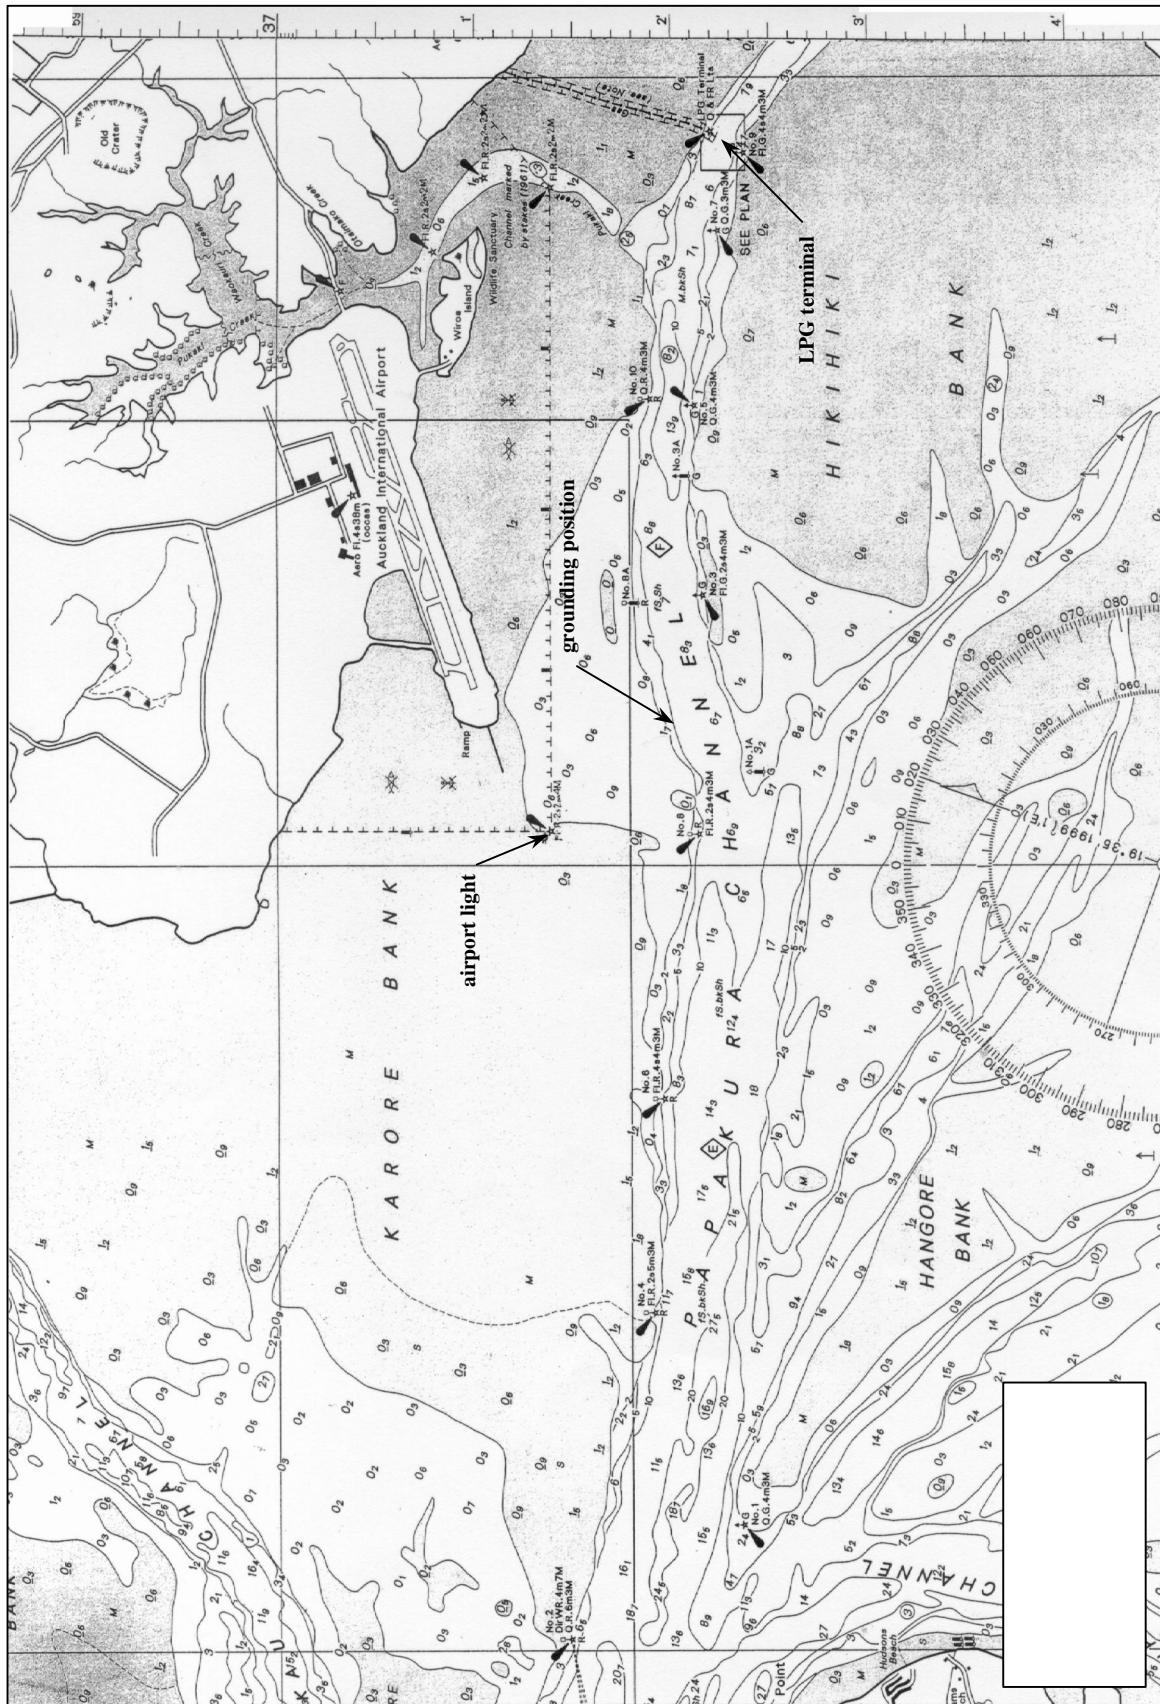
Figure 1
Part of chart NZ 4314 showing Papakura Channel

- 1.1.17 The master and second mate plotted the ship's position and found it to be on the north side of the channel with beacon 8 bearing 256 degrees true about 0.6 miles distant. The master then showed the pilot the position and they then agreed that the ship was on the north side of the channel.

- 1.1.22 At 0123 the engine was put ahead and the vessel proceeded down the channel. On the way down the channel it was noted that the lights on beacons 8, 6 and 4 were extinguished and the light on beacon 2 was very weak. The pilot's intention was to anchor in Big Bay to await crossing the bar but when they arrived there was another vessel anchored in Big Bay so the *Boral Gas* continued to Wattle Bay, anchoring at 0306. At 1231 the anchor was aweigh and at 1348 the ship was clear of Manukau Bar and proceeding back to New Plymouth.

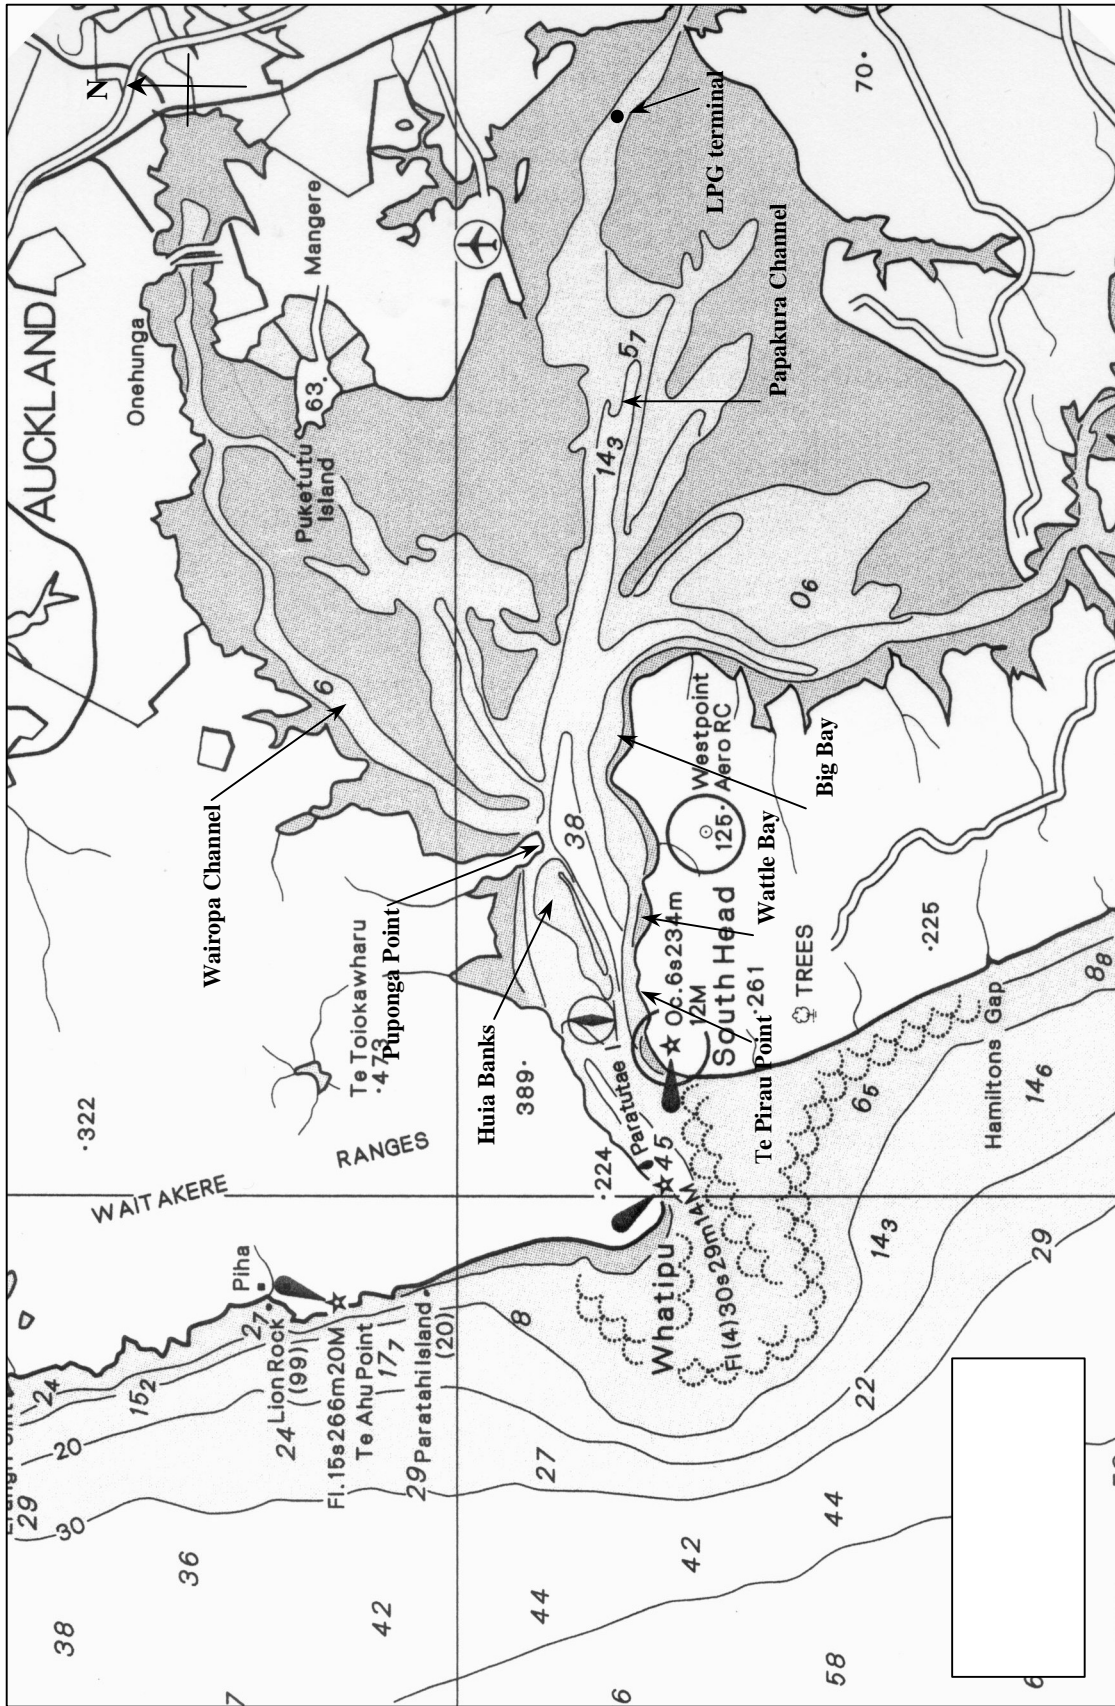
Figure 2
Part of chart NZ 43 showing Manukau Harbour and Bar

- 1.4.1 Manukau Harbour provides access to Auckland from the west coast of New Zealand. At the entrance to the harbour is a shifting bar with banks and shoals extending 5 miles seaward. Inside the bar the harbour is almost filled with mud and sandbanks that dry at low water. After crossing the bar there is a natural channel up to Huia Bank which splits at Puponga Point into 4 navigable channels. The 2 main channels are Wairopa Channel, which accesses Onehunga, and Papakura Channel, which accesses the Liquigas terminal (see Figure 2).
