## **Report 01-208**

**coastal passenger and freight ferry *Arahura***

**machinery space flooding**

**7 June 2001**

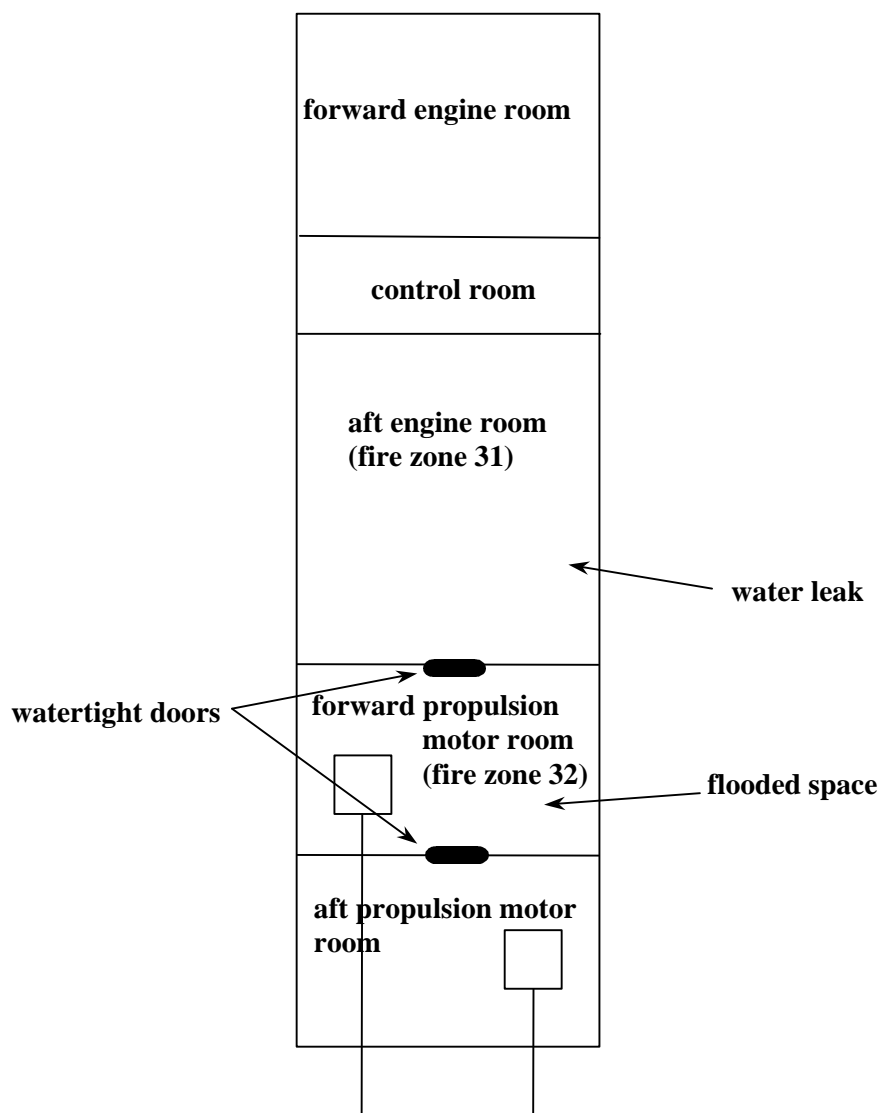
**Figure 2**  
**Machinery space layout**  
 (not to scale)

- 1.1.6 The *Arahura* cleared Tory Channel at 2224 and shortly afterwards the watchkeeper left the control room to start his rounds of the machinery spaces. He started at the forward engine room and was working his way aft, checking each space as he went. At 2248 the aft propulsion motor room bilge high-level alarm sounded. The watchkeeper had not by then reached that space so he cancelled the alarm with the intention of checking the bilge when he got there (see Figure 2).

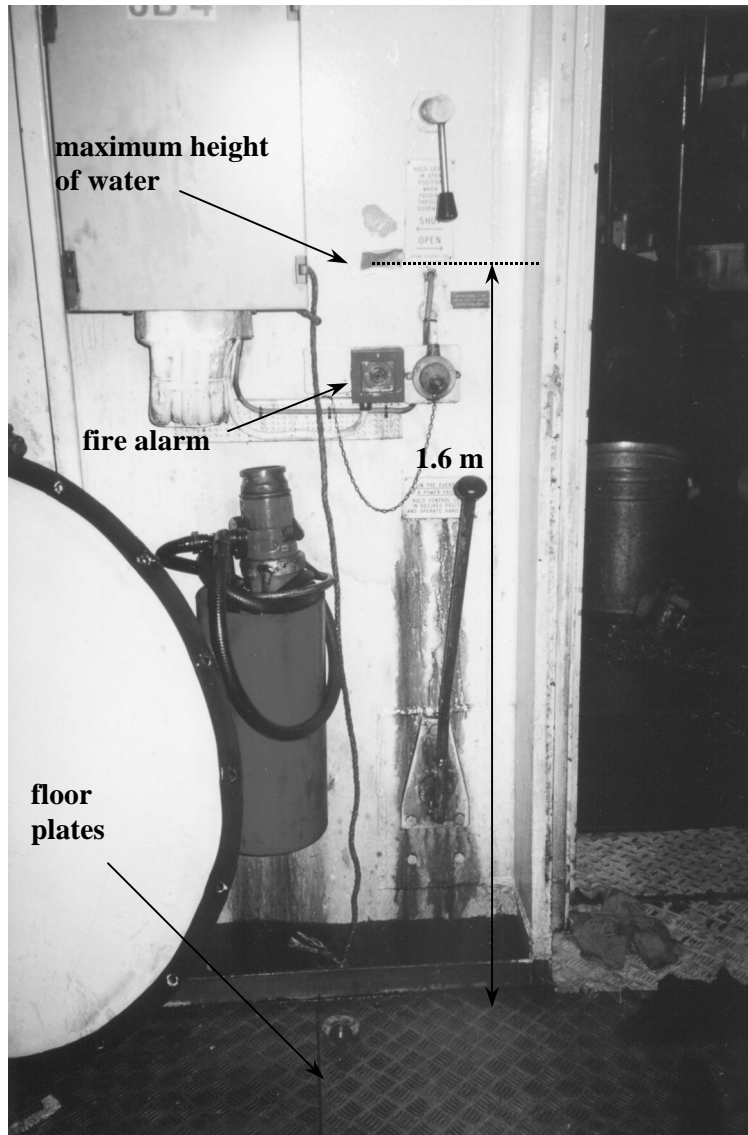
**Figure 3**  
**Fire alarm and water level**

- 1.1.11 The watchkeeper then mentioned to the first engineer that a fire alarm had sounded for fire zone 32 and when he went to investigate he discovered the leak, which must have activated the alarm. The first engineer realised that they were not in fire zone 32, but actually in fire zone 31, so together they proceeded to fire zone 32, the forward propulsion motor room. When they started to open the sliding watertight door separating the 2 spaces they were met by water pouring from the space at a height of about 1.6 m above the floor plates (see Figure 3).

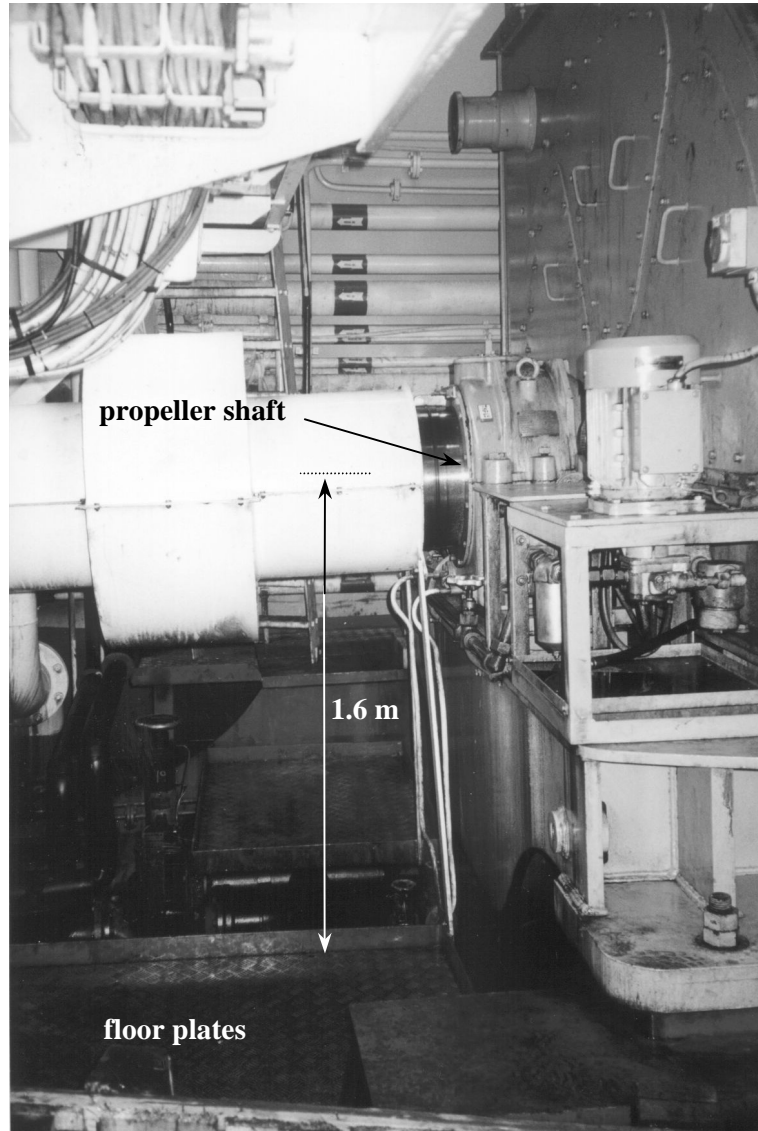
**Figure 4**  
**Rear of propulsion motor and water level**

- 1.1.14 The chief engineer and other engineers started to arrive in the control room and the first engineer briefed them on the problem. The first engineer and another engineer went up to the rail deck and entered the forward propulsion motor room through its emergency escape hatch. They saw that the water was about halfway up the propeller shaft. The level was later measured to be about 2.1 m above the tank top or 1.6 m above the floor plates (see Figure 4).

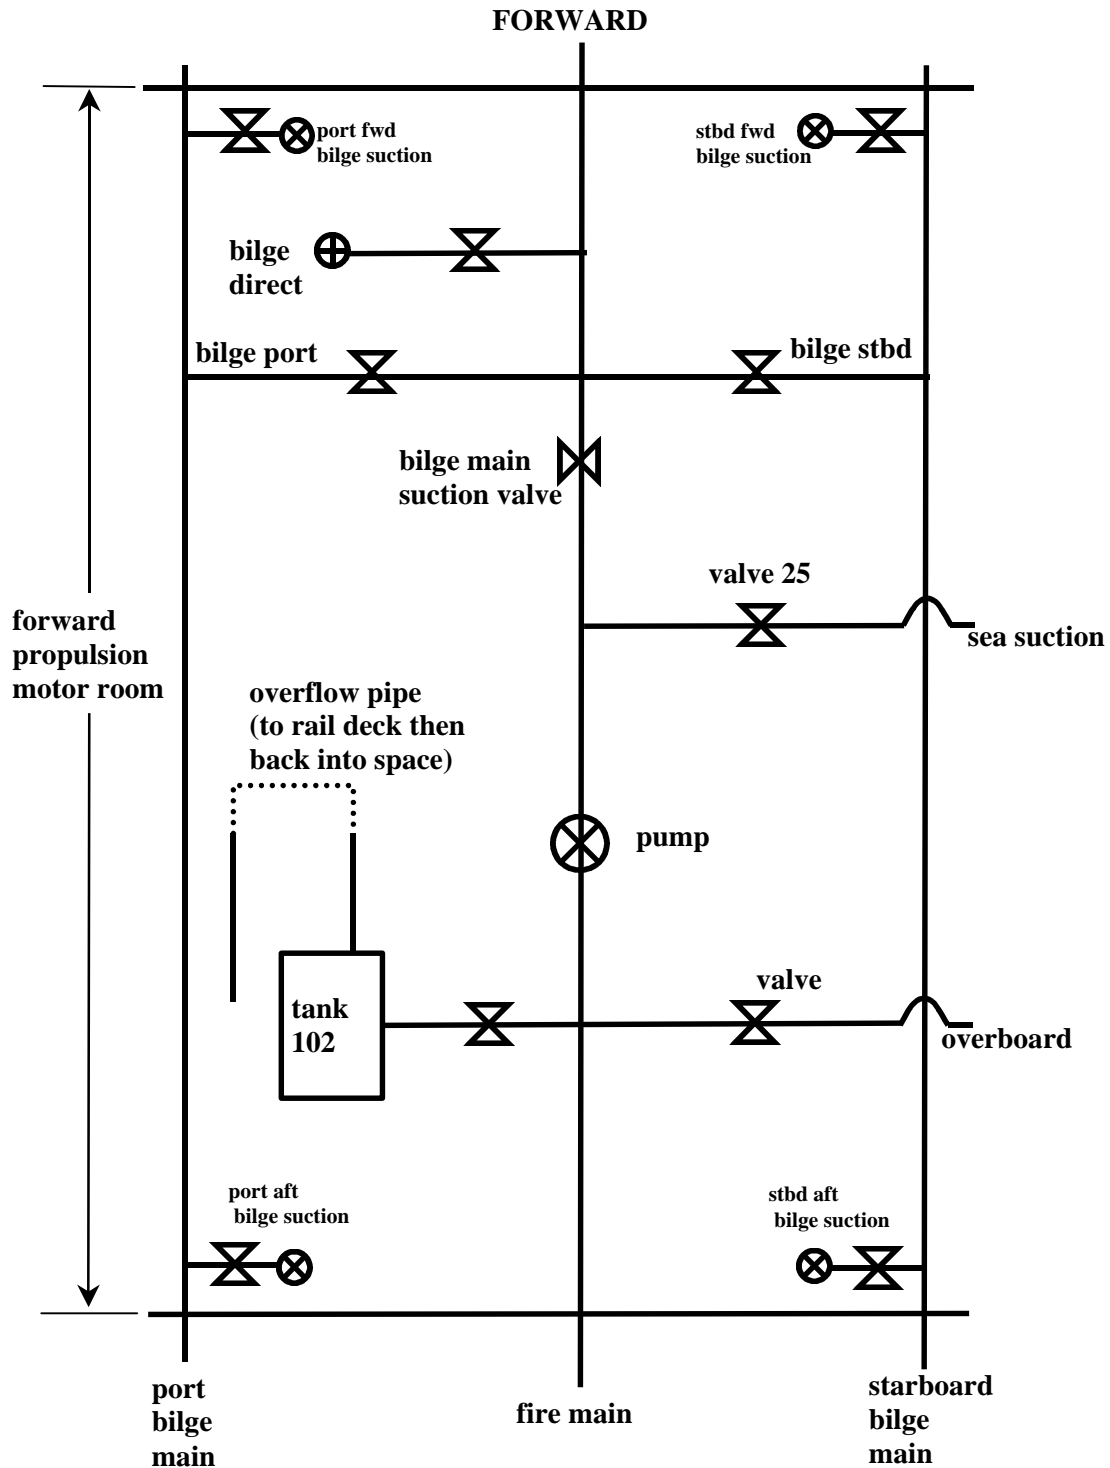
**Figure 5**  
**Bilge pumping arrangement**

- 1.4.1 A common bilge main ran down each side of the 4 machinery spaces and was connected at the forward end. There were 4 pumps connected to the bilge main. The one in use at the time of the flooding was the emergency fire and bilge pump, which was situated in the forward propulsion motor room and was submersible. All the pumps were capable of pumping directly overboard, to the fire main, or to tank 102. In each space where a pump was situated there was also a direct bilge suction, which was a direct suction from that space to the pump and not connected to the bilge main. The bilge high-level alarms were mounted outboard in each space about 150 mm above the tank tops (see Figure 5).

- 1.4.7 Valve 25 had remained in this condition for the life of the ship. The engineers accepted this as one of the small idiosyncrasies found aboard ships from time to time. Some other watchkeepers and the chief engineer said that they usually either operated or checked the sea suction valve manually or kept the close button on the mimic panel pressed in after the indicator showed closed to ensure the valve was fully closed.

- 1.4.8 After the flooding, tests were undertaken on the valve and it was found that after remotely closing the valve from the mimic panel in the control room it could still be manually closed about one turn at the valve. By opening a drain cock on the inboard side of the valve with the valve in the closed position as indicated on the mimic panel, a large volume of water was observed flowing past the valve.
- 1.4.9 After the flooding, the valve was dismantled and aligned correctly, which took about 30 minutes to complete.

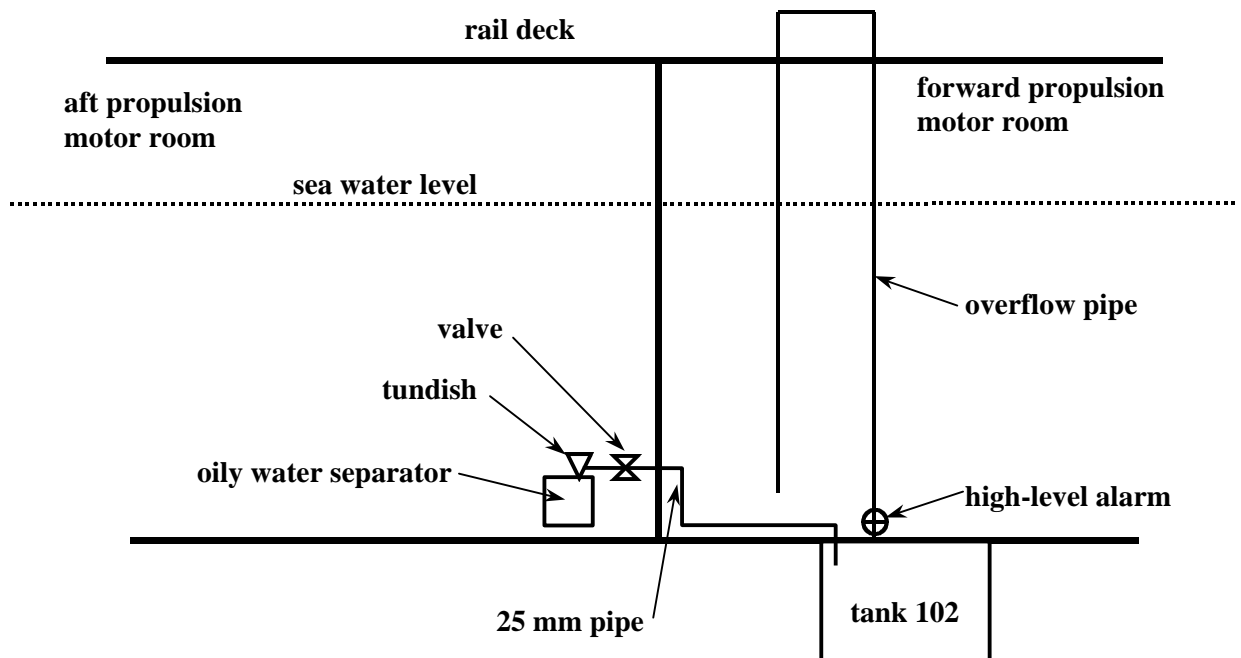
**Figure 7**  
**Pipe from tundish to tank 102**

- 1.4.10 The 25 mm pipe that drained from the tundish on the oily water separator in the aft propulsion motor room was about 600 mm above the tank top. It joined into a 60 mm pipe that ran back to tank 102 in the forward propulsion motor room. The 25 mm pipe was fitted with a valve that when open allowed any oil residue in the tundish to drain back to tank 102. If tank 102 was full and had sufficient head on it, and the valve was open, water would flow back through this line into the aft propulsion motor room bilge (see Figure 7).
