Report 01-211

Aratere

lifeboat incident

6 August 2001

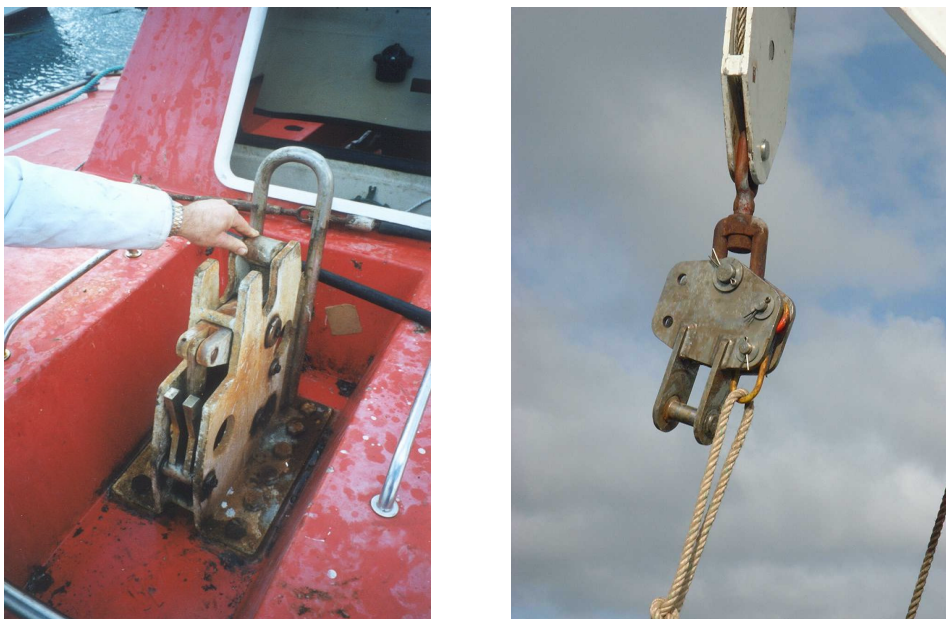
Figure 2
Lifeboat release hook and davit falls block

- 1.3.1 The lifeboat was attached to the davit falls by a hook secured to each end of the boat. The lifting pins of the fall blocks were engaged with the hooks and there was a securing mechanism within each of the hooks that was activated from a remote control station in the lifeboat and designed to release both hooks simultaneously (see Figure 2).

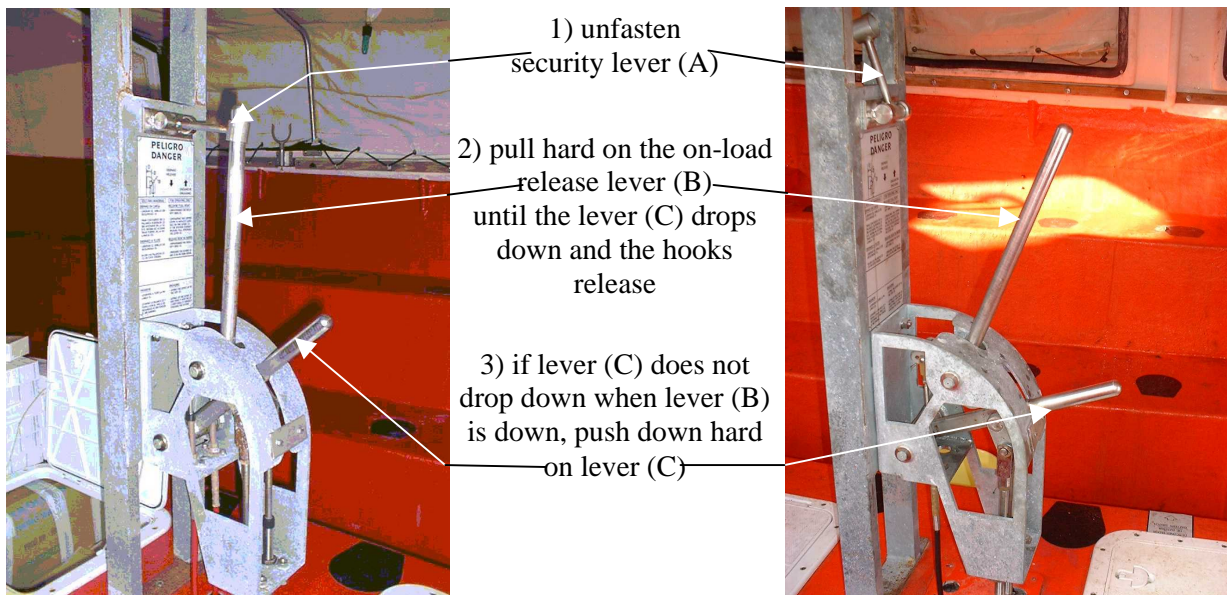
Figure 3
Remote control of release mechanism with operating instructions from SOLAS manual

- 1.3.3 The release sequence was described in the Pesbo manual, reproduced in the SOLAS training manual and was also shown on a notice at the remote operating station. A security lever (A) had to be unfastened before the on-load release lever (B) could be pulled. That lever was interlocked with the off-load release lever (C), which should naturally disengage when the interlock came free (see Figures 3 and 4). The remote operating station required positive action by the operator and the lifeboat release mechanism could not be accidentally operated once correctly attached.

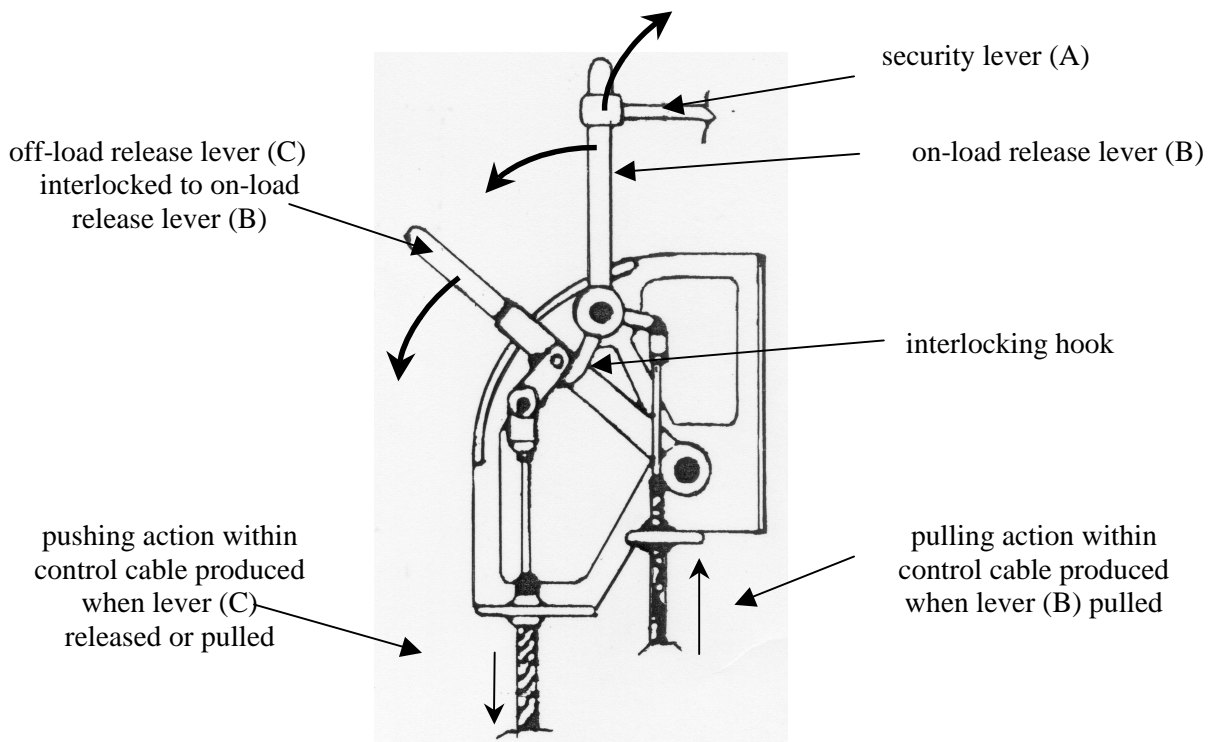
Figure 4
Internal mechanism of the remote operating station

1.3.4 The action of pulling lever (B) pulled the inner core of the sheathed control cables running to the hook at each end of the boat. Those inner cores were attached to security brake pawls that were set into recesses in the on-load release hooks to keep the hooks in place. Pulling the inner cores withdrew the security brake pawls (see Figure 5).

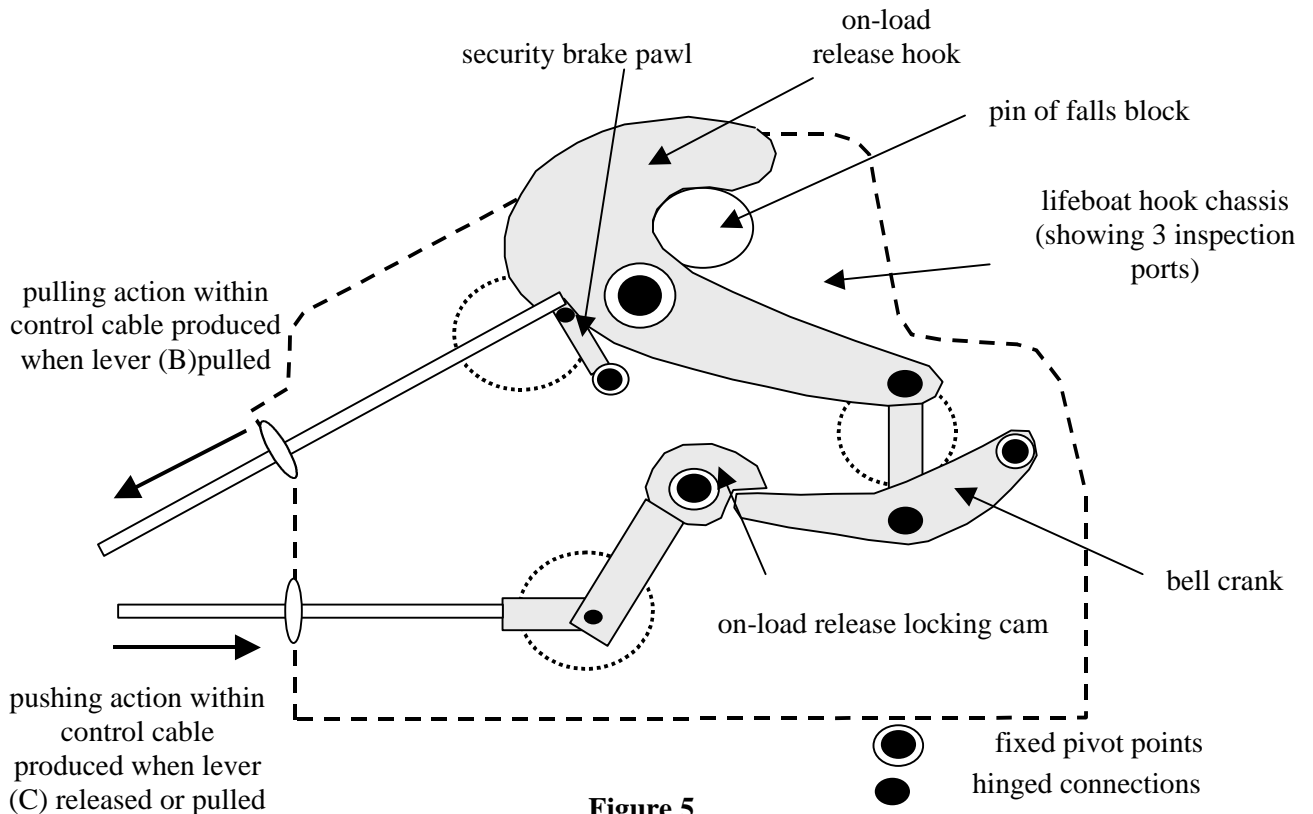
Figure 5
Correctly secured hook

1.3.5 When lever (B) was pulled down, the interlocking hook that held lever (C) in place was released and lever (C) was supposed to fall under its own weight, thus pushing the inner cores of control cables running to the lifting hooks at each end of the boat. Those inner cores were attached to the on-load release locking cams, which held the bell cranks in place. Pushing the inner cores rotated the cams and released the bell cranks, which in turn released the hooks (see Figure 5).

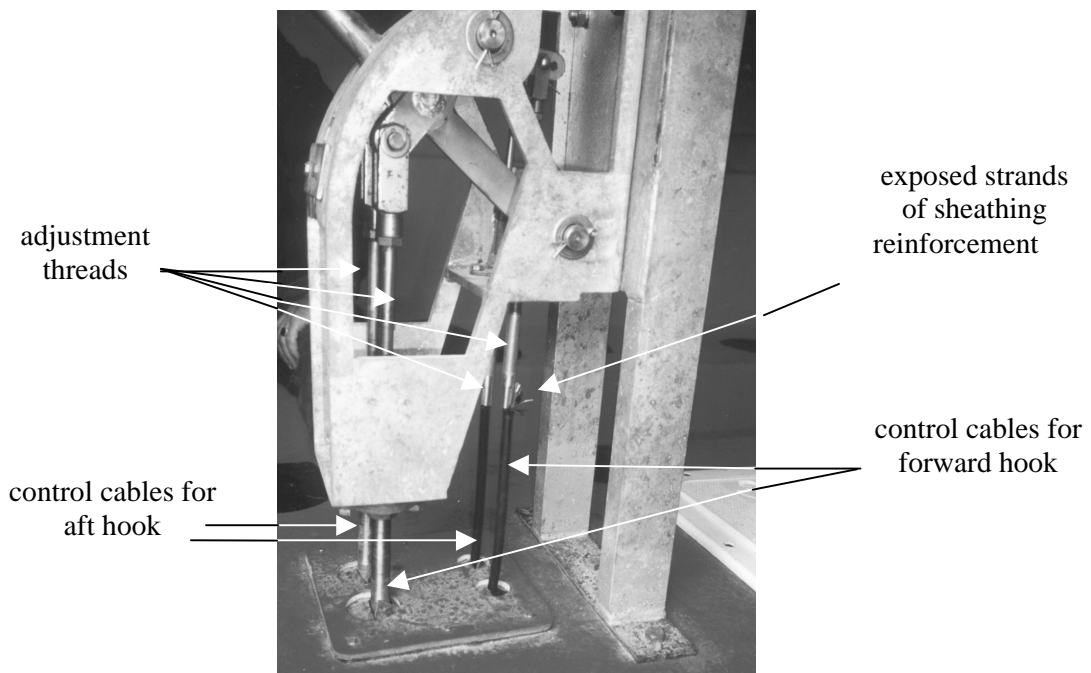
Figure 6
View of remote control cables as found after the incident

1.4.1 Once the port lifeboat was recovered and stowed in the davits, the release equipment was inspected. At the remote operating station, the control cable for the forward security brake pawl was found strained. Part of the cable sheathing at the crimped joint between the cable and the adjustment threads was exposed and several strands of the sheathing reinforcement were protruding. The multi-strand wire within the sheathing appeared to be intact.

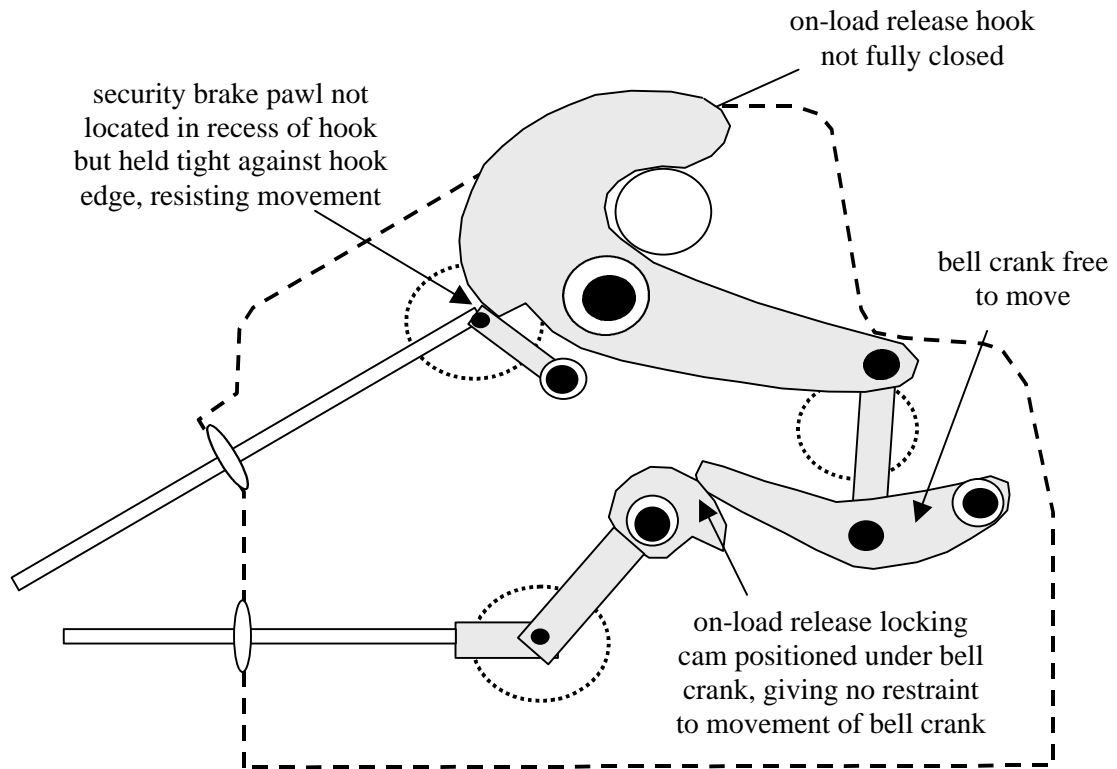
Figure 7
Incorrectly secured hook

- 1.4.5 With the hook held in place as if engaged with the lifting pin of the falls block, but not quite fully closed, the remote operating levers could be pushed into position and secured, giving the impression from within the boat that the release locking mechanism was correctly locked. However, the on-load release locking cam was under the bell crank so not holding it, and the security brake pawl was not fully engaged with the recess in the on-load release hook.

- 1.4.6 The release locking mechanism was operated several times with the release hook in various positions other than fully closed. Little deviation from the closed position was necessary to allow the remote operating station to be locked but the release mechanism not properly engaged. In all cases the on-load release locking cam was under the bell crank but the security brake pawl was in various positions, either pushing on the outside of the hook recess or just engaged into the recess.

- 1.4.8 When the operating handles were locked in place but the release hook was not fully closed, the on-load release locking cam did not prevent movement of the bell crank. However, the security brake pawl was also incorrectly positioned but held against the release hook with sufficient force to hold the hook in position under light loading.

- 1.4.9 The strained control cable for the forward security brake pawl was removed from the lifeboat. The sheathing had separated from the crimped joint with several of the reinforcing strands exposed. The inner core moved freely within the sheathing and was not damaged. The core was steel multi-stranded wire but was not of original specification. The inner core was designed to push or pull on freely moving parts of the release mechanism and, while it had to be rigid within the sheathing, was not required to be particularly strong.
- 1.4.10 With the control cable removed, the release locking mechanism was worked by hand and again when the lifting hook was not in the fully closed position, it was possible to engage the security pawl into the recess of the lifting hook while the on-load release locking cam was under the bell crank.
