Report 01-212

fishing vessel *Hans*

grounding and sinking

19 August 2001

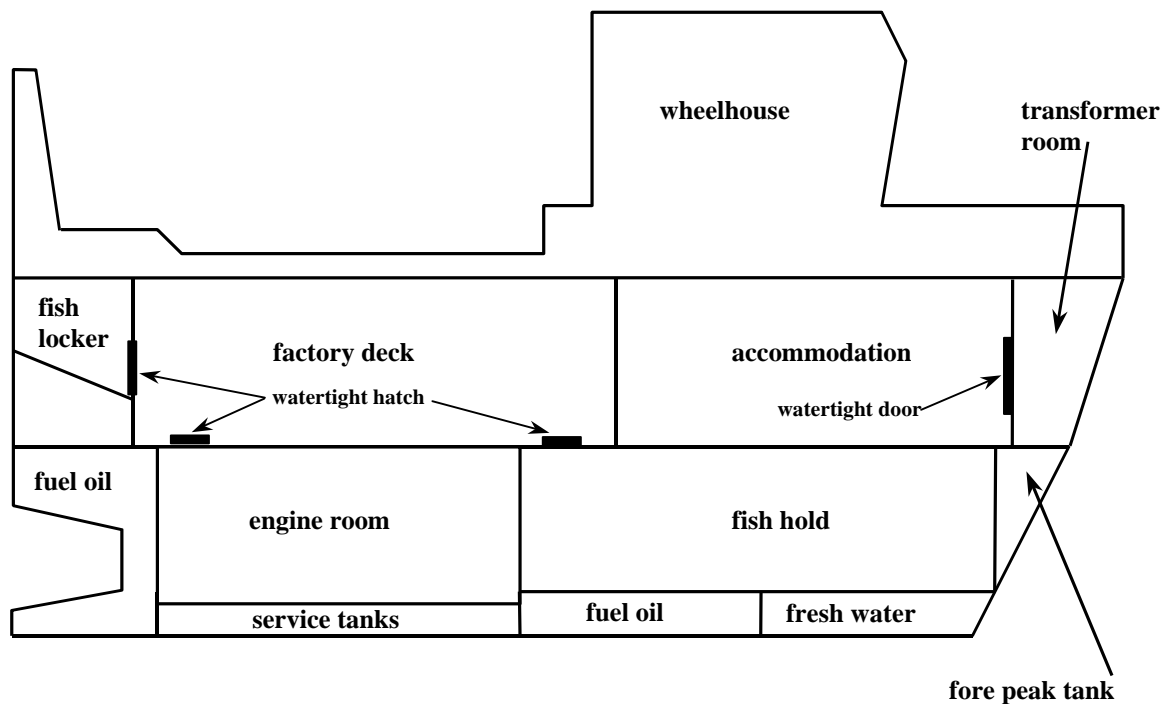
Figure 3
Plan of the *Hans* (not to scale)

- 1.4.5 Aboard the *Hans*, the trawl was hauled up the stern ramp to the main deck where the fish were transferred to the factory deck via the fish locker. On the factory deck, the fish were placed in fish bins and iced before being stowed in the fish hold. The factory deck and fish hold were totally enclosed and without portholes, making it impossible to observe what was occurring outside (see Figure 3).

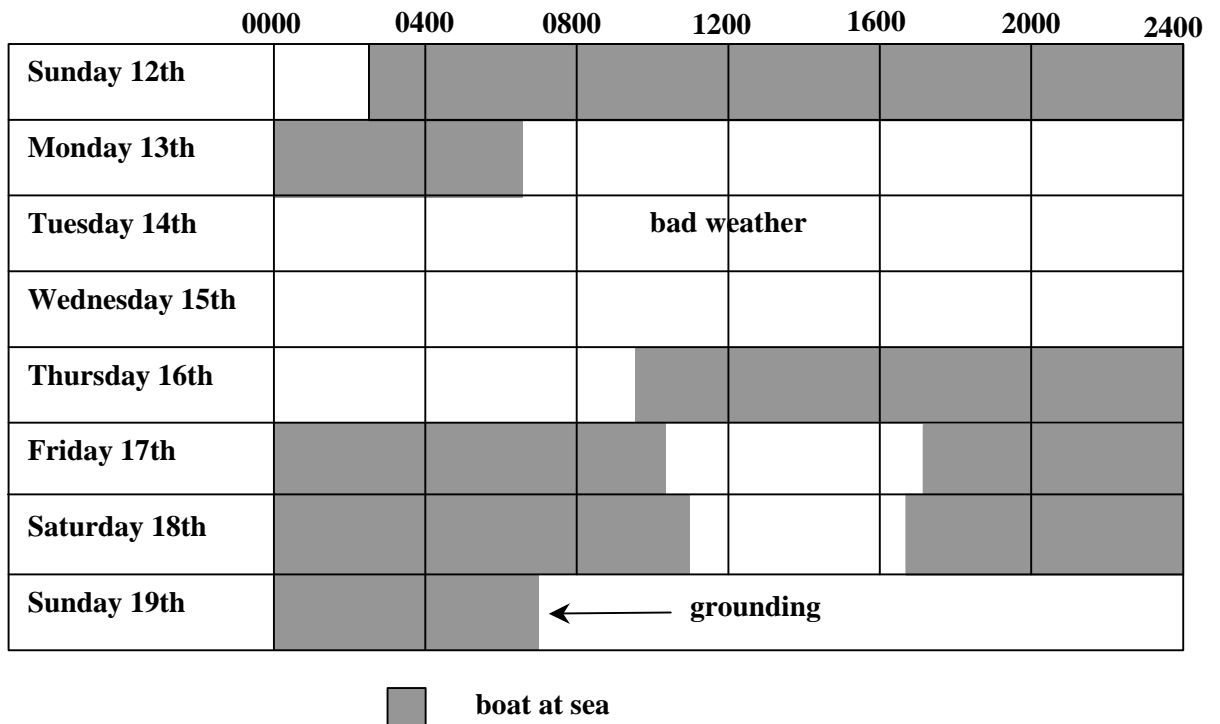
Figure 4
Probable movements of the *Hans* prior to grounding

- 2.12 The skipper recalled observing that the *Hans* had 11 minutes to run before reaching Tory Channel entrance and was aware that he had to make a radio call one minute later, but in that minute he fell asleep before he could make the planned call. At 0700 in the morning the circadian rhythm of alertness and tendency to sleep would be approaching the "wakeful phase" but any benefits would have been offset by fatigue. The skipper would have been suffering from extended wakefulness, having been working continuously for 14 hours after only about 5 hours' sleep, leading him to fall asleep unintentionally.
