MARINE OCCURRENCE REPORT

01-214

Coastal cargo ship *Kent* and passenger freight ferry
Arahura, close-quarters incident, Tory Channel entrance

14 September 2001

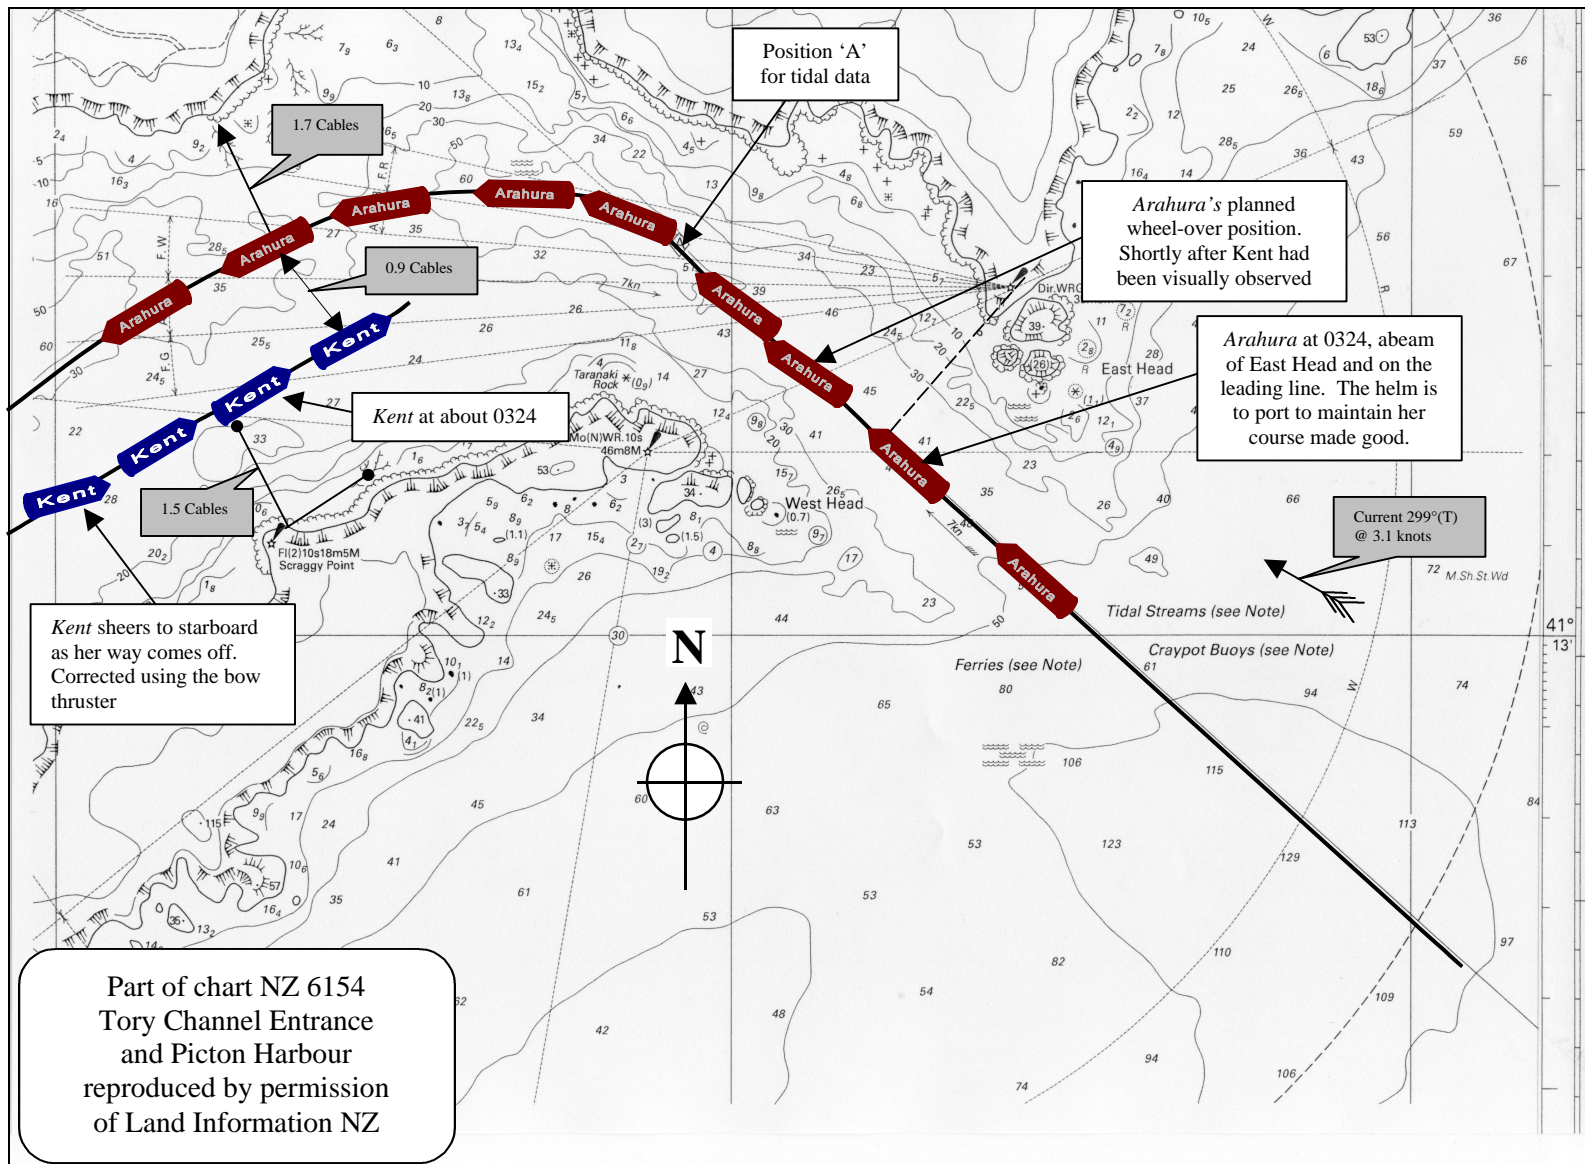
- 1.1.19 According to the mate/master of the *Kent*, his ship was over one cable off the shore and about 1.5 cables past Scraggy Point when the *Arahura* came into sight. The mate/master stated that his ship had just moved into the green sector of East Head directional leading light at that time. This position placed the *Kent* to the starboard side of the channel.

Figure 1
Entrance to Tory Channel showing the tracks of the *Arahura* and the *Kent*
as determined by the information supplied by the crew of the *Kent*

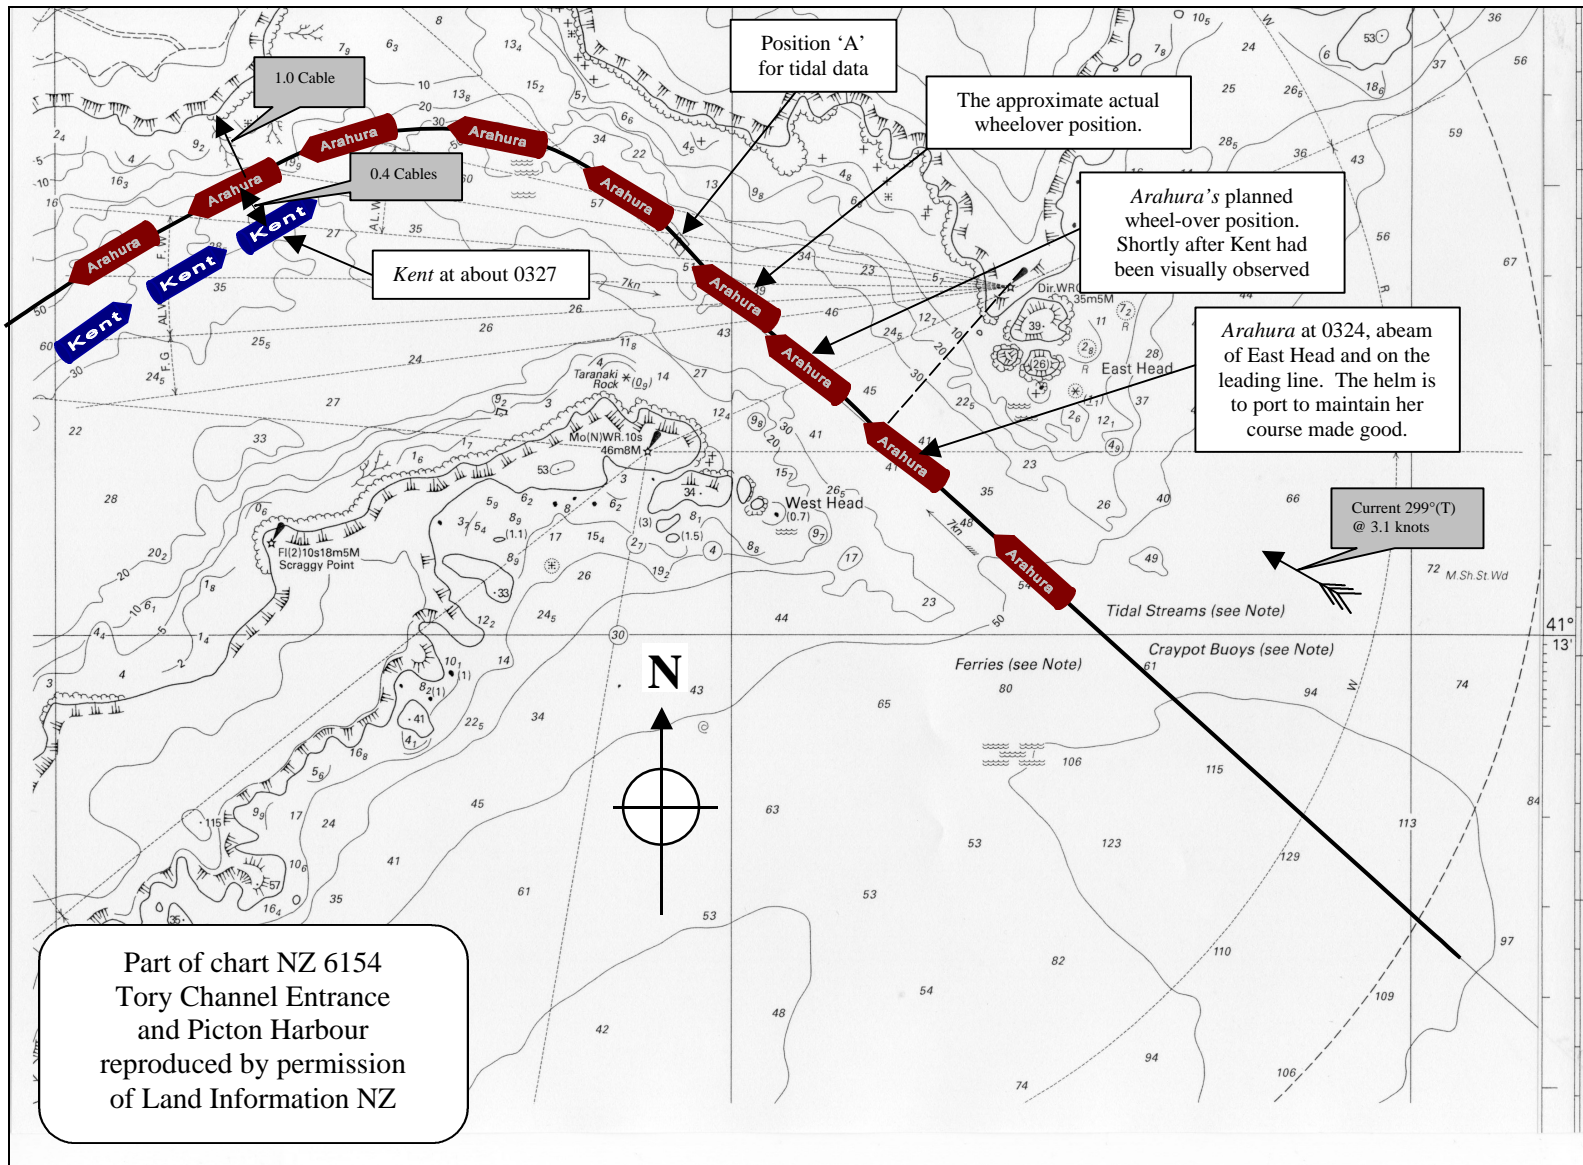
- 1.1.18 Shortly after he had passed East Head, the master of the *Arahura* saw the *Kent* close on his port side and noted that it was to the north-east of Scraggy Point. He perceived that the other ship was in the centre of the channel, or slightly to the north of it.

Figure 2
Entrance to Tory Channel showing the tracks of the *Arahura* and the *Kent* as determined by the information supplied by the crew of the *Arahura*
