## AVIATION OCCURRENCE REPORT

02-015 Piper PA31-325 Navajo ZK-TZC, loss of control and collision with the ground during a one-engine-inoperative landing approach, near Feilding Aerodrome

17 December 2002

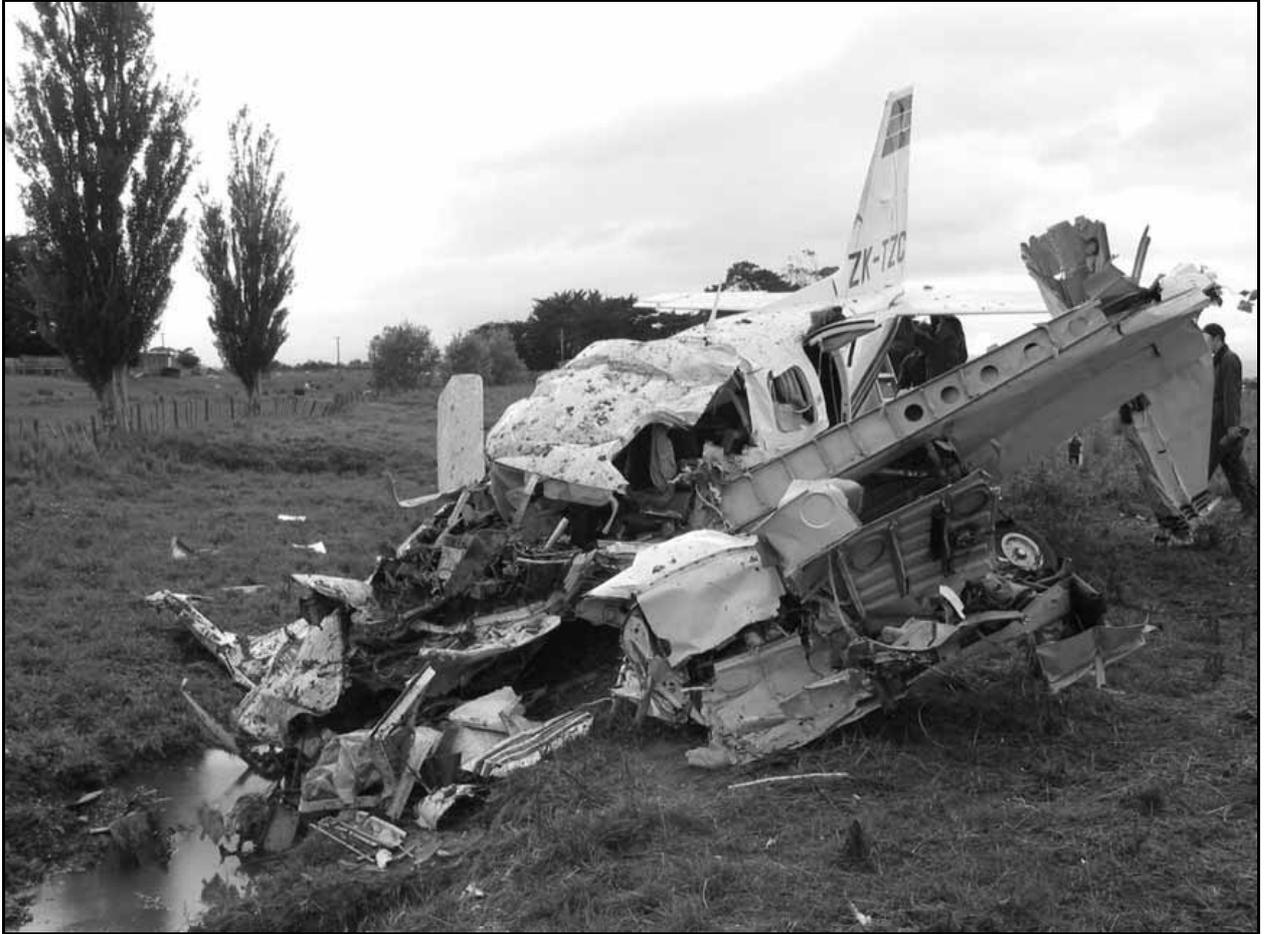
**ZK-TZC after the accident**

- 1.10.2 The entire aeroplane was accounted for at the accident site, which was contained within a small area. There was no evidence of any in-flight structural failure or component separation, or any evidence the aeroplane had struck an obstacle, such as trees, wires or birds. The aeroplane broke up extensively during the impact sequence. The empennage was the only intact section of the aeroplane.

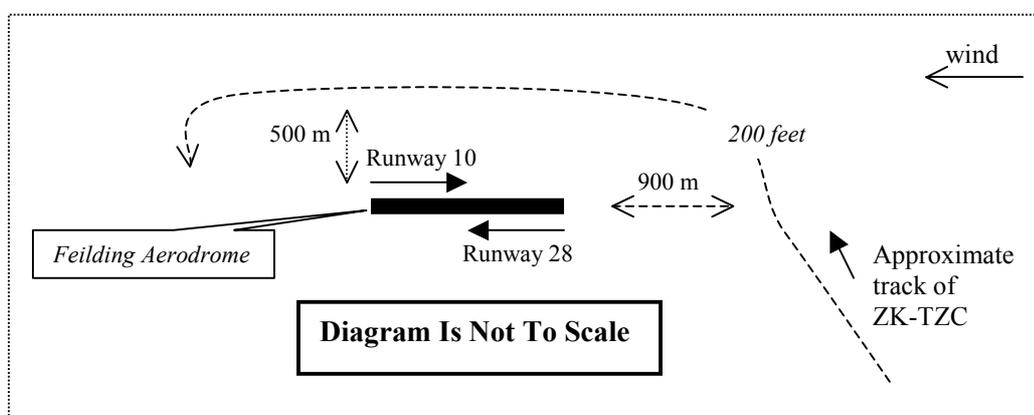
**Figure 1**  
**ZK-TZC approximate approach track**

- 1.1.5 The radar data plot showed that after take-off ZK-TZC turned right, climbed to 1000 feet above mean sea level (amsl) and headed for Paraparaumu. When the aeroplane was about 2.7 nautical miles (nm) (5 km) from Feilding Aerodrome and tracking approximately 1.3 nm (2.4 km) northwest of Palmerston North Aerodrome it turned to the left, descended and headed back to Feilding Aerodrome. The aeroplane descended at about 500 feet per minute rate of descent to 400 feet amsl. At 400 feet amsl (about 200 feet above the ground) the aeroplane passed about 0.5 nm (900 m) east of the aerodrome and threshold for runway 28, and joined left downwind for runway 10. In the downwind position the aeroplane was spaced about 0.3 nm (500 m) laterally from the runway at an initial height of 400 feet amsl, or about 200 feet above the ground (see Figure 1).

- 1.1.6 ZK-TZC departed from controlled flight when it was turning left at a low height during an apparent approach to land on runway 10, with its undercarriage and flaps extended. ZK-TZC first rotated to face away from the aerodrome before striking the ground in a nose down attitude. The 3 occupants were killed in the impact.
