## RAILWAY OCCURRENCE REPORT

02-104

Express freight and passenger trains, derailments or near  
derailment due to heat buckles, various localities

**derailments and near-derailment due to track buckles 2001/2002**

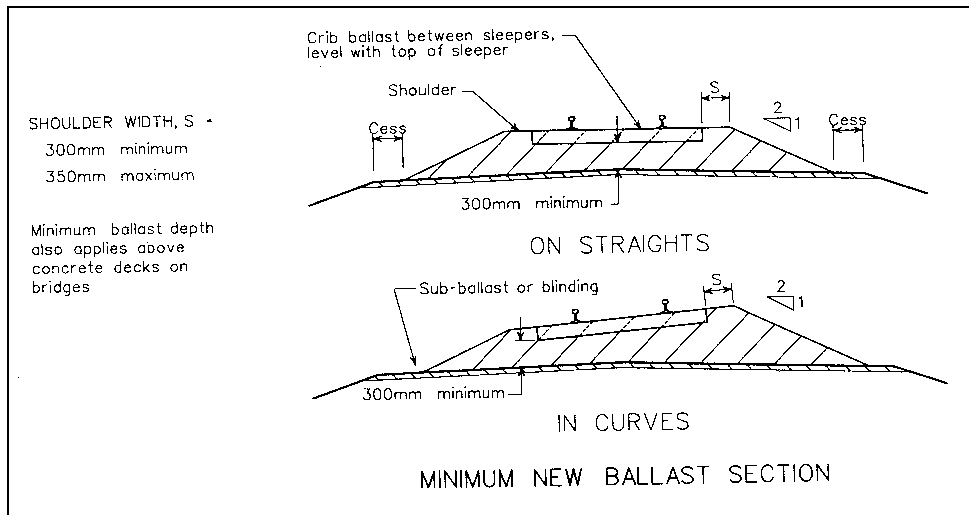
**Figure 1**  
**Minimum new ballast section**  
 (diagram from Tranz Rail Infrastructure Handbook, courtesy of Tranz Rail)

- 2.1.7 Tranz Rail’s Infrastructure Engineering Handbook T:200 prescribed a minimum depth of 300 mm of ballast under the sleeper for new ballast section for CWR and a shoulder width of between 300 mm and 350 mm flush with the top of the sleeper (refer Figure 1). The specified shoulder width was the same standard as for maintaining existing track.

2. The ballast profile was inadequate in that the shoulder section was less than the code requirement and this contributed to the lowering of resistance to buckling during hot rail conditions.

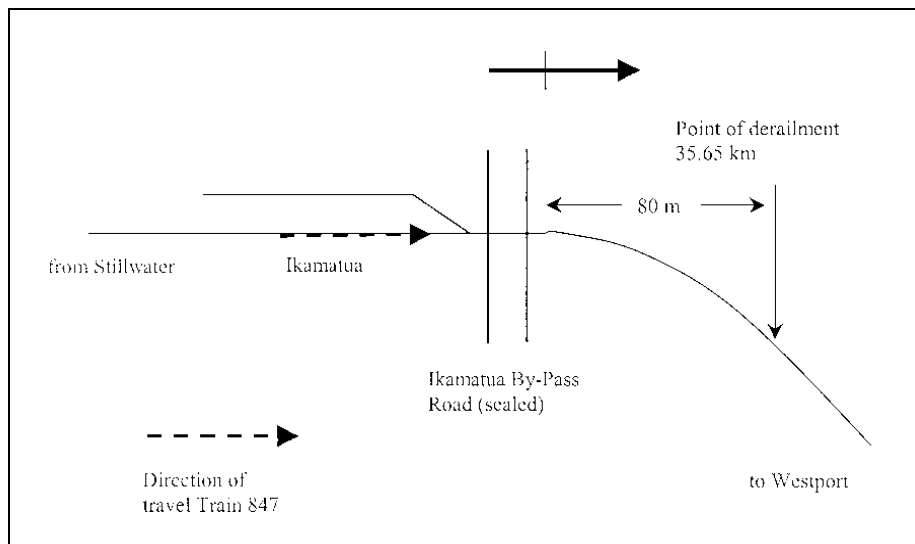
**Figure 2**  
**Site plan of track buckle derailment at Ikamatua**  
**(not to scale)**

- 3.1.6 The track buckle occurred 80 m into a 200 m long, 400 m radius right-hand curve on a rising gradient of 1 in 330 in the direction of travel of Train 847.

- 3.1.9 Although the ballast profile complied with the code, a localised “mud spot”<sup>8</sup> had developed on the low leg of the curve near the track buckle point.

1. The track buckle was probably initiated at the mud spot by the loaded coal train that had negotiated the curve about 30 minutes before Train 847. Mud had infiltrated the ballast under the sleepers which would have encouraged pumping (vertical movement of the track under load) and reduced the lateral stability.
2. The Type A fastenings provided limited longitudinal restraint to the rail on the adjacent straight, and with loaded coal trains travelling down the gradient, the sealed level crossing some 80 m south of the buckle site, provided an anchor point. This anchor point prevented rail creep continuing in the direction of the loaded trains but allowed rail stresses to build up in the curve, increasing the probability of track buckling during hot rail conditions. The lack of anchors on the straight adjacent to the derailment curve lowered the resistance to track buckling.

3. Rail creep introduced large compressive forces into the curve, which became so great with thermal expansion on a particularly hot day that the lateral resistance of the track structure was exceeded and the track buckled.
4. The train was travelling about 5 km/h above the authorised line speed but the increased speed had no influence on the cause of the track buckle and was unlikely to have contributed to the resulting derailment.
