RAILWAY OCCURRENCE REPORT

02-113

Passenger express Train 700 *TranzCoastal* and petrol tanker, near collision, Vickerman Street level crossing, near Blenheim

25 April 2002

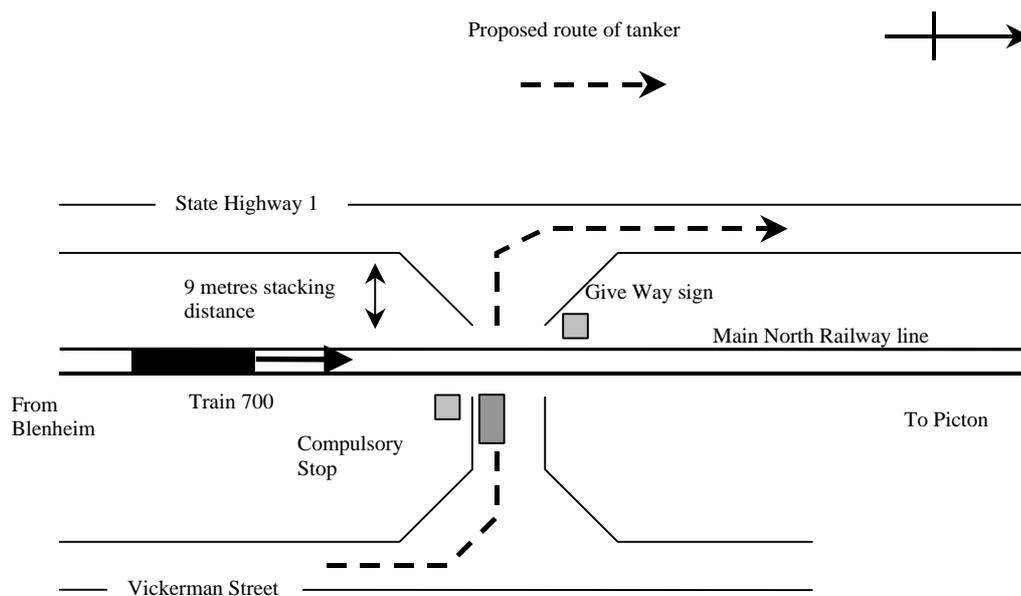
Figure 1
Site Plan of Vickerman Street level crossing and junction with State Highway 1 (not to scale)

- 1.3.3 On the State Highway 1 side of the crossing there was a total distance of 12 metres from the nearest rail to the intersection. The “Manual of Traffic Signs and Markings”¹ stipulated a minimum distance of 3 m from the limit lines to the nearest rail for traffic approaching a Give Way sign at a level crossing. At this crossing there was 9 m of space remaining for vehicles to park awaiting a rail clearance (see Figure 4). There was no stipulated minimum distance clear of the railway for vehicles having crossed over a level crossing and stopped.

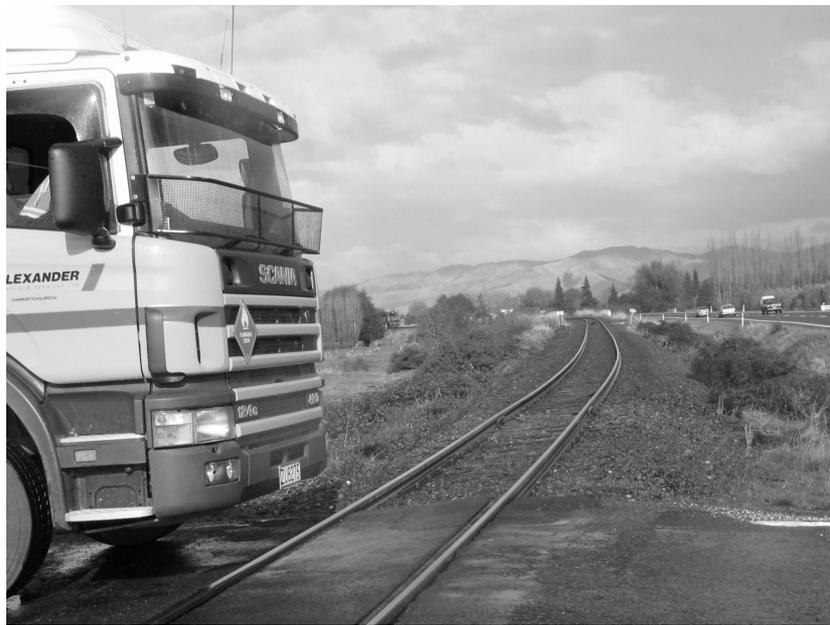
- 1.2.4 The tanker had moved forward about 3 m to the point where the cab was positioned over the nearest rail (see Figure 2) when the driver was alerted to the approach of Train 700 from his left side. He had turned to his left at the same time as the trainee driver had called "train". He cautiously reversed off the crossing, mindful of any other vehicles that may have parked behind him and were not visible in his rear vision mirrors. He reversed at a speed that would have allowed any such vehicles to get clear, but fast enough to clear the track before the train arrived.

Figure 2
The simulation petrol tanker parked where the tanker driver had originally stopped when he became aware of the approach of Train 700

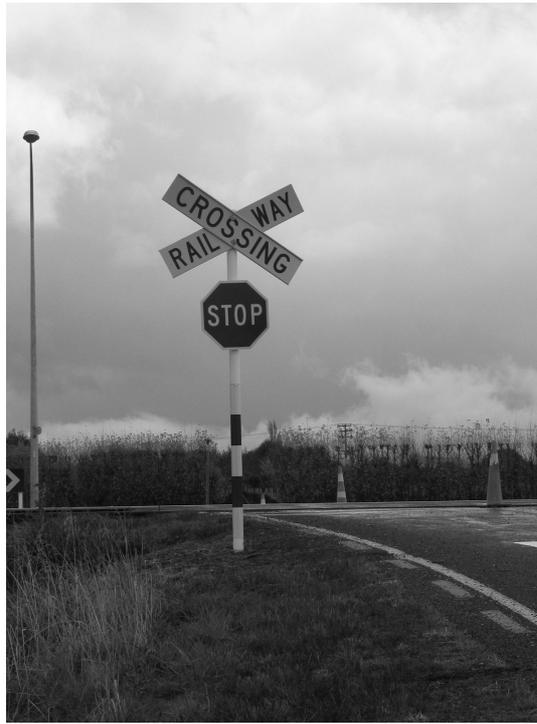
Figure 3
The Compulsory Stop sign on the Vickerman Street side of the level crossing

- 1.3.2 The level crossing was not protected by warning lights, bells or barriers. Rather, it was protected by roadside signage, which included a Compulsory Stop sign immediately before the level crossing on the Vickerman Street side, and a Give Way sign on the State Highway 1 side. There were also appropriate road markings on both sides of the level crossing.

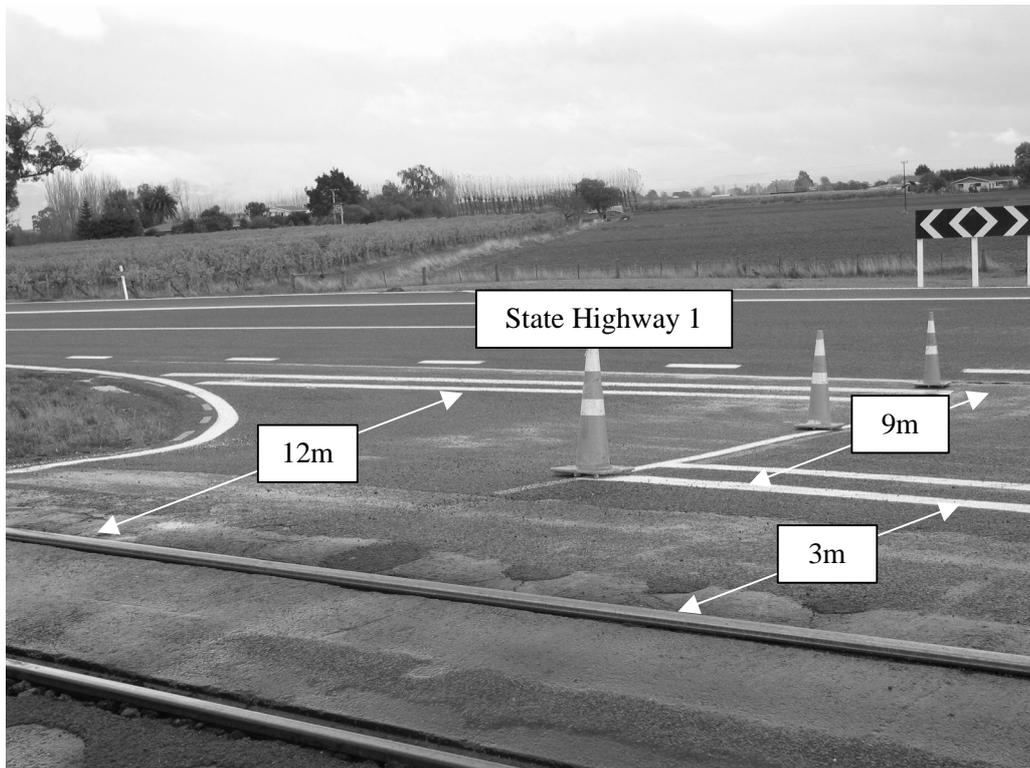
- 1.2.5 From his cab, the driver could not see the yellow limit line road markings to advise him when his truck was safely clear of the crossing, so he continued reversing until the compulsory stop sign was adjacent to his cab, at which point he was about 3 m clear of the crossing and was clear of the limit lines. He stopped and waited as the train approached and stopped also. There was no contact between the tanker driver and the locomotive engineer and after the train had gone he contacted his office by cell phone to report the incident.

Figure 4
The State Highway 1 side of the level crossing showing the limit lines for traffic approaching the intersection and approaching the level crossing

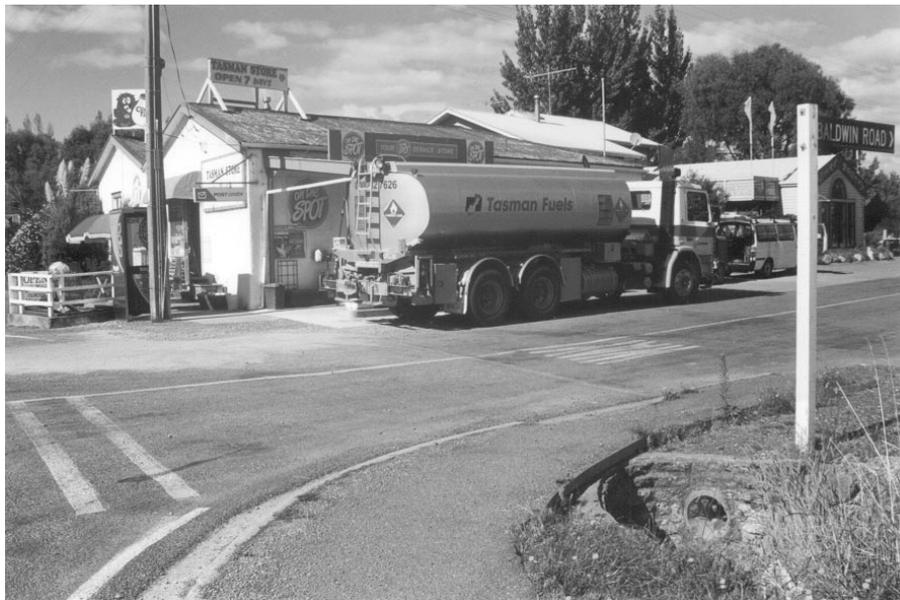
1.5.1 The petrol tanker was a 1995 Scania P113ML, with a tare weight of 10 300 kg. It was 7.6 m long and was equipped with a 15 000 litre tank. It was owned by Alexander Petroleum Services Ltd and used for petrol deliveries under contract to Shell New Zealand Ltd (Shell). It had a current certificate of fitness and registration.

Figure 5
The petrol tanker in the livery of its previous owner
(photograph courtesy of Alexander Petroleum Services Ltd)
