RAILWAY OCCURRENCE REPORT

02-114 Electric Multiple Unit Train 2643, passenger fell from stationary train, Silverstream

12 June 2002

**TRANSPORT ACCIDENT INVESTIGATION COMMISSION
NEW ZEALAND**

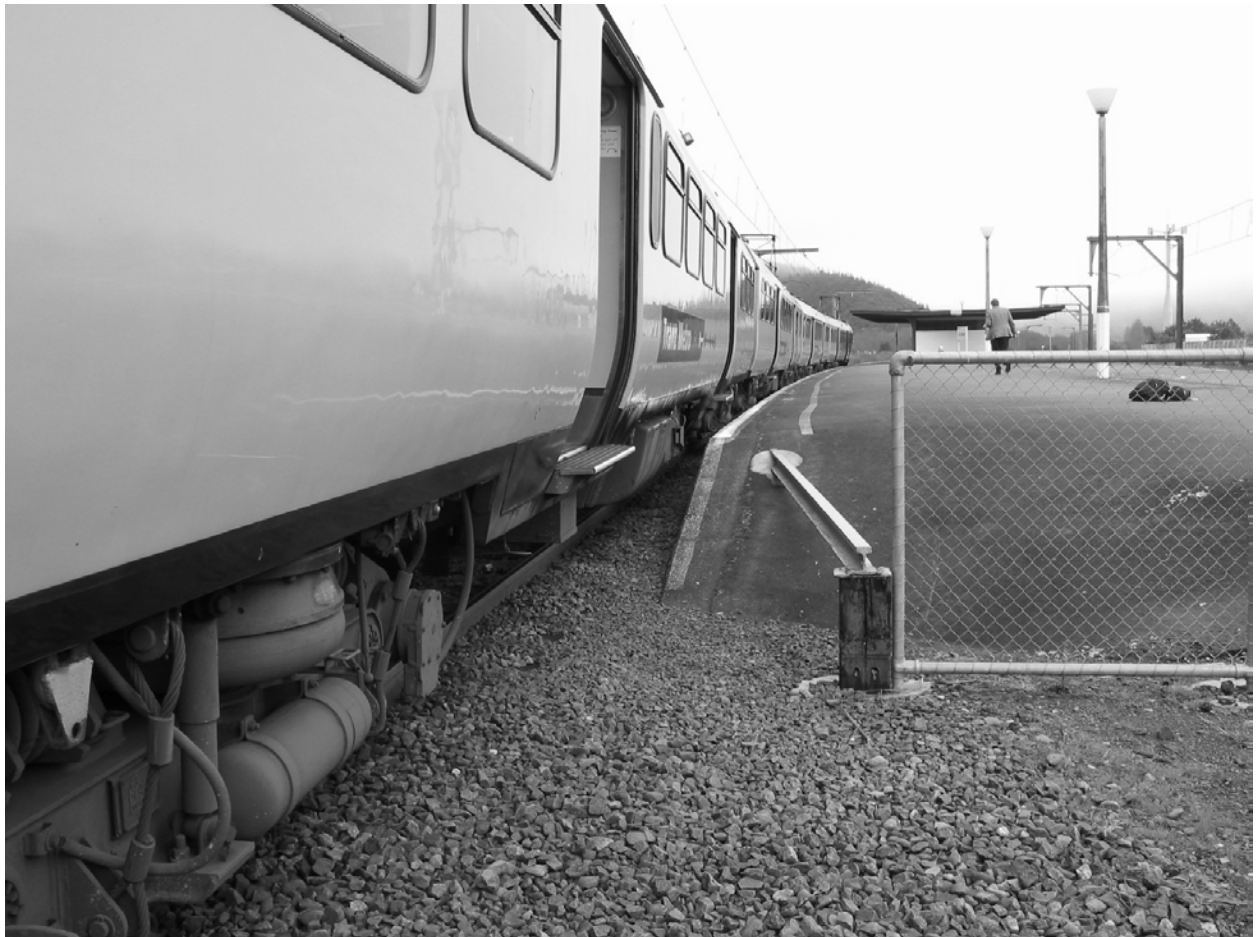
- 1.1.6 Once the doors were opened, a partially-sighted passenger, who was travelling alone in the last car, gathered her belongings and grasping the right hand rail for assistance, stepped out of the doorway. She fell about 930 mm to the ground and landed on her feet between the train and a barrier. The barrier, constructed of railway iron, was intended to prevent pedestrian access to the track from the ramp at the end of the platform (see Figure 1). Her left leg was hard against the barrier.

Figure 1
The position of the train when it was stopped at Silverstream.
The passenger fell from the nearest door.

- 1.2.4 A 4 car EMU set is about 86 m long. The front of Train 2643 had stopped about 4 m short of the south end of the platform shelter and about 56 m short of the 4 car marker. As a result, the last car overhung the end of the platform by about 10 m, with the rear door being short of the platform.

- 1.2.5 From the north end of the platform a barrier constructed from a piece of railway iron stretched about 4 m to join with a mesh fence (see Figure 1). Its purpose was to prevent members of the public access from the platform to the railway line.

- 3.1 The sight-impaired passenger was severely injured when she fell from the train to the ground having stepped out of the rear door of the last car expecting that it was properly positioned at the platform.

- 3.2 Had the driver stopped the train at the appropriate guidance mark on the platform, the rear of the train would not have overhung the platform.
- 3.3 The driver stopped the train in accordance with the guard's request, which inevitably led to the rear of the train overhanging the platform.

- 4.1 On 10 October 2002, Tranz Rail advised that, following the Silverstream accident, it had completed painting platform markings to indicate the correct stopping distances at all suburban stations and that the approved safety system had been enhanced with the following instruction:

All platforms have been marked with stopping marks for various consists that run on the line. Drivers must stop at the mark applicable to the number of cars on their service.

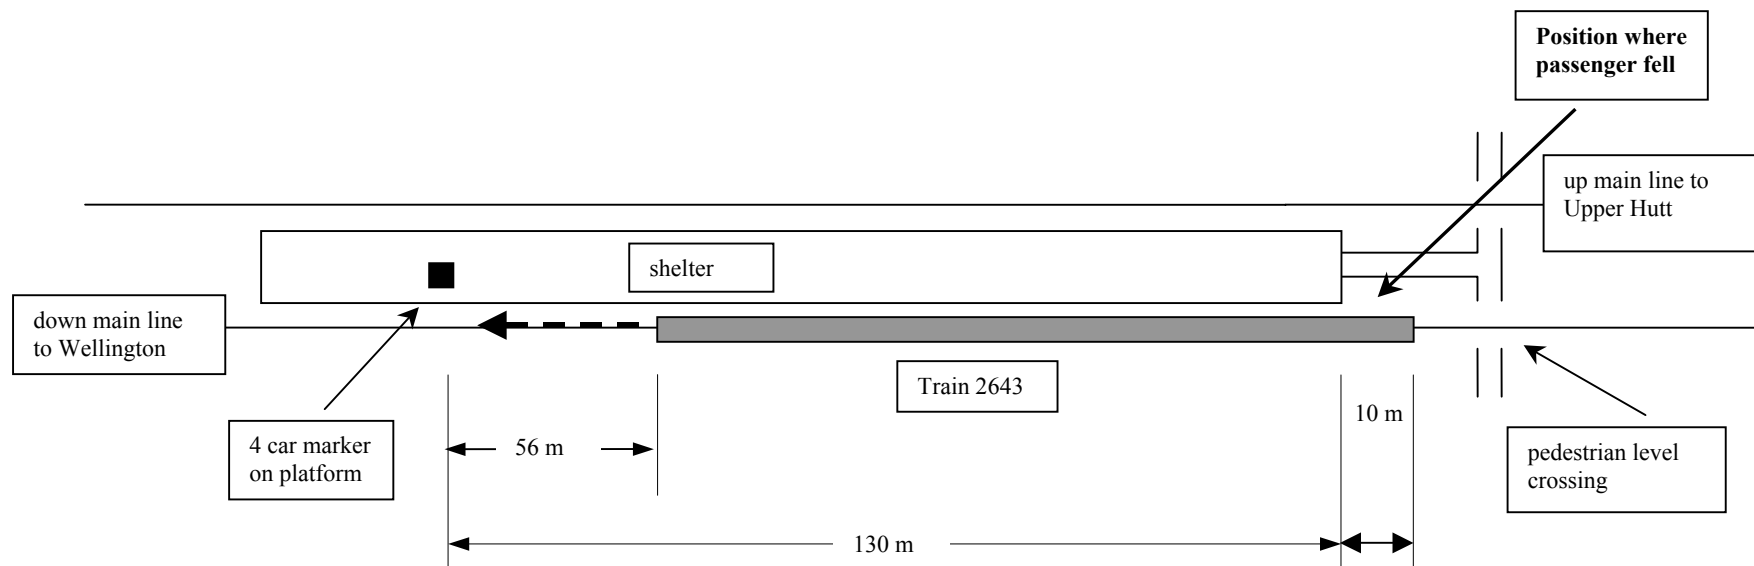
Figure 2
Plan of Silverstream station (not to scale)

- 1.2.1 Silverstream was an island platform station with the up main line and the down main line on either side. There was a passenger shelter positioned about 70 m from the north end of the platform (see Figure 2).

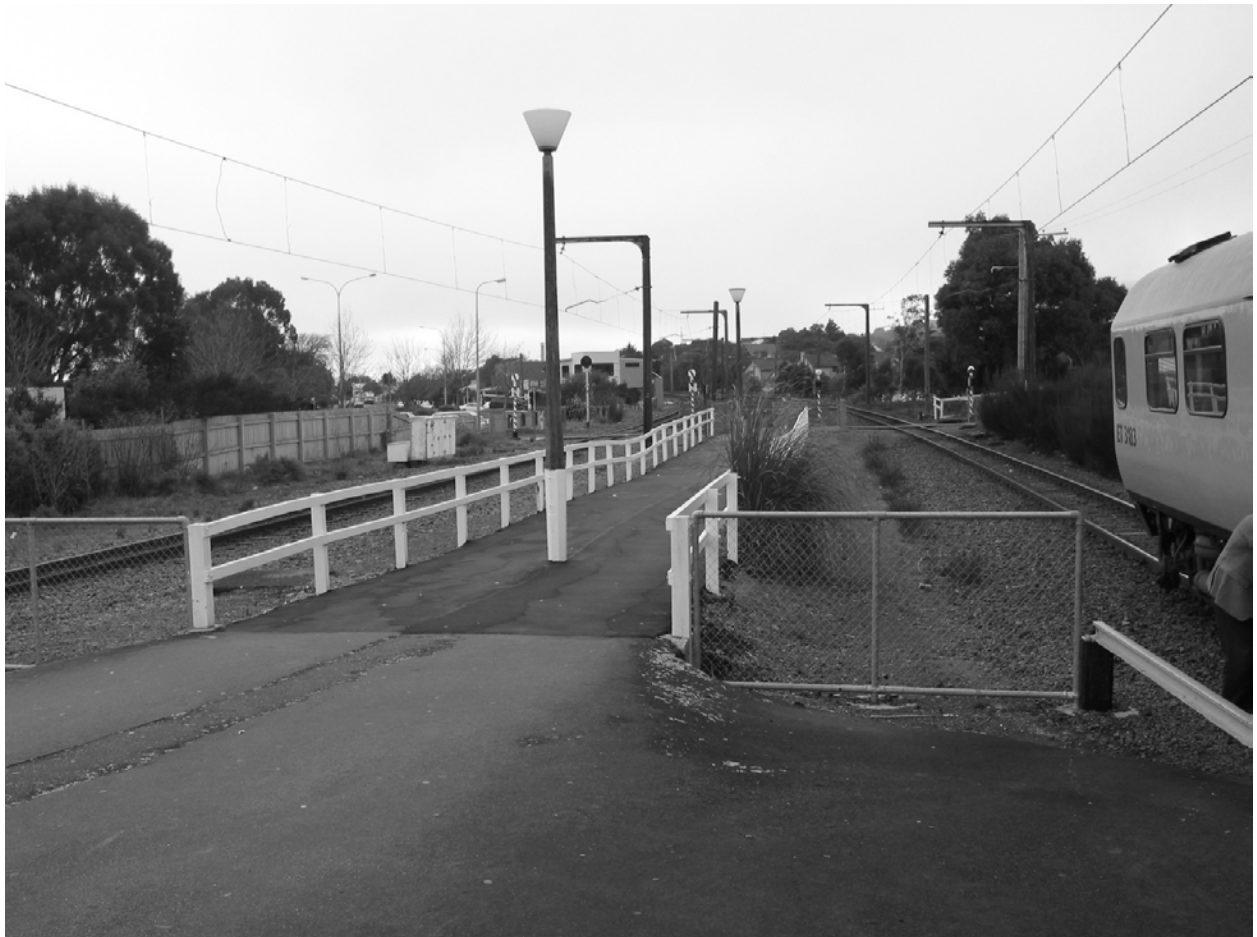
Figure 3
The north end of Silverstream platform

- 1.2.2 Pedestrian access to the station was from the north via a public access way that went from the end of the platform and between the main lines for a distance of about 60 m to where it branched left and right through protected pedestrian level crossings over the respective main lines (see Figure 3).
