## RAILWAY OCCURRENCE REPORT

02-116      express freight Train 533, derailment, near  
Te Wera

26 July 2002

**Report 02-116**  
**express freight Train 533**  
**derailment**  
**near Te Wera**  
**26 July 2002**

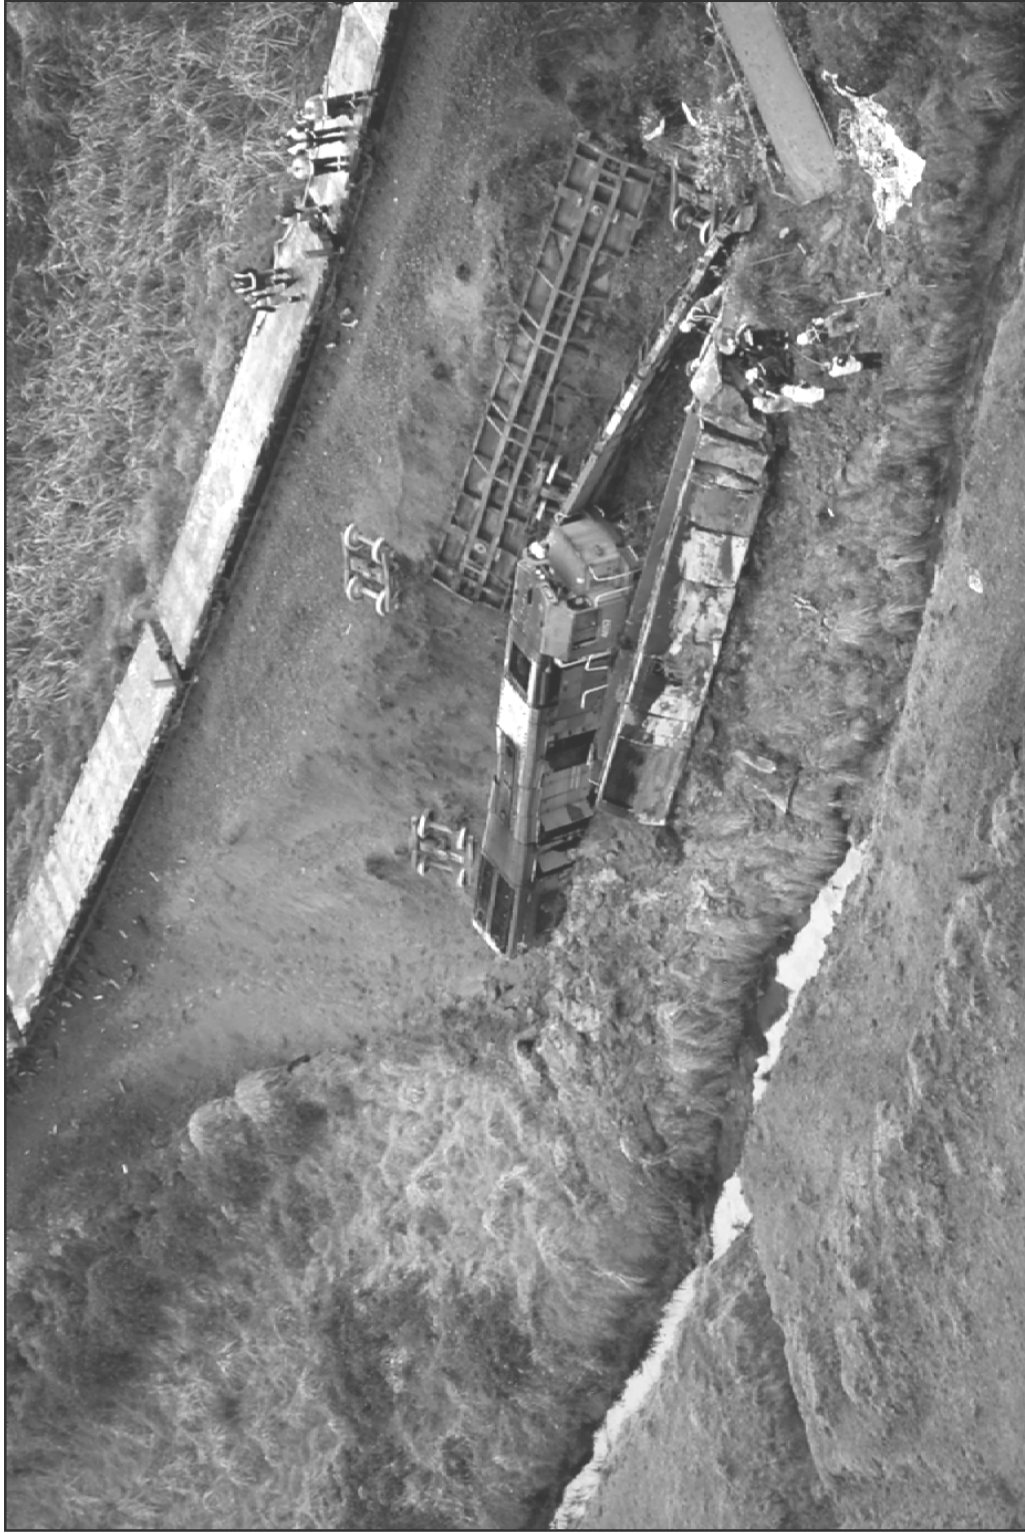
The 2 locomotives and several wagons on the train were extensively damaged, but the track sustained minor damage only.

**Train 533 after derailment  
(courtesy Taranaki Daily News)**

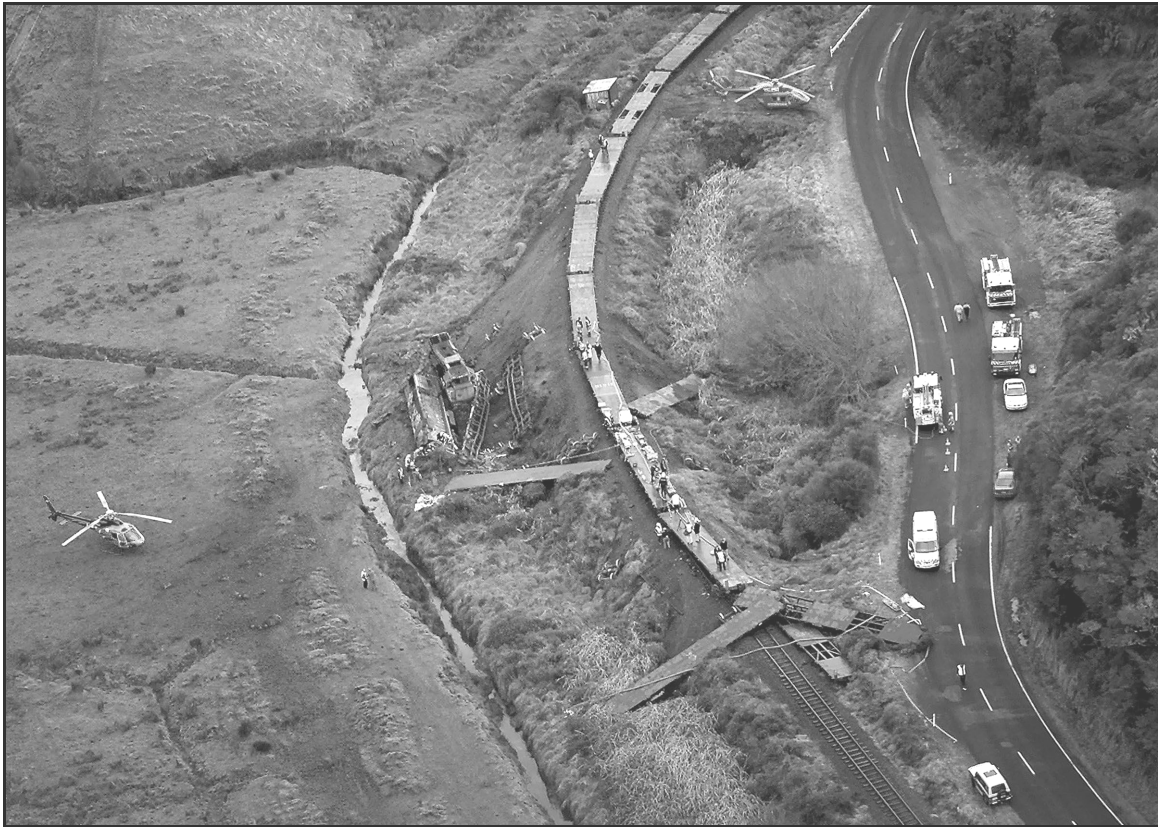
**Figure 2**  
**The derailment site looking east (courtesy Taranaki Daily News)**

- 1.2.6 The track formed a 400 m radius, 70 km/h, right-hand curve and straightened for about 40 m before it entered the reverse 160 m radius, 45km/h, left-hand curve on which the train derailed.
- 1.2.7 The locomotives derailed to the outside (right) of the curve in the direction of travel. Three empty flat deck wagons followed the locomotives down the side of the track formation while another 4 empty flat deck wagons derailed at various angles to the track formation (see Figure 2), the front of one wagon coming to rest about 1 m across adjacent SH43.

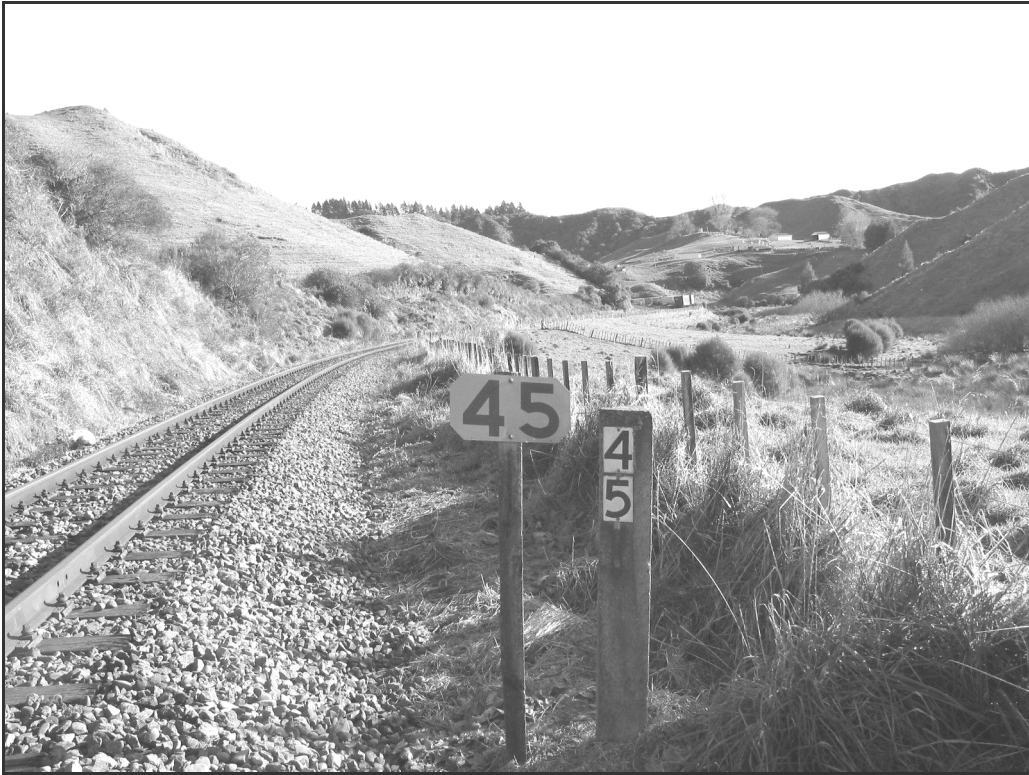
**Figure 3**  
**The 45 km/h curve warning board to the left of the 45 km metrage peg**

- 1.2.8 To warn locomotive engineers of the upcoming restricted speed curve, a 45 km/h curve warning board<sup>2</sup> was positioned 2.63 m from centre line of track, and 266 m before the start of the curve (see Figure 3). A 45 km/h curve board<sup>3</sup> was positioned 3.35 m from centre line of track and 39 m before the start of the curve (see figure 4). The boards were 574 m and 347 m respectively before the point of derailment (POD), were in good condition, clearly visible and positioned in accordance with Tranz Rail's Engineering Rules 911 (b) and (c).
- 1.2.9 The nominal overturning speed of a locomotive on the curve was about 75 km/h, close to the 70 km/h maximum authorised line speed for trains for that section of the line, and the curve could be considered a "speed trap."<sup>4</sup>

1. Although the curve warning board and the curve board were correctly positioned, in good condition and free of any obstructions, the presence of any fog would have reduced the distance from which they could be seen. However, under normal circumstances the locomotive engineer's situational awareness and route knowledge would have alerted him to their presence and that of the approaching 45 km/h curve to which they referred.

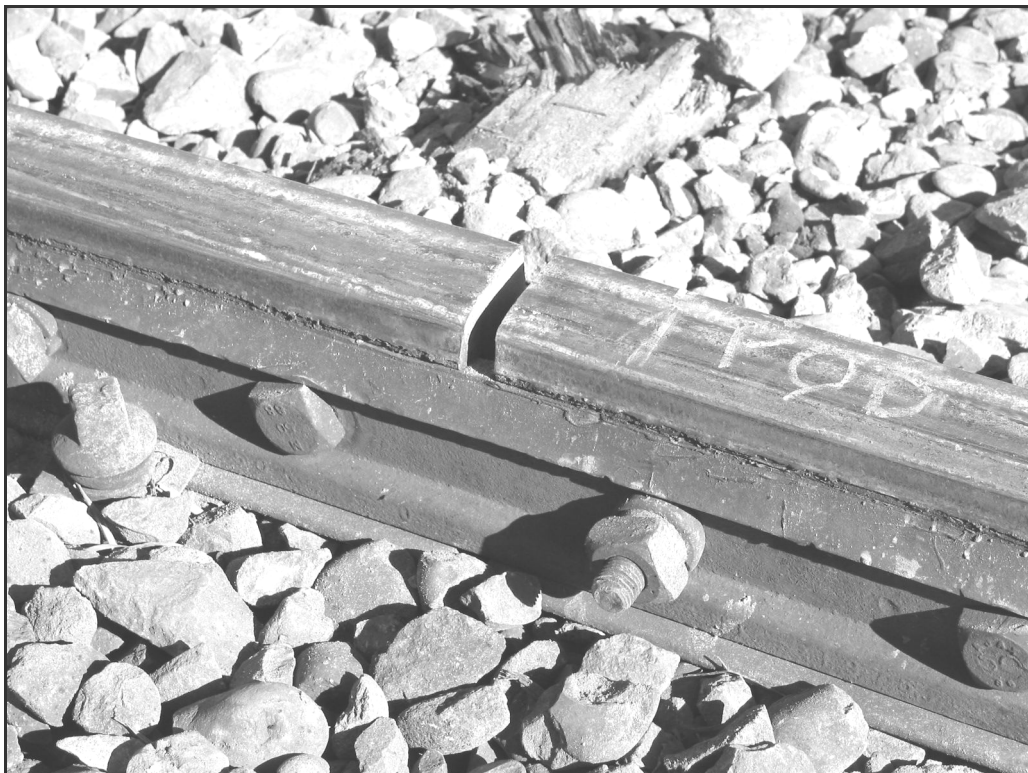
**Figure 5**  
**The marks at the point of derailment**

- 1.2.10 The POD was determined as the point where the flange of the wheel of the first axle that derailed started to mount the head of the rail. The position was identified by marks on the rail head near a bolted rail joint (see Figure 5), which indicated that a right-hand wheel flange had started to climb against the gauge side<sup>5</sup> of the high leg rail<sup>6</sup> and had then travelled about 1.2 m along the rail head before dropping off the track.

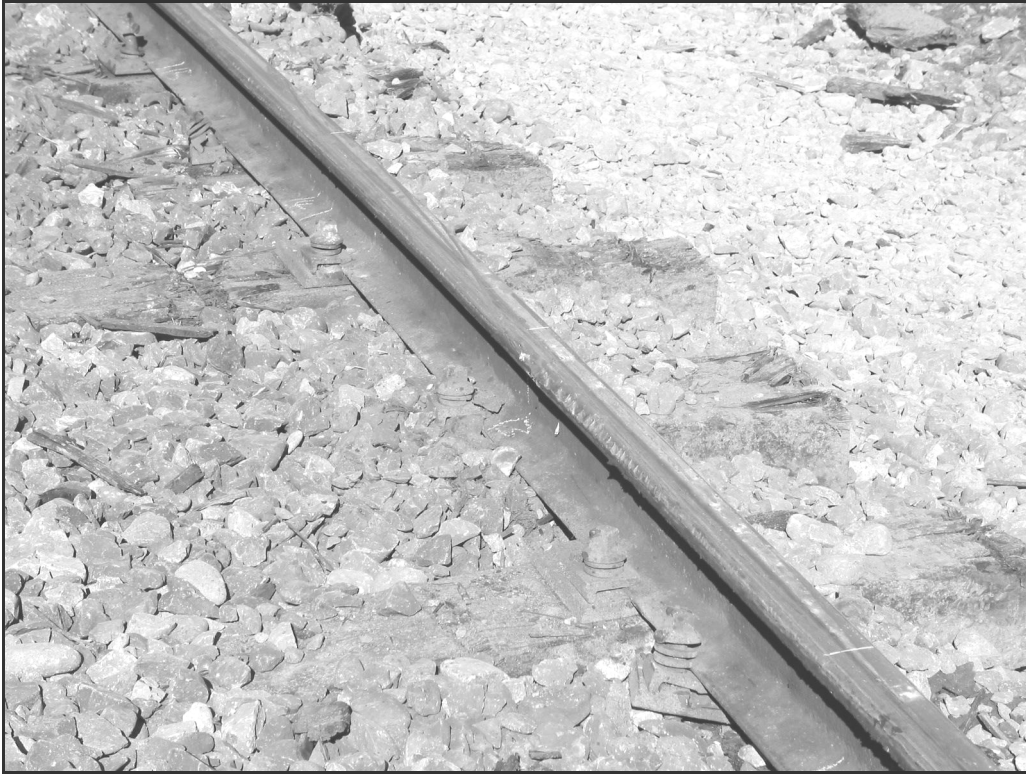
**Figure 6**  
**The heavy scoring on the gauge side of the high leg rail**

- 1.2.11 About 13 m beyond the POD, 1.1 m of the gauge side of the high leg rail and along the head of the rail was heavily scored (see Figure 6). This scoring indicated where the flanges of either the leading left-hand wheel of the front axle or the left hand wheels of the leading bogie of DX5045 had climbed on to the head of the rail and travelled to the drop off point. The high leg rail was fractured near the end of the scoring (see Figure 7).

2. No track defects were identified which could have contributed to the derailment. Most of the damage to the track occurred near and immediately beyond the POD, and was probably caused by the locomotives as they derailed.

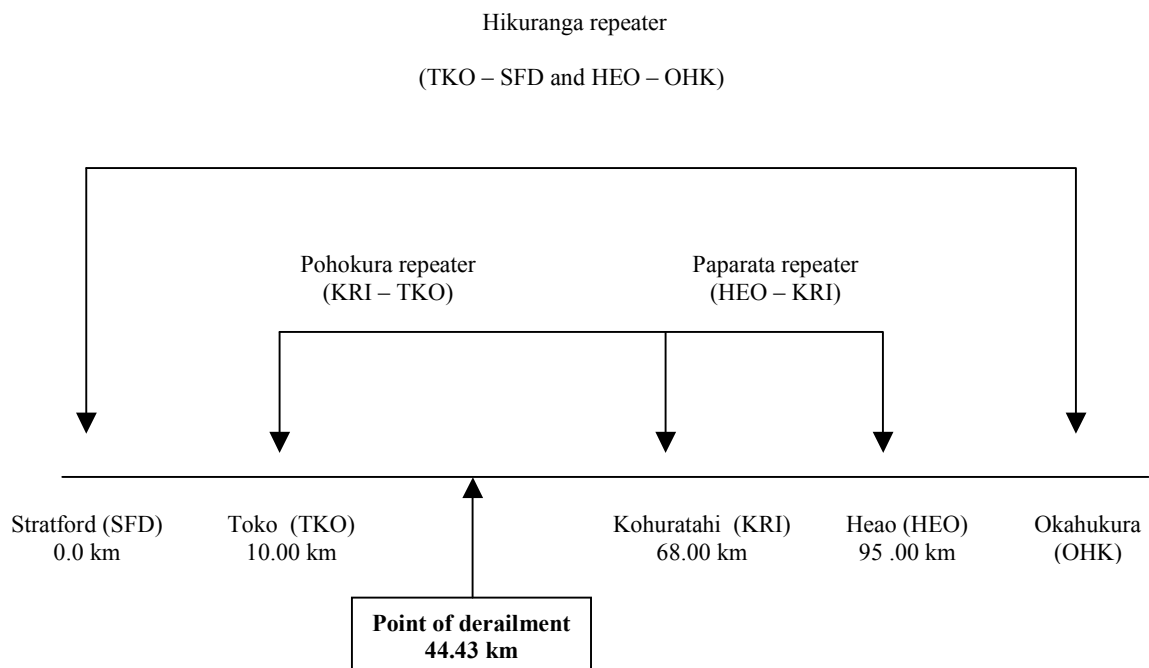
**Figure 8**  
**Repeater coverage of the SOL (not to scale)**

- 1.11.5 To increase the radio coverage on the SOL, radio transmissions from trains were routed via repeaters located enroute at Hikurangi, Pohokura and Papanui. Figure 8 shows the coverage of each repeater across the SOL.

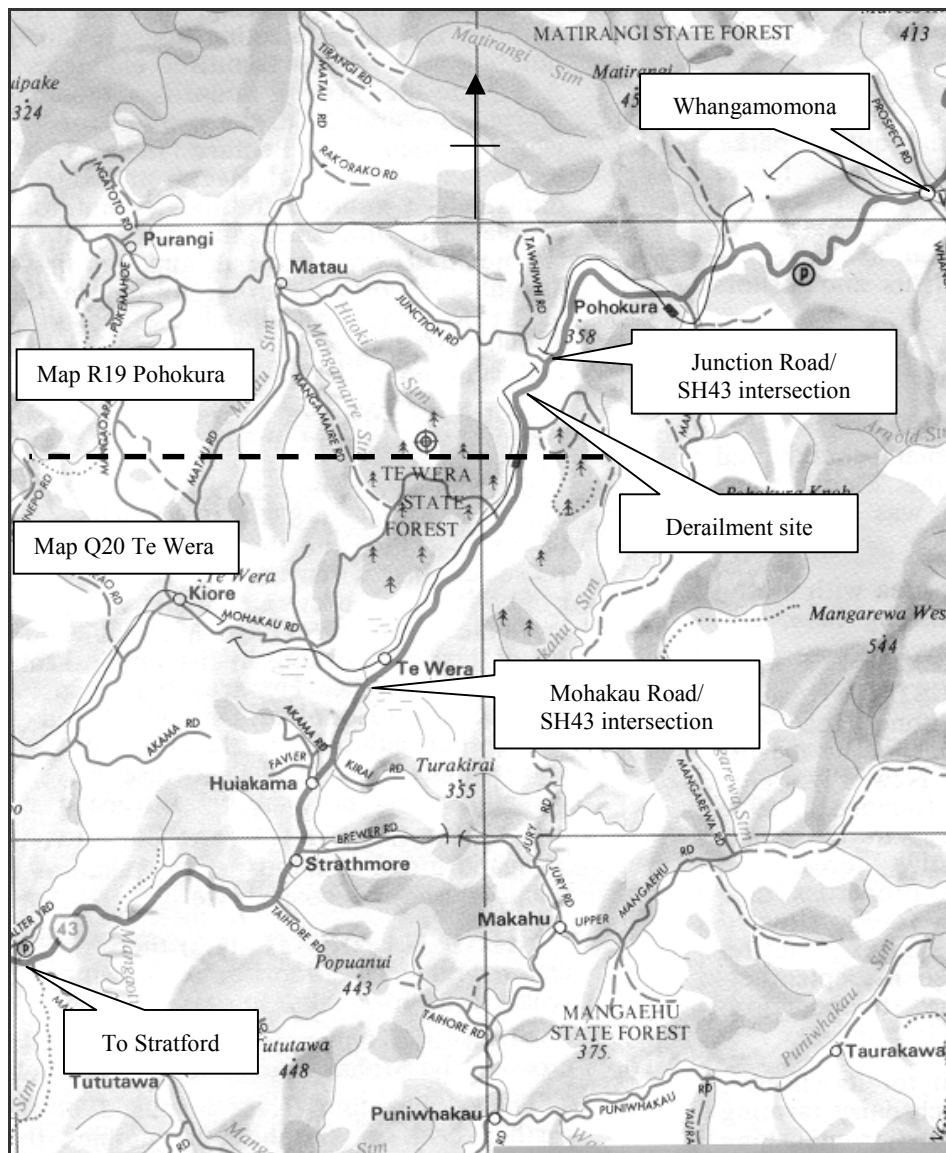
**Figure 9**  
Automobile Association map showing relevant sites and delineation of LINZ maps

- 1.19.12 When TC1 referred to the Te Wera map, he found it did not cover the accident site so he got the Pohokura map to identify the true location.
- 1.19.13 Three train controllers were involved in various aspects of the recovery response.
