## RAILWAY OCCURRENCE REPORT

02-118

express freight Train 484, near collision with hi-rail vehicle,  
Tauranga

7 August 2002

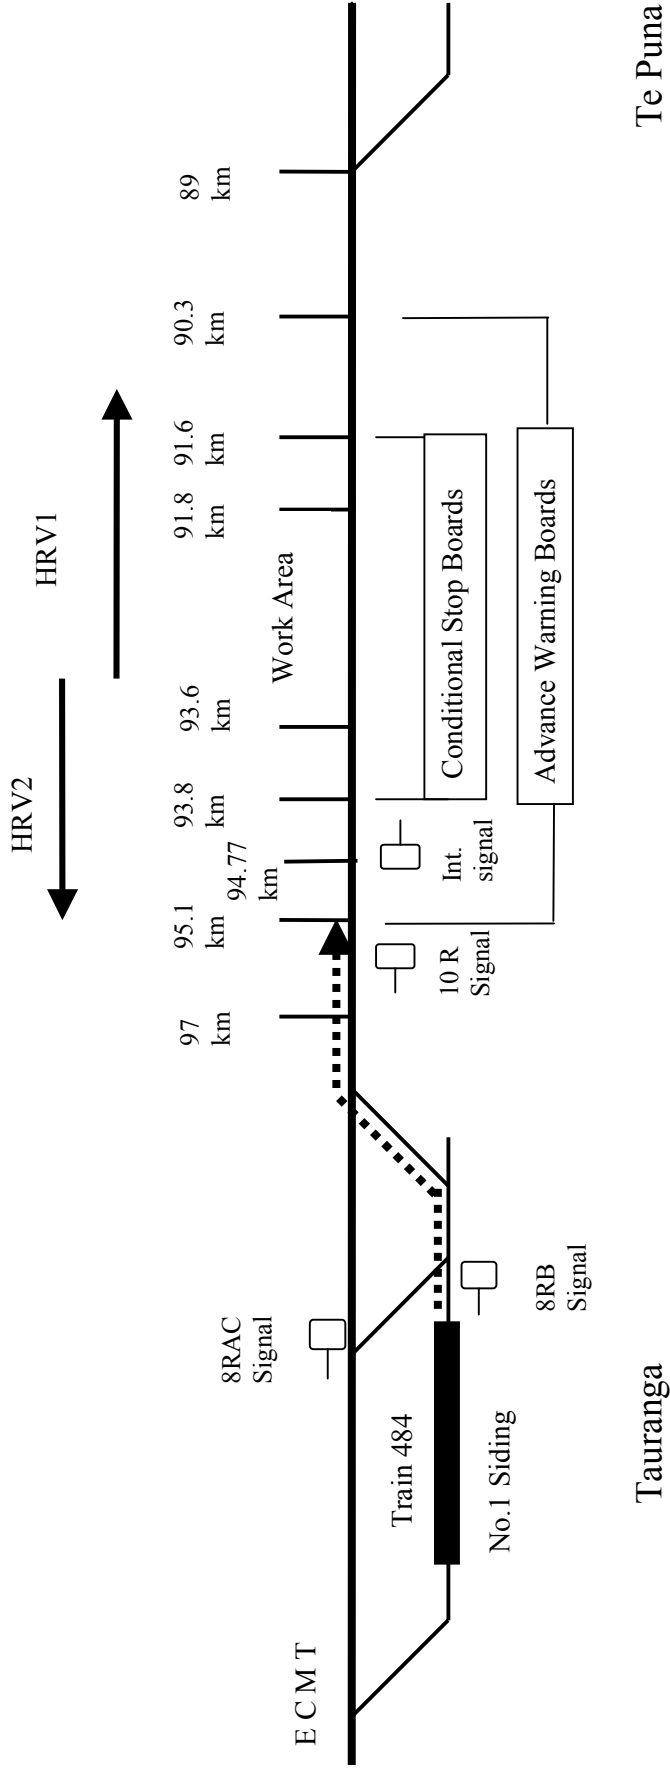
**Figure 1**  
**Site plan of work area in Tauranga-Te Puna track section**  
 (not to scale)

- 1.1.3 At about 1305 the person-in-charge of the worksite authorised Train 483 to proceed through the worksite. After the train cleared the worksite, the person-in-charge contacted train control by radio at about 1320, and was granted authority for 2 hi-rail vehicles to on-track at 93 km; one hi-rail vehicle (HRV1) to travel west and off-track at Te Puna (88.58 km) and the other (HRV2) to travel east and off-track at Tauranga (97 km), both retrieving site protection boards and other equipment on the way. The authority was valid until the designated time of 1345. TC1 did not advise the person-in-charge that Train 484 was waiting in Tauranga and would be the next train into the Tauranga-Te Puna track section (see Figure 1).

1.2.7 Before commencing work the person-in-charge of the worksite established with train control that no trains were approaching the work site. TC1 authorised HRVs to on-track in order to erect the advance warning boards and conditional stop boards (see Figure 1).
