RAILWAY OCCURRENCE REPORT

02-121

express freight Train F 8829, derailment, Waikokopu

29 September 2002

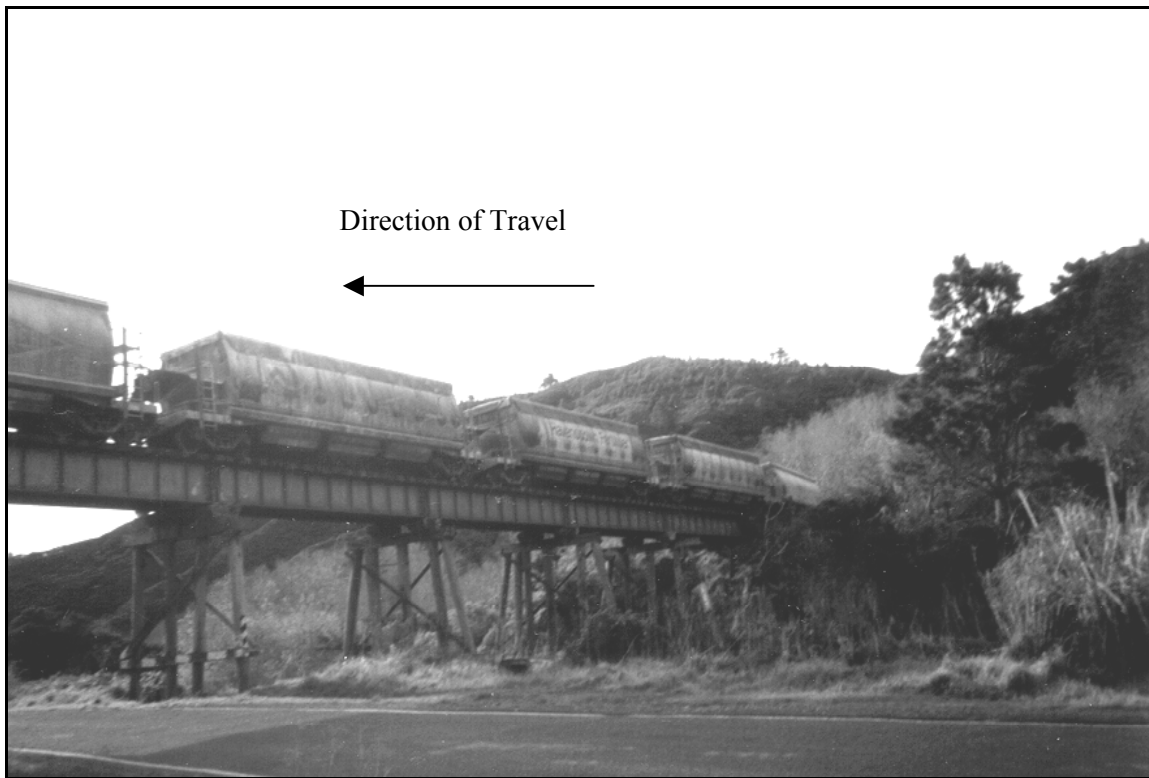
- 1.2.3 The point of derailment (POD) was recorded as 332.777 km on the PNGL. The train stopped about 300 m past the POD with the locomotive and 5 wagons on the north side of Bridge 260, 4 wagons on the bridge, and the rear wagon on the approach to the bridge (see Figure 1). Bridge 260 was a rail bridge over Nuhaka-Oputama Road.

Figure 1
Derailed wagons on Bridge 260 PNGL

- DX 5068 all wheels on the running rail
- CF 125 all wheels on the running rail
- CF 926 leading axle of leading and trailing bogie derailed
- CF 1015 leading axle of leading bogie derailed
- CF 978 leading axle of leading bogie derailed
- CF 955 leading axle of leading bogie derailed
- CF 713 all wheels on the running rail
- CF 1332 all wheels derailed
- CF 1021 all wheels derailed
- CF 1067 leading axle and all wheels of the trailing bogie derailed
- CF 1171 all wheels derailed.

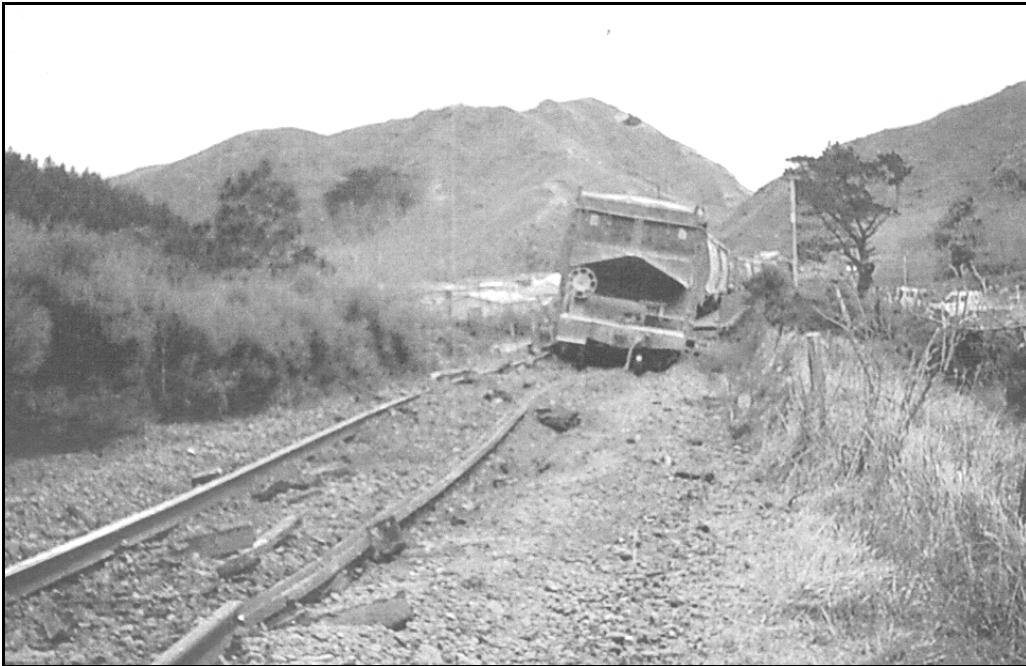
1.2.5 The track between the POD and the bridge was destroyed (see Figure 2). However, all wagons remained on their wheels after the derailment.

Figure 2
Damaged track past the POD

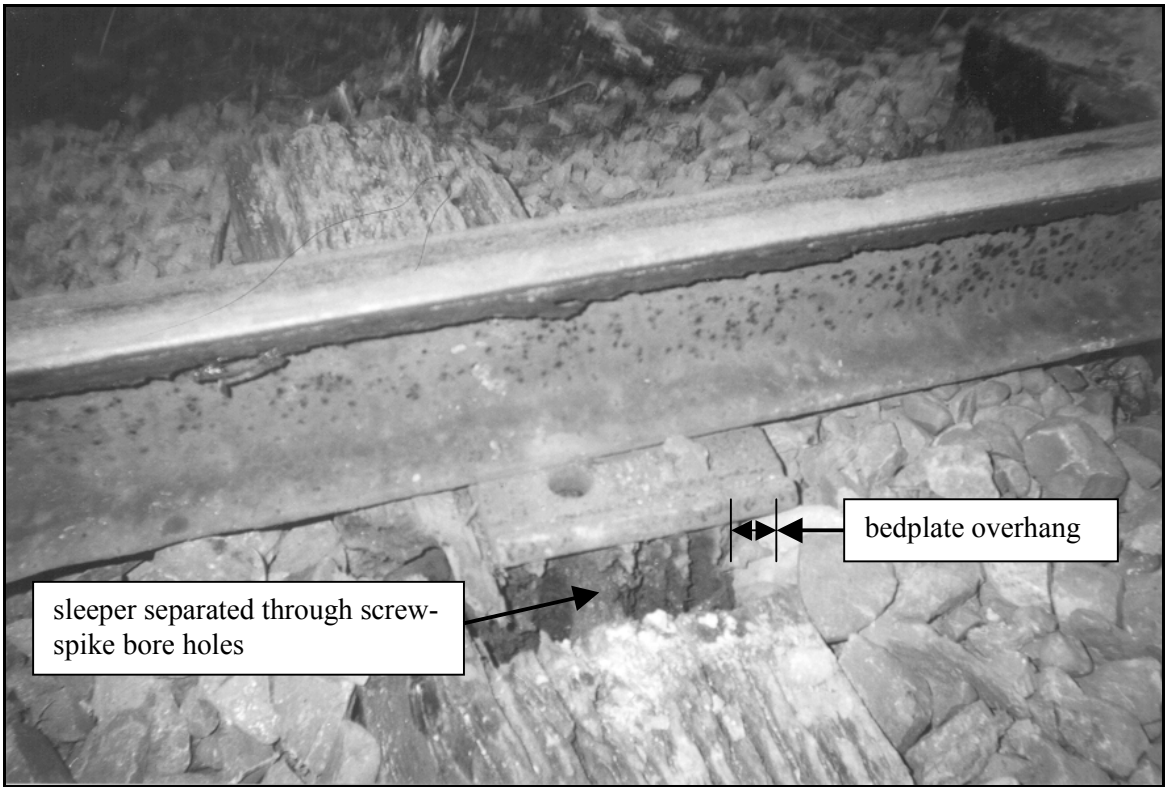
Figure 3
First sleeper past the POD

- 2.1.1 The position of the derailed vehicles, markings on the sleepers and sleeper condition indicated the leading axle on the leading bogie of wagon CF 926 derailed due to gauge spread. The N type bedplate assembly at the POD provided insufficient lateral restraint, and the resulting movement of the high-leg rail permitted the wheels to drop between the rails.
- 2.1.2 The wheel flange of the derailed vehicle then applied sufficient force to roll the high-leg rail out of the bedplates, which allowed the following wagons to also drop between the rails.

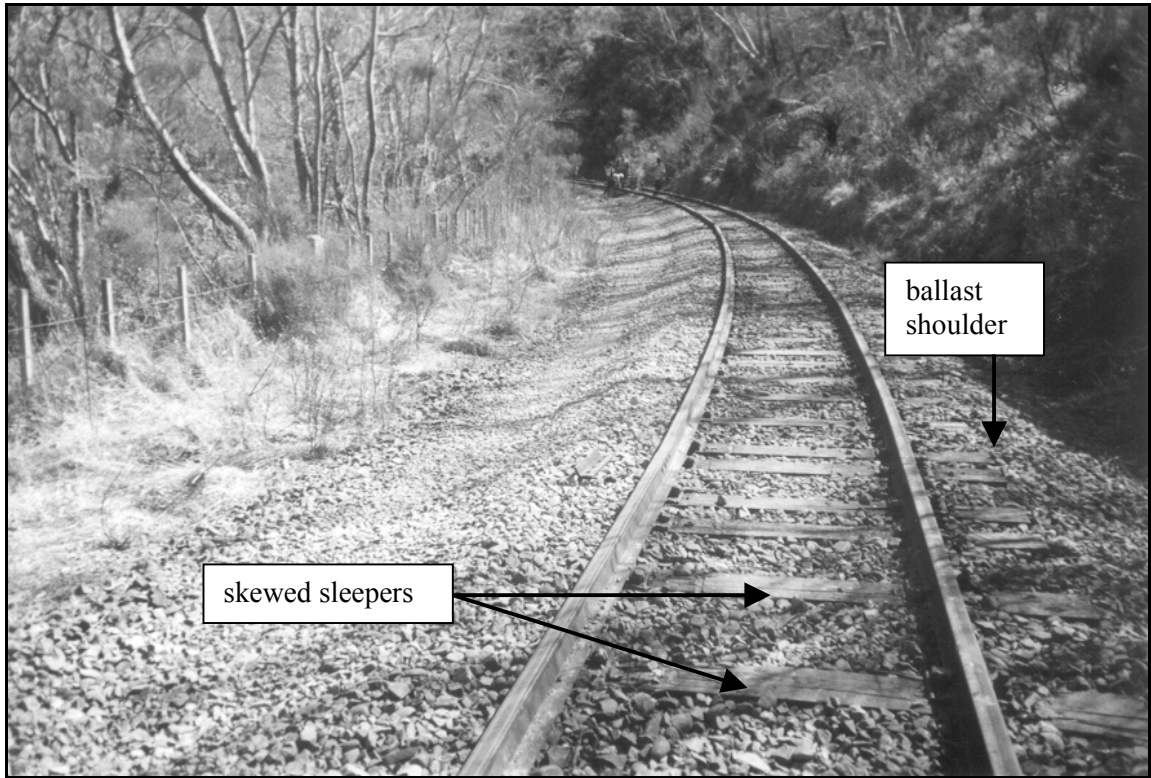
Figure 4
Ballast section on the derailment curve approaching the POD
