RAILWAY OCCURRENCE REPORT

02-126 hi-rail vehicle 64892, occupied track section without authority, 18 November 2002 near Kai Iwi

Report 02-126

18 November 2002

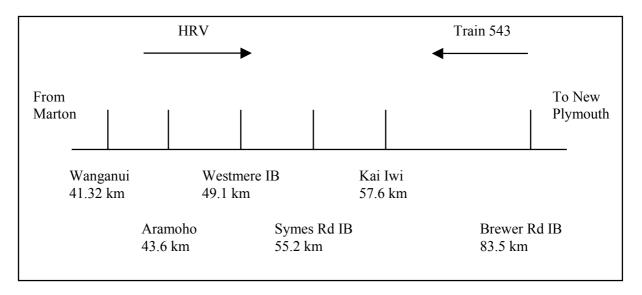
Figure 1
Site plan of track section between Wanganui and Brewer Road (not to scale)

On Monday 18 November 2002, a hi-rail vehicle overran its track authority from Westmere Intermediate Board to Symes Road Intermediate Board on the Marton-New Plymouth Line and continued a further 28.3 km to Brewer Road Intermediate Board.

- 1.2.1 Symes Road IB was located at 55.2 km MNPL, between Aramoho and Kai Iwi.
- 1.2.2 HRVs operating between Aramoho and Westmere IB were restricted to a maximum operating speed of 40 km/h because of the many tight-radius curves with non-standard transition lengths⁵ and a constant 1 in 35 rising gradient between Aramoho and Westmere IB.
