MARINE OCCURRENCE REPORT

02-204 coastal cargo ship Kent, collision and flooding, Wellington Harbour

14 July 2002

collision with pontoon and subsequent flooding of engine room

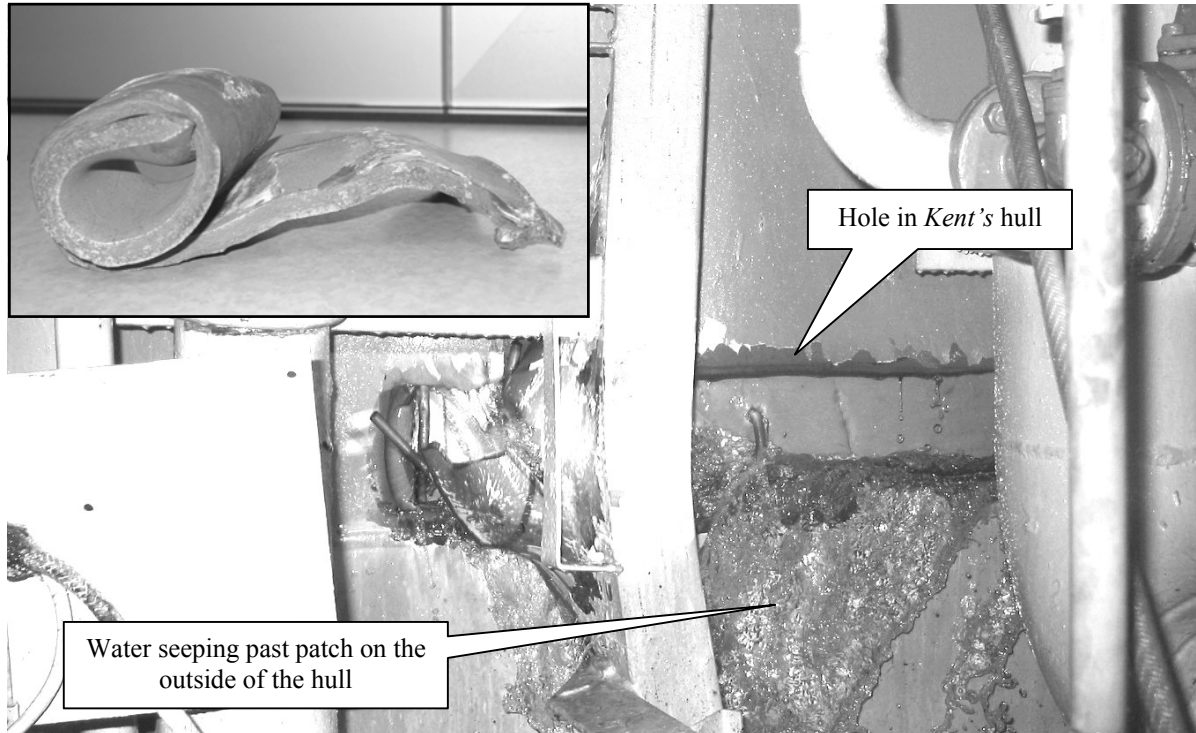
Figure 3

The hull plating of the *Kent* in way of the hole. A temporary patch in place over the outside of the hole. Insert shows section of hull plate peeled from the ship by the protrusion on the pontoon

1.7.1 During the collision, the hull of the *Kent* was torn open by the protrusion on the pontoon. A hole that measured approximately 1000 mm by 125 mm was cut into the hull. The hull plating in way of the hole was curled into a tight spiral by the forward momentum of the ship at the time of impact (refer Figure 3). Two frames were also bent as the protrusion tore into the side of the ship. The hole was initially about 380 mm below the waterline, this increased as the ship settled in the water.

- 1.1.9 During the remainder of that night and the following day, temporary repairs were carried out to patch the hole in the hull and portable pumps, supplied and operated by the local fire service, were used to pump out the engine room.
- 1.1.10 The pontoon grounded on the rocky shore to the south of the Thorndon Container Terminal close to the beacon on the south-west corner.

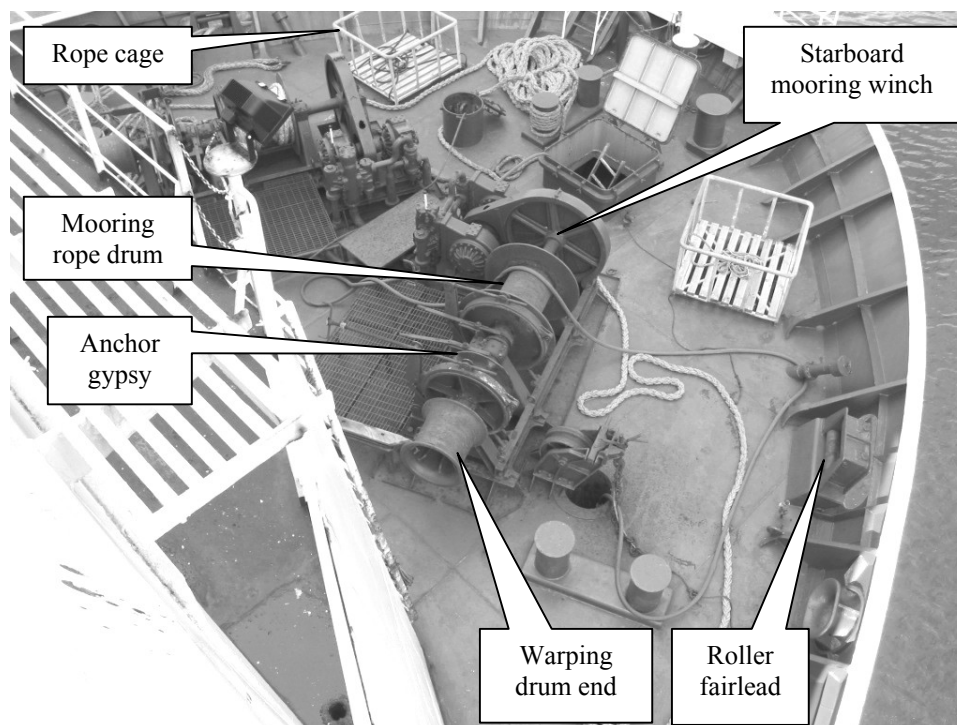
- 1.2.12 There were 2 mooring winches (windlasses) on the forecastle of the *Kent* (refer Figure 4). Each winch comprised an anchor cable gypsy and a mooring rope drum, both of which could be separately engaged or disengaged by clutches, and secured by separate brakes. There was also a warping drum end that was used to tighten ropes that were not on the dedicated mooring rope drums. The warping drum end was driven directly by the winch and rotated constantly when the winch was running. On either side of the forecastle there was a cage in which additional mooring lines were stowed. These additional mooring lines had to be manually handled and led via a centrally mounted dolly (vertical mounted free standing fairlead) to the drum end for tightening. The ship usually moored to a headline and a backspring forward. These 2 mooring ropes were those permanently rigged on the mooring rope drums.

Figure 4
Forecastle of the *Kent* showing the mooring winches

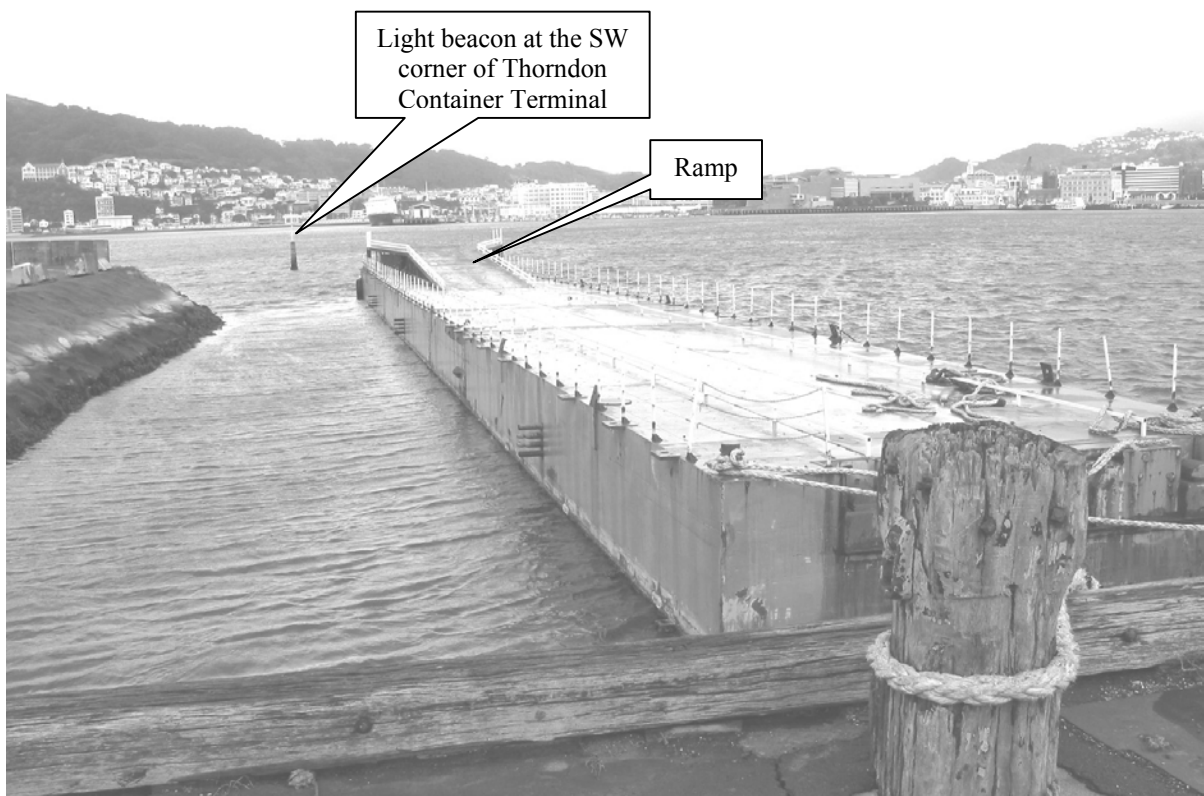
Figure 5
The Wellington (long) pontoon, photographed looking south from the end of Kings Wharf

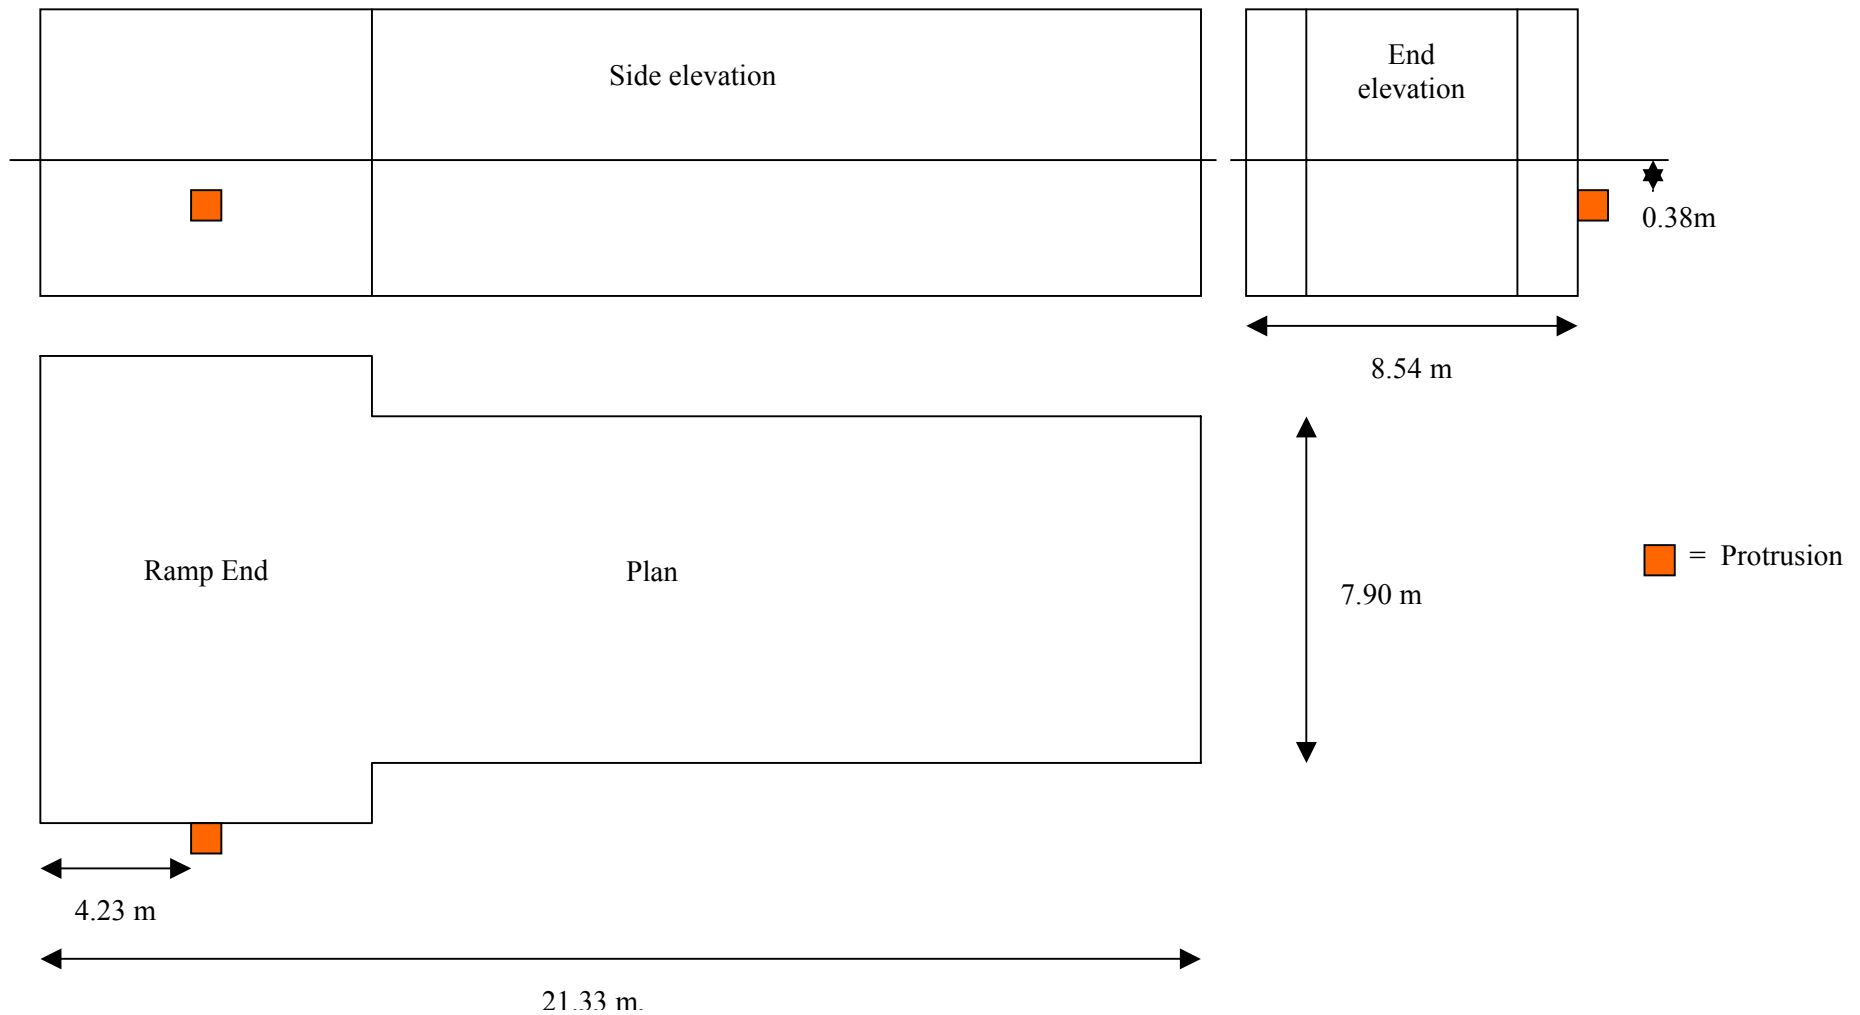
- 1.3.3 The lug that remained on the Picton pontoon was located on the outboard side approximately 4.23 m from the ramp end, 380 mm below the waterline and extended outwards approximately 300 mm from the side of the pontoon. It was approximately 250 mm wide and 180 mm deep at the root, tapering to a rounded point at the outboard end (refer Figure 8).
- 1.3.4 CentrePort, the Wellington harbourmaster and the operators of ships using Kings and Glasgow Wharves were not aware that there was a dangerous underwater projection on the pontoon.

Figure 6
Plan of the Picton (short) pontoon, showing position of the protrusion (not to scale)

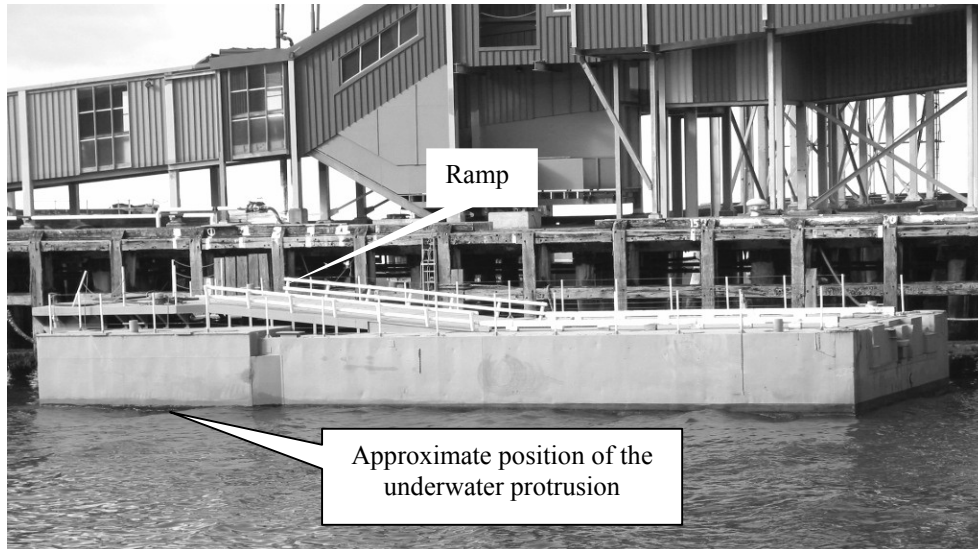
Figure 7
The Picton (short) pontoon

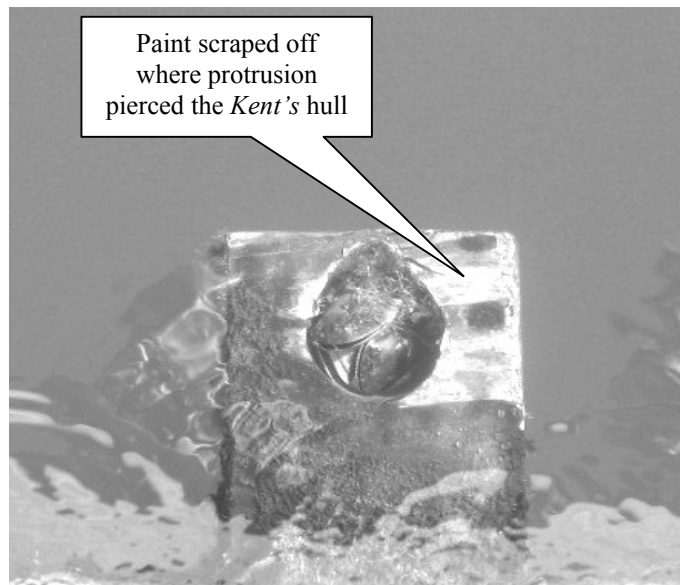
- 1.3.2 In their original configuration the small barges had numerous lugs protruding from their sides for mooring arrangements in the ironsand pits. When the barges were re-configured into the pontoons the majority of these protrusions were removed, however one remained on the Picton pontoon (refer Figures 6 and 8). The remaining protrusion had a shallow cut on its after side indicating that there had previously been an attempt to remove it.

Figure 8
Underwater protrusion on the Picton pontoon
