MARINE OCCURRENCE REPORT

02-206 bulk carrier *Tai Ping*, grounding, Bluff Harbour

8 October 2002

**TRANSPORT ACCIDENT INVESTIGATION COMMISSION
NEW ZEALAND**

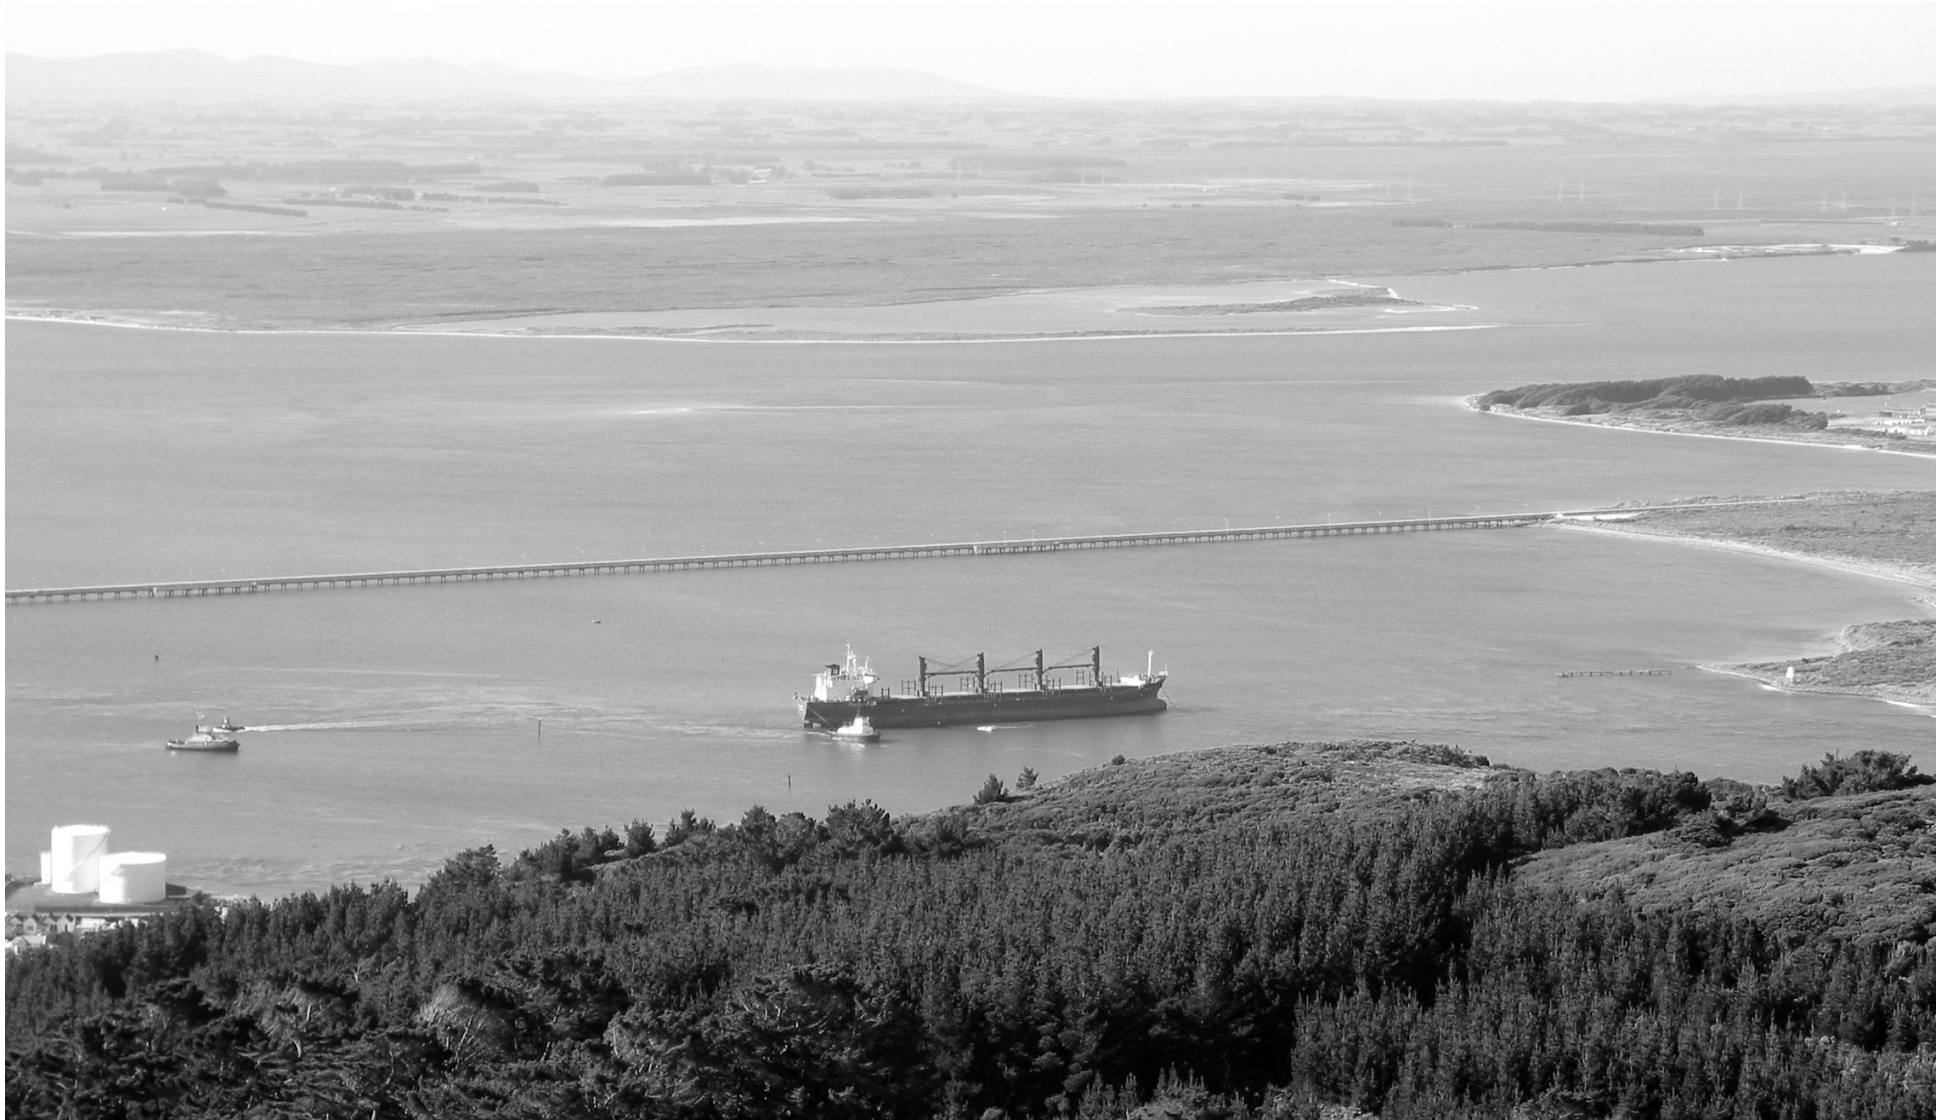
Tai Ping aground in Bluff Harbour

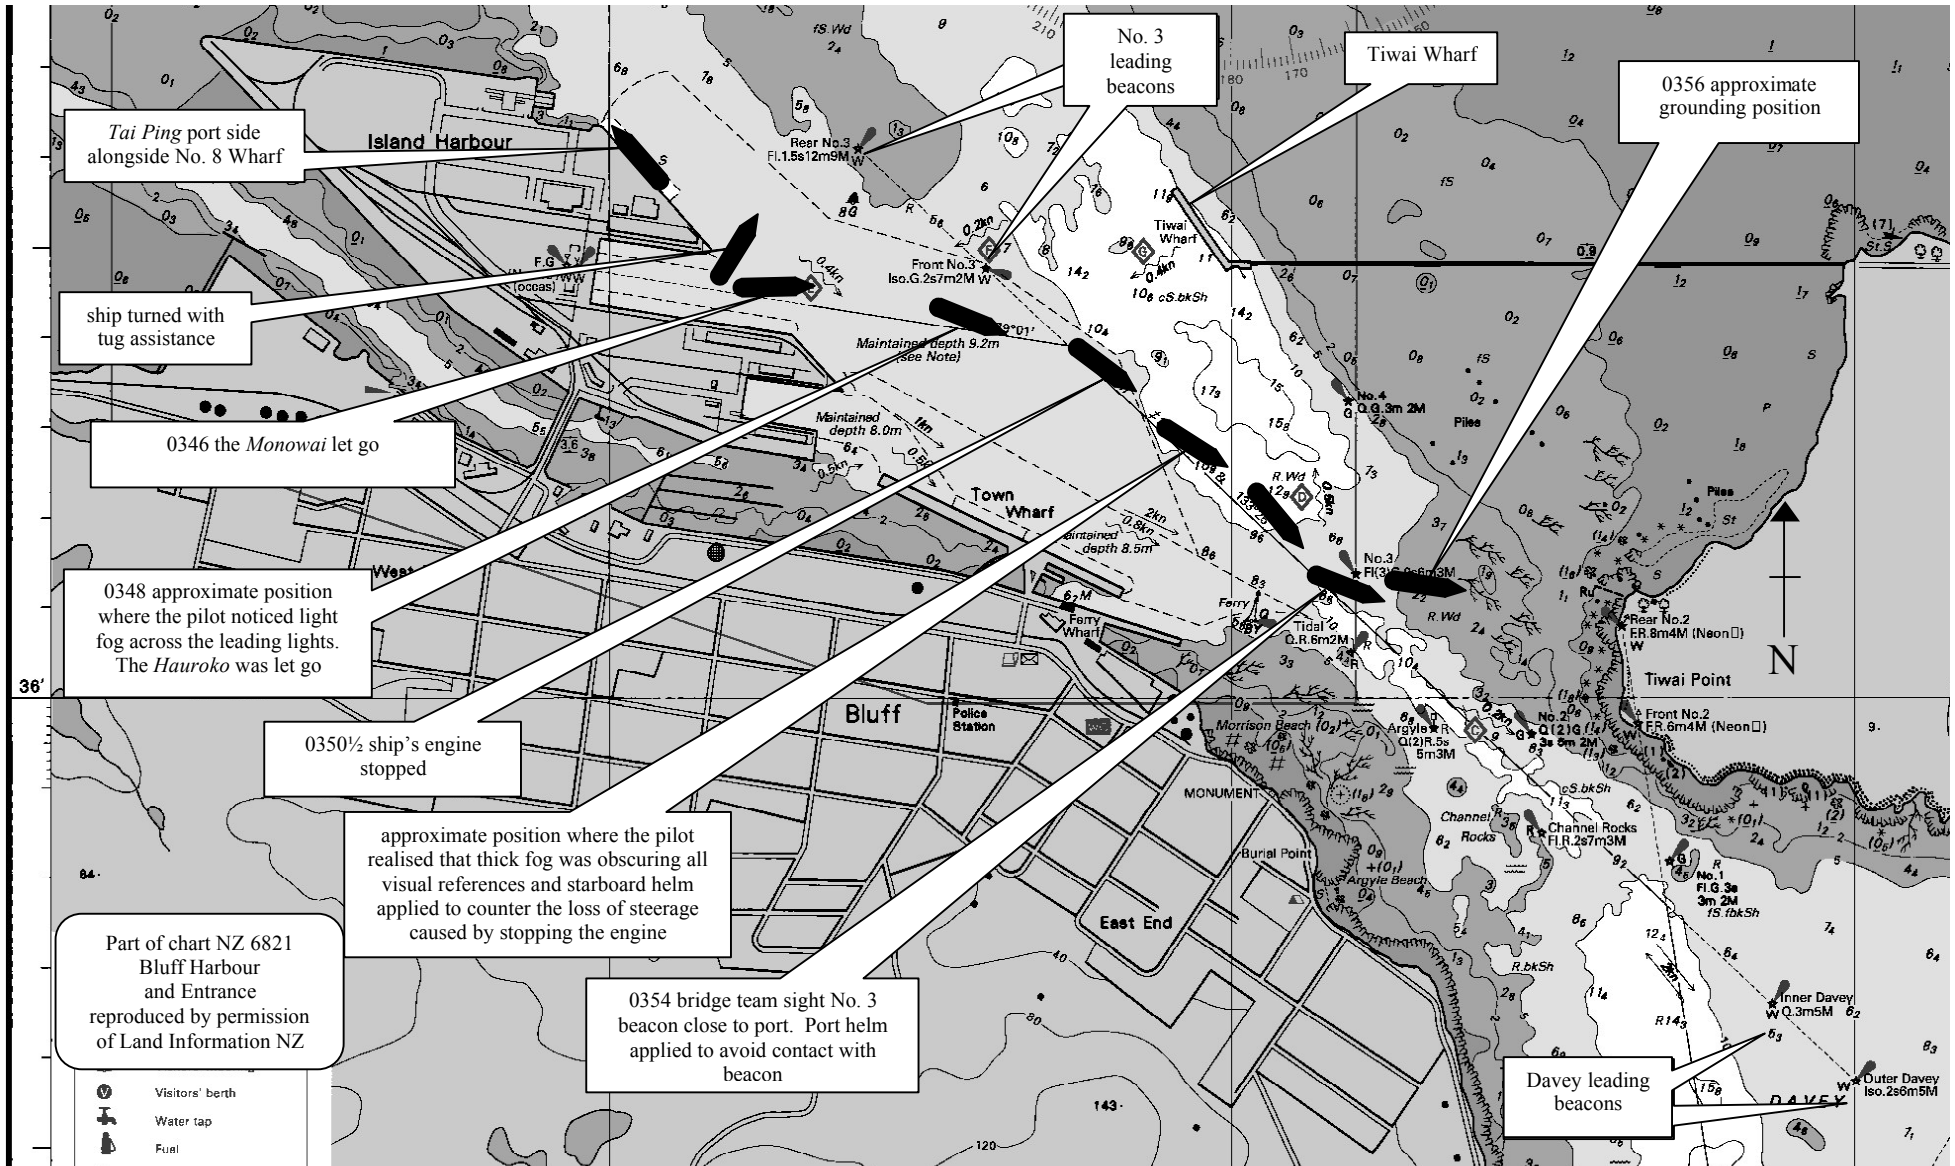
Figure 1
The approximate track of the *Tai Ping*

- 1.1.1 In the early morning of 8 October 2002, after discharging part of its cargo of urea, the geared bulk carrier *Tai Ping* departed Bluff. As it proceeded towards the approach channel fog formed ahead of it and it was subsequently engulfed in thick fog, severely restricting visibility. The *Tai Ping* left the channel and grounded on the north-eastern side of the channel, coming to rest on shoal ground west of Tiwai point (refer Figure 1).

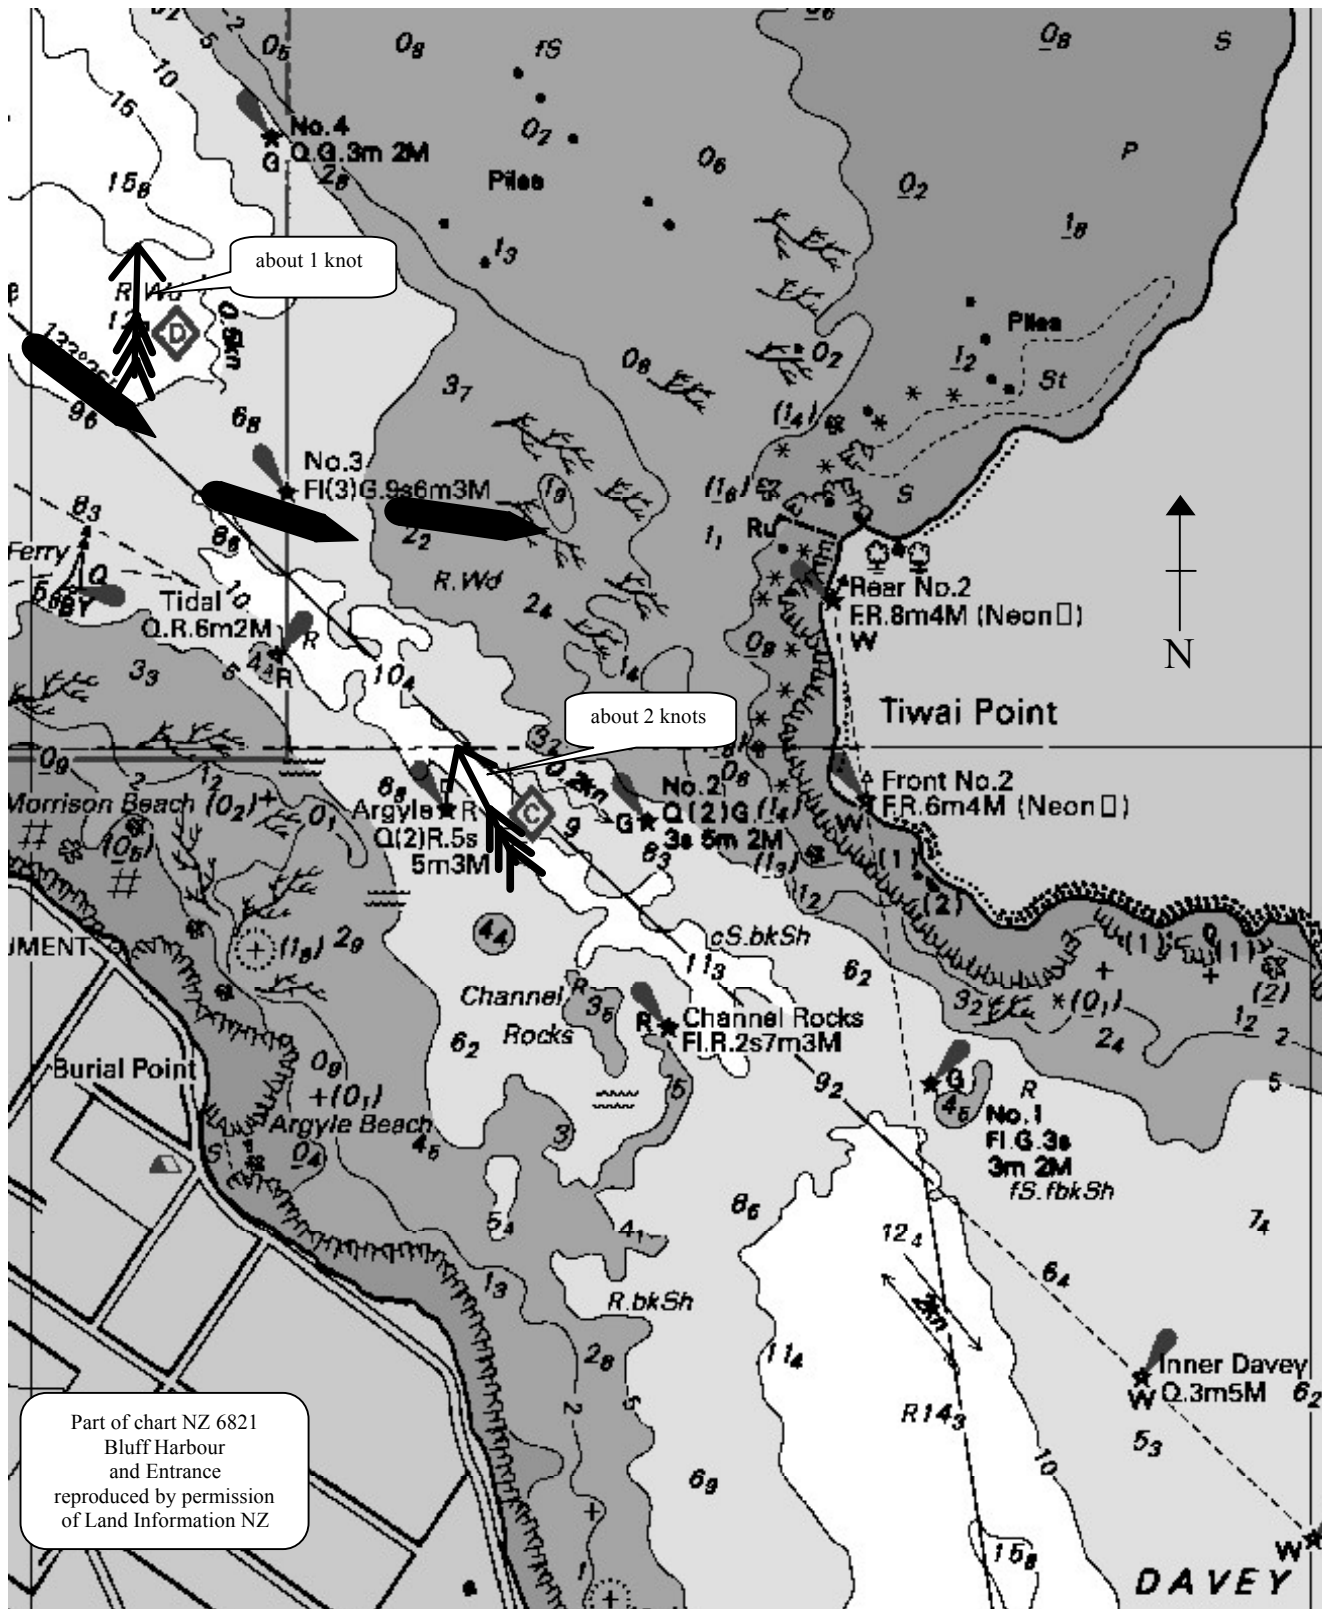
Figure 2
Entrance channel and the position of the *Tai Ping* after grounding.
Approximate direction and strength of tidal streams indicated

- 1.1.9 The ship's stern cleared the beacon by about 2 or 3 m. Immediately, the pilot ordered amidships and reduced the engine speed to dead slow ahead but before corrective helm could be applied to bring the ship back on track, the ship grounded on the north-eastern edge of the channel at 0356. The pilot ordered the engine be stopped and then subsequently ordered it to dead slow ahead to maintain the ship's position against the current that was setting to the north.

- 1.5.15 There is no fully slack water in the port of Bluff. The tidal streams swirl around the inner harbour. Around the time of high water, the flood continues to run in the northern part of the harbour, in way of Tiwai wharf, while the ebb tide starts to flow on the Island Harbour or southern side of the harbour. The narrow entrance causes strong tidal streams in the vicinity of the approach channel. The tide generally runs in the direction of the channel except that the flood tide tends to flow more to the north, towards Tiwai Wharf at the inner end of the channel.

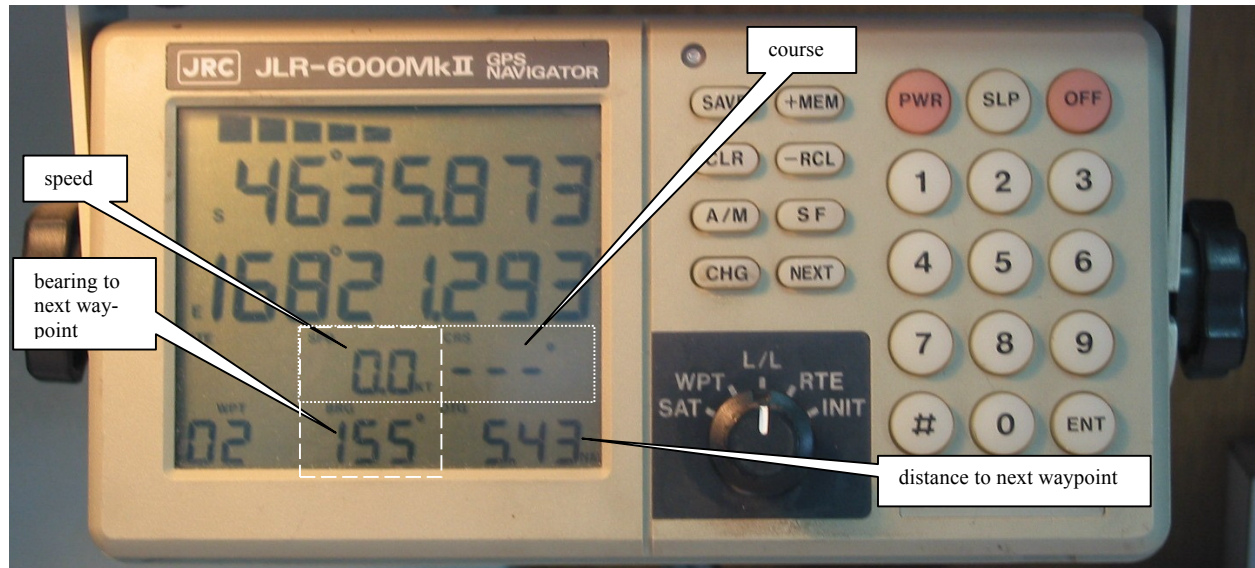
- 1.2.10 When queried later, the third officer indicated that he had read a heading of 155° and a speed of 3.5 knots from the GPS (see Figure 4) and these figures were entered into the movement book. The same figures were used in the master's draft statement of facts. Later, the third officer indicated that he had read the speed and what he thought was the heading, vertically, rather than horizontally from the GPS display, as shown by the outlines in Figure 4. When asked to show which figure he had used he pointed to the lower left one, which was the bearing to the next waypoint rather than the heading.

Figure 4
GPS receiver display showing ship's course and speed, and bearing and distance to next waypoint.
(Photo taken on 9 October while *Tai Ping* was aground)

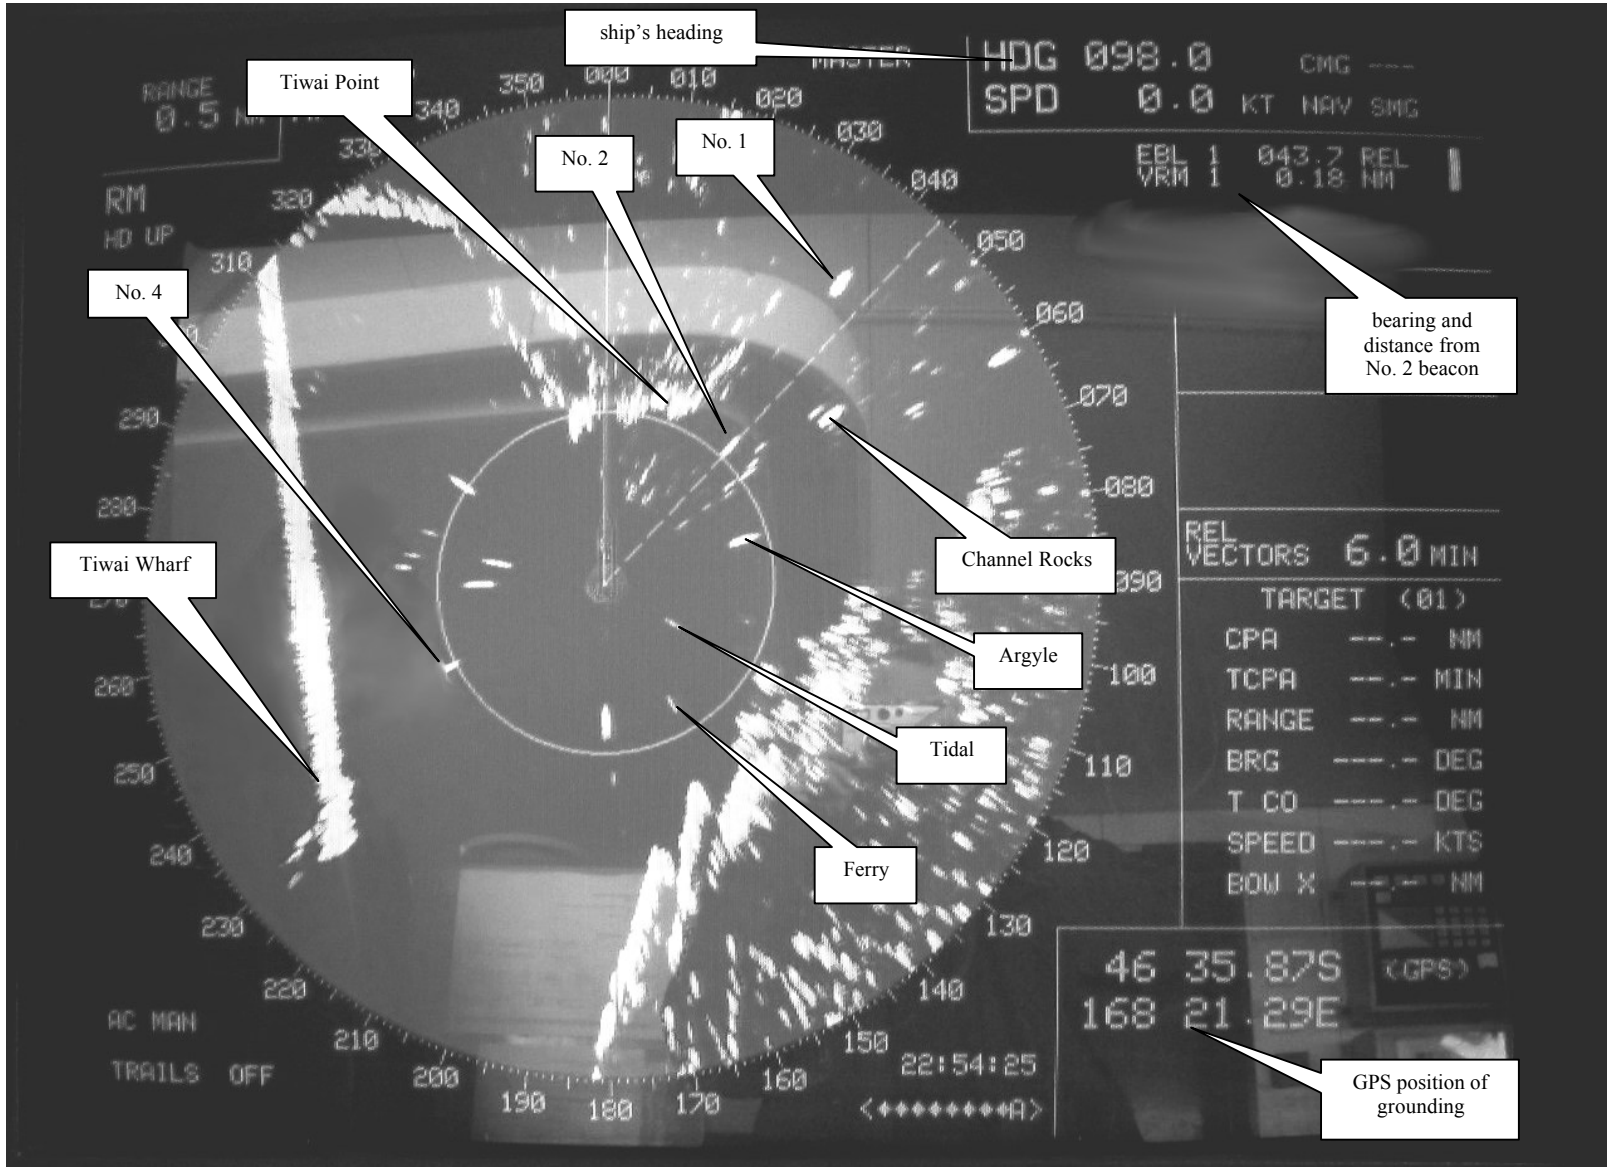
- 1.2.12 A ship's head up, or un-stabilised, radar display has the ship's heading marker fixed at 000°, at the top of the screen. All targets, fixed or moving, then move relative to the ship's position in the centre of the screen and the heading marker. As the ship moves through the water, fixed targets appear to track down the screen on a reciprocal heading at the speed the ship is moving and when the ship alters course targets appear to rotate in the opposite direction to that of the ship, so targets appear to move on the radar screen while the ship's heading remains fixed. The coating on a radar display is designed to allow a certain amount of afterglow of targets, which in the ship's head up mode causes smearing and may make the identification of smaller targets difficult. In addition, when targets, particularly large landmasses, are in close proximity interference occurs, which can further inhibit the detection of small targets. Notwithstanding the above limitations, the pilot stated that he was able to identify the beacons on the radar (refer Figure 5).

Figure 5
Photograph of the *Tai Ping*'s port radar, taken on 9 October 2002, beacons and landmasses can be clearly distinguished

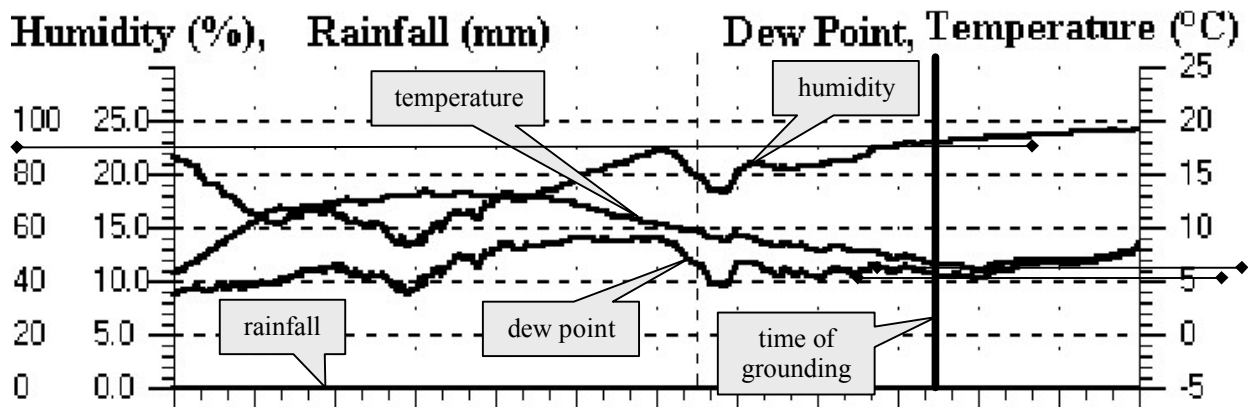
- 1.5.6 A private automatic weather station situated about 100 m from the town wharf, Bluff, also recorded the conditions at the time of the grounding. That data was used to produce a graph (refer Figure 6). It can be seen from the graph that the temperature was falling towards the dew point and the humidity was high. The weather recorded that it was calm and there was no rainfall.

Figure 6
Weather conditions in Bluff for the 24 hours up to 0900 on 8 October 2002
(graph courtesy of Mr T Hardwick)
