AVIATION OCCURRENCE REPORT

03-003

Boeing 747-412 9V-SMT, flight SQ286, tail strike during take-off,
Auckland International Airport

12 March 2003

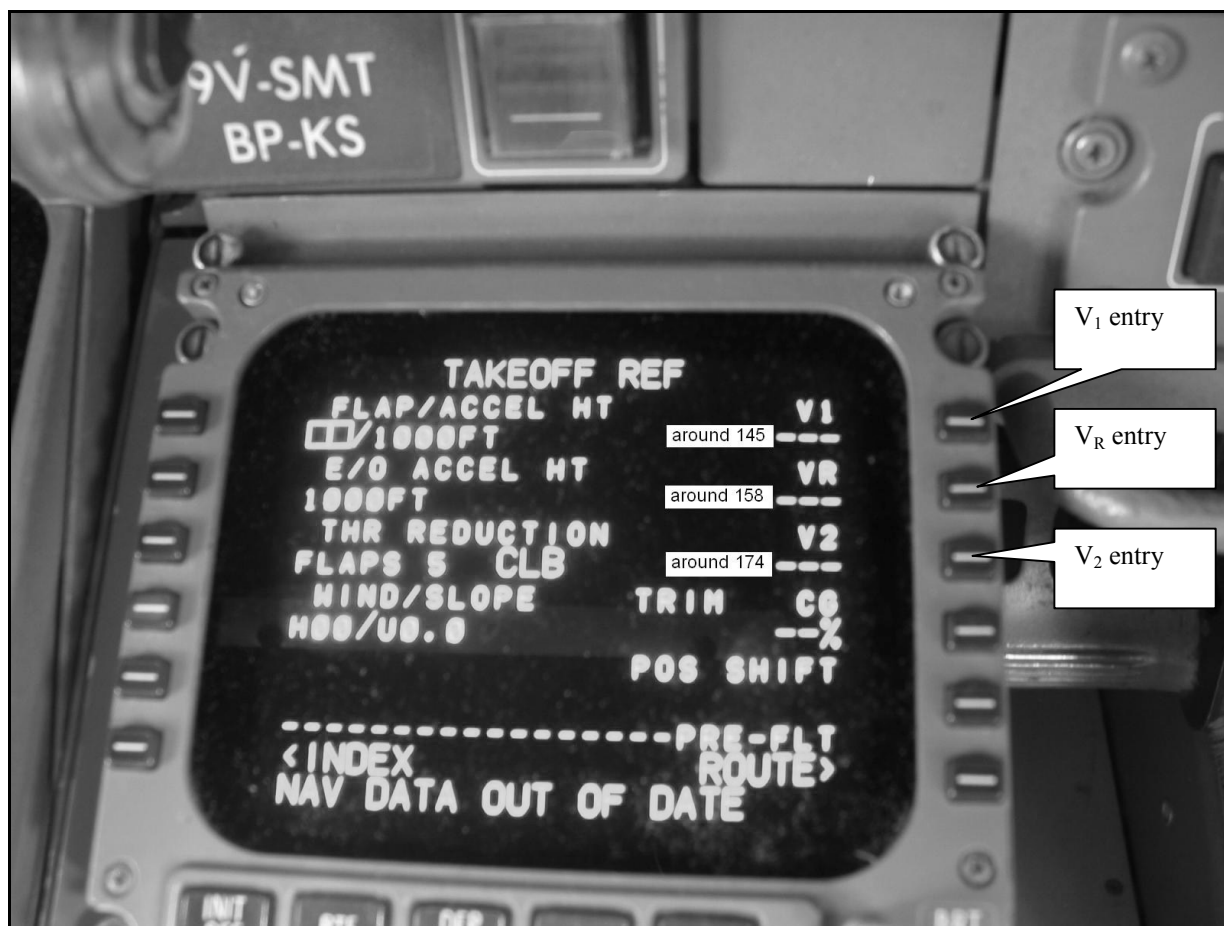
Figure 3
9V-SMT FMC display of V speeds

- 1.1.14 The captain entered the manually calculated V speeds directly into the FMC's V_1 , V_R and V_2 fields, replacing the V speeds the FMC had itself computed and was displaying on its display unit (see Figure 3). Despite significant differences the FMC accepted the input V speeds, showing them on its display and storing them in the flight management system (FMS), which highlighted them on the captain's and first officer's primary flight displays (PFD) air speed tapes. The PFD highlighted V speeds were normally hidden from view until the aeroplane speed increased during take-off, at which time they appeared on the speed tapes so the pilots could refer to them. The before take-off procedure called for the pilots to check the EPR thrust setting on the engine indication and crew alert system display (EICAS), and to check that the correct V speeds were set and appeared on the PFD airspeed indicators.

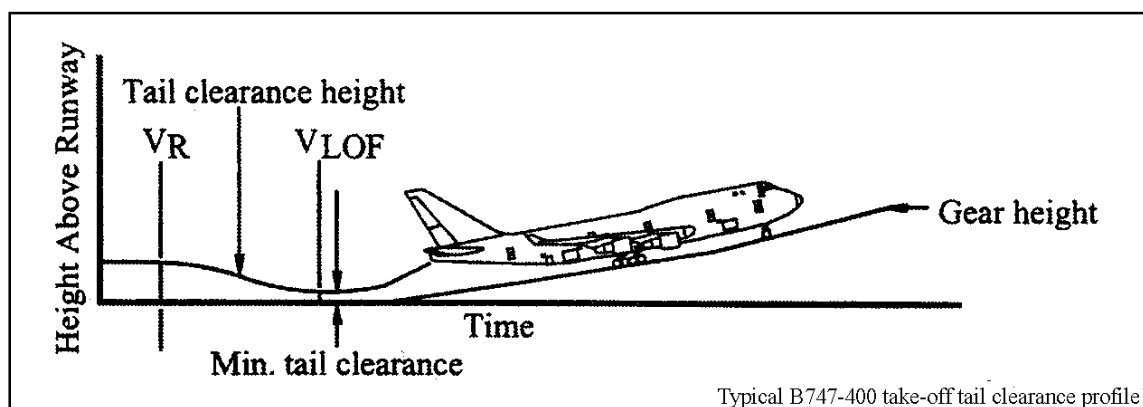
Figure 6
Typical take-off tail clearance height depiction

- 1.17.13 The aeroplane manufacturer had determined and published the geometry-limited tail strike aeroplane body angles necessary to achieve a tail strike on its various aircraft during take-off and landing. For the Boeing 747-400 this was 11° with the main undercarriage oleos fully compressed and 12.5° with the oleos extended. Any time the body angle approaches these geometric limits the possibility of a tail strike increases dramatically. The point of minimum tail clearance during a normal take-off occurs immediately after the aeroplane has lifted off (see Figure 6). This is a consequence of the aeroplane geometry and the dynamic forces that are acting after take-off rotation has been initiated. If the rotation is started too early, or is performed at too high a rate, the minimum tail clearance decreases and may result in ground contact. A rotation rate in excess of 3° per second could bring about a tail strike. For a normal take-off, lift-off would occur at 8.5° to 10° body angle.
