RAILWAY OCCURRENCE REPORT

03-102

hi-rail vehicle 67425, derailment, near Fordell

10 February 2003

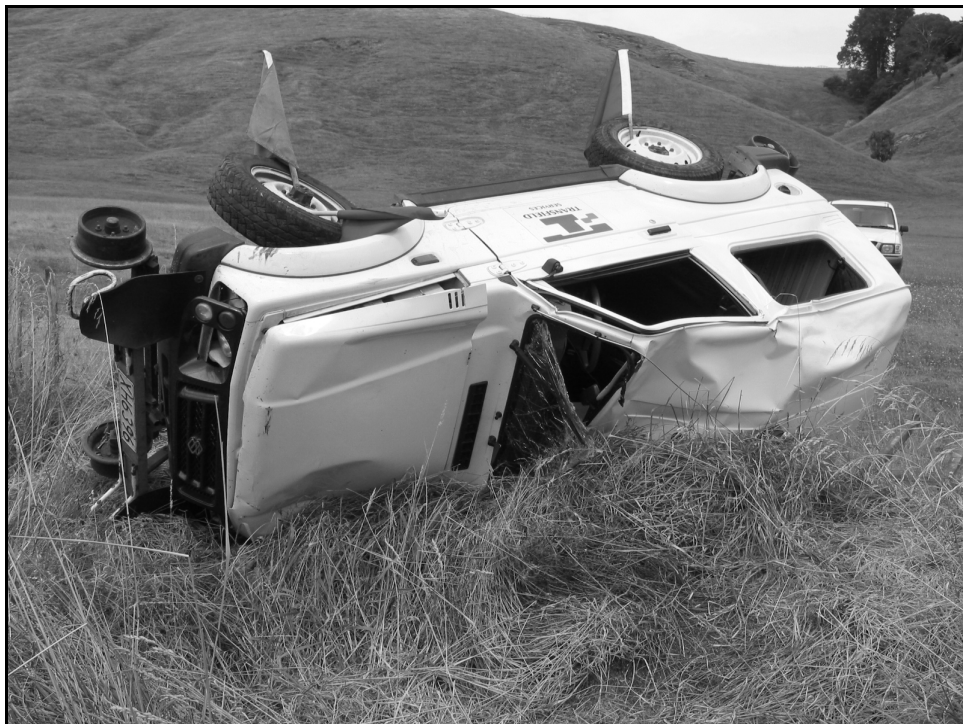
Figure 1
Hi-rail vehicle 67425 at the accident site

- 1.1.4 At about 1600, the rear wheels of the HRV derailed at 27.439 km MNPL, about 82 m past the west portal of Tunnel 3 near Fordell. The vehicle had travelled upright for about a further 70 m, when the driver sensed that the front wheels had lost contact with the rails, so he grabbed and turned the steering wheel and applied the brakes. The HRV rolled clear to the left-hand side of the track and came to rest on its side facing the direction from which it had travelled (see Figure 1). The driver estimated he was travelling at about 45 km/h when exiting the tunnel.

- 1.1.5 The driver who was wearing a seatbelt at the time of the accident, suffered back and rib injuries and lost consciousness for about 90 minutes. He managed to free himself from the vehicle and place danger flags on the vehicle wheels, before climbing a hill to a location where he was able to use his personal cellphone to call the police.
- 1.1.6 In the meantime, at 1732, expecting HRV 67425 to have been off-track by 1615, the train controller issued a track warrant to the locomotive engineer of shunt service P29 to travel from Marton and enter the loop at Ruatangata (21 km) to cross Train 545 (see Figure 2).
- 1.1.7 At 1736 the train controller issued a track warrant to the locomotive engineer of Train 545 to travel from 16L Signal Aramoho (43.61 km) to the mainline at Ruatangata to cross shunt service P29.

- 1.2.1 Marks on the track indicated that the right-hand rear hi-rail wheel climbed the high-leg⁴ rail at 27.436 km, between Ruatangata and Wanganui, as the HRV was travelling westward around a 330 m long, 320 m radius left-hand curve on a descending gradient of 1 in 114. The hi-rail wheel travelled on the railhead for 3 m before it dropped off to the outside of the railhead.

- 1.2.2 The HRV travelled with the rear wheels derailed and the front wheels on the rail to 27.502 km where the flange of the left-front hi-rail wheel climbed the railhead on the low-leg side of the curve before dropping off at 27.510 km. The HRV came to rest a further 39 m past the second drop-off point.

- 2.5 The damage to the right rear hi-rail wheel suspension and axle assembly was consistent with the right rear rail wheel having derailed first. It was possible the derailment was initiated by an object such as a track component or ballast becoming wedged between the left-front rail wheel flange and the rail, setting up a sudden transverse loading on the right-rear rail wheel. Grease on the high-leg curve rail, which was beyond the maximum wear limits, would have allowed the right rear rail wheel to ride up and climb over the railhead and in so doing the road wheels lost contact with the rail.

- 3.3 The rear axle of the HRV probably derailed as a result of a sudden increase of transverse loading on the right-rear rail wheel. The combination of excessive rail wear and grease on the railhead reduced the friction between the flange and railhead thereby allowing the flange to climb over the railhead.

ensure that where fitted to HRVs, seat belts must be worn by the driver and all passengers when driving on track, except in situations where movements are at slow speed and it is necessary to frequently stop and get in and out of the vehicle. (018/04)
