RAILWAY OCCURRENCE REPORT

03-104 express freight Train 380, derailment, near Taumarunui 16 February 2003

TRANSPORT ACCIDENT INVESTIGATION COMMISSION
NEW ZEALAND

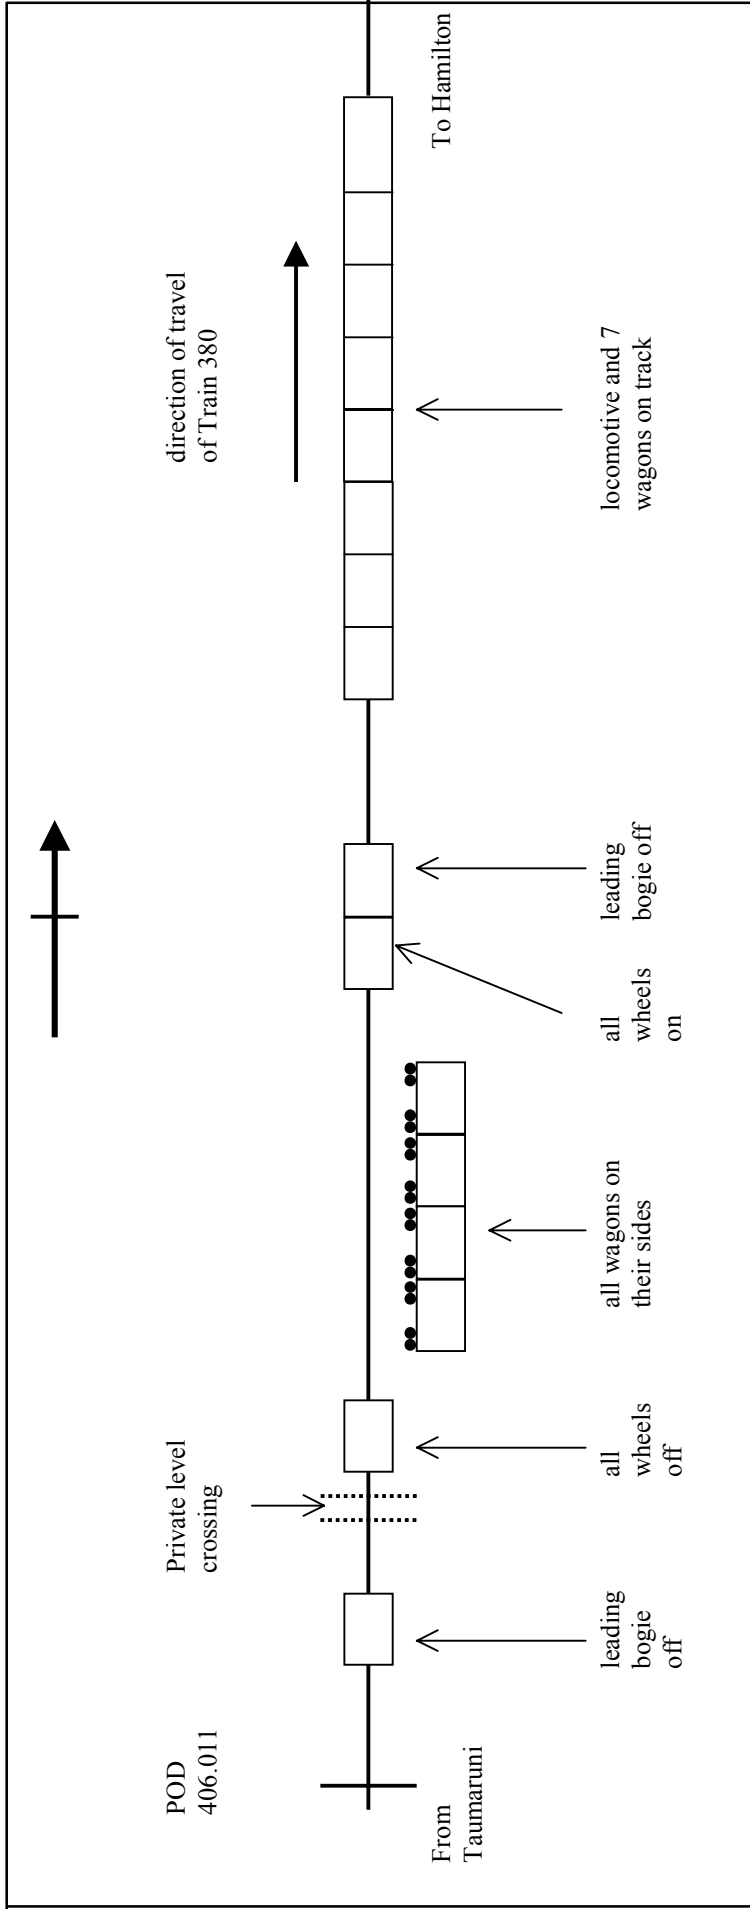
Figure 2
Location of wagons after the derailment

- 1.1.5 At about 1823, while travelling at about 90 km/h, Train 380 approached a curve that was covered by a THR. The train had negotiated about 180 m of the curve, slowing to about 85 km/h before the eighth wagon on the train derailed to the low-leg³ side of the curve. By the time the locomotive and leading 7 wagons stopped, about 800 m past the point of derailment (POD), the train had split into 5 sections (see Figure 2).

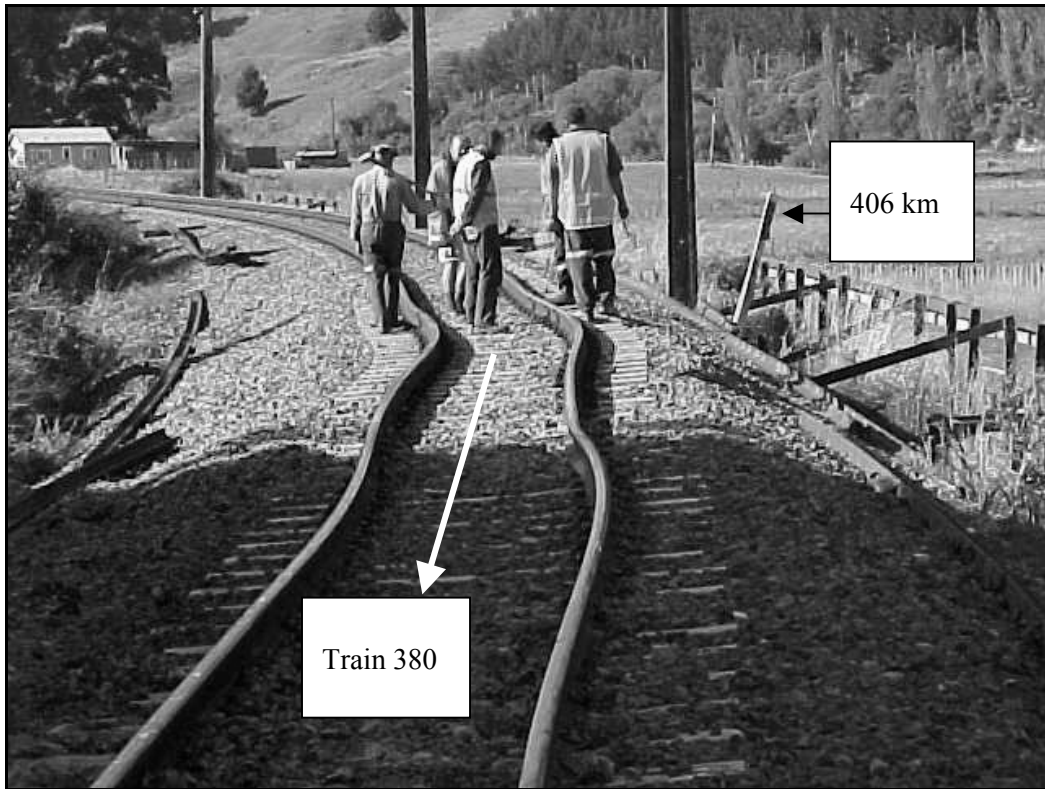
Figure 3
Track at the point of derailment (looking south)

- 1.2.1 The derailment occurred at 406.011 km between Taumarunui and Okahukura as Train 380 negotiated a 480 m radius right-hand curve (see Figure 3). The 314 m long curve was on a descending 1 in 239 gradient and was approached from a 400 m long straight at grade⁴.
- 1.2.2 On 6 April 2002, concrete sleepers with standard pandrol “e clip” fastenings were laid to replace treated pinus radiata sleepers on the derailment curve. On 12 June 2002 a production tamper⁵, fitted with a computerised track lining system known as ‘compuline’ (trade name) was used to lift and line the curve. The compuline system measured and recorded the length of the curve and produced a model of the curve and a solution termed ‘best fit’.

- 1.2.3 On 30 June 2002, new rail was laid in 153.4 m lengths on the derailment curve. A tie-down temperature of 18° C was recorded when the rail was fastened to the sleepers. However, because the Tauramarunui track gang's rail tensor⁶ was being used on destressing work in Wellington, the track had not been destressed between the time of laying and when the derailment occurred.

- 1.2.4 At the time of the derailment, the thermal expansion gap of the rail joint approximately 20 m past the POD was tight.
- 1.2.5 The clean crushed ballast had a depth of 300 mm under the sleeper at the POD. The cribs were full and the ballast shoulder width was 100 mm on the high leg, and 250 mm on the low leg. Tranz Rail standard specified a ballast shoulder width of between 300 and 350 mm on curved track to provide lateral restraint to the track structure. (see Figure 4).

- 2.2 The inadequate ballast shoulder width of 100 mm, instead of 300 mm, on the high-leg side of the curve near the POD reduced the ability of the track structure to withstand the dynamic lateral forces imposed by the moving train under the hot rail conditions and probably contributed to the track buckle.

- 2.3 A further contributing factor to the track buckle was that in June 2002 when the curve was re-railed and fastened to the sleepers, the rail temperature was 18°C. To destress the rail to the neutral temperature of 32° C a rail tensor was needed to stretch the rail, but the rail tensor was being used in Wellington and so the rail remained in a stressed condition and at risk of buckling should hot rail conditions prevail. To reduce the risk, the section of track between 405.75 km and 409.78 km was identified in Bulletin 96 as a THR site, with a maximum speed of 40 km/h during such times.

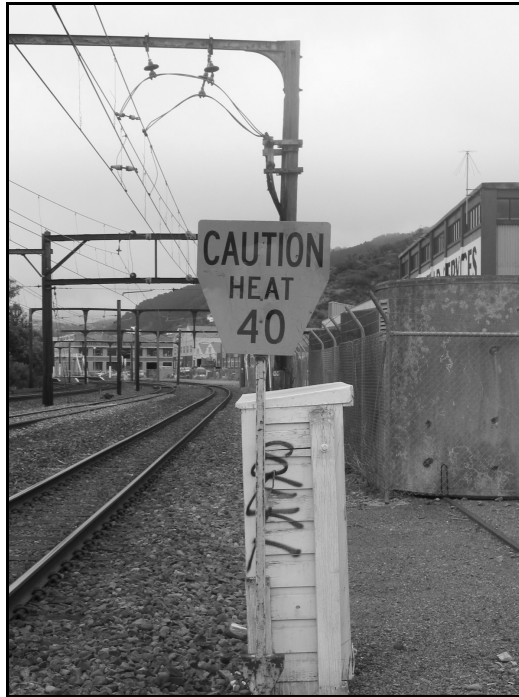
Figure 5
Special outer speed warning board for heat restrictions

- 1.3.9 When the maximum line speed was reduced for THRs, a speed warning board (see example in Figure 5) was erected at least 1500 m in advance of the speed restriction board and displayed in such a position that locomotive engineers were able to gain a distant view of the board.
- 1.3.10 The inner speed board was a white diamond-shaped board with a black lettered “H” at the commencement of the restriction and “T” at the termination of the heat restricted track section (see Figure 6).

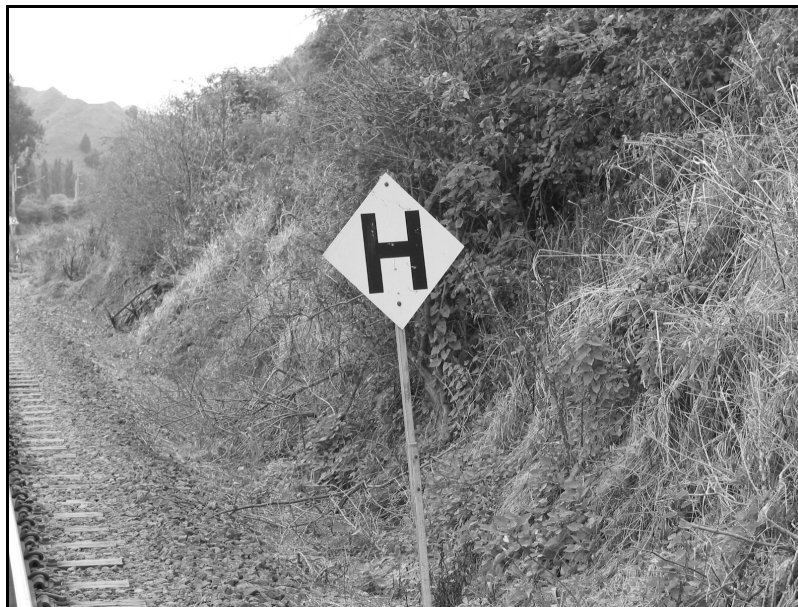
Figure 6
Temporary Heat Restriction board approaching the derailment curve

1.3.11 An inspection of the speed boards after the derailment confirmed that the warning and speed boards for the THR were correctly positioned.
