RAILWAY OCCURRENCE REPORT

03-107

diesel multiple unit Train 3247, passenger injury, Glen Innes

15 May 2003

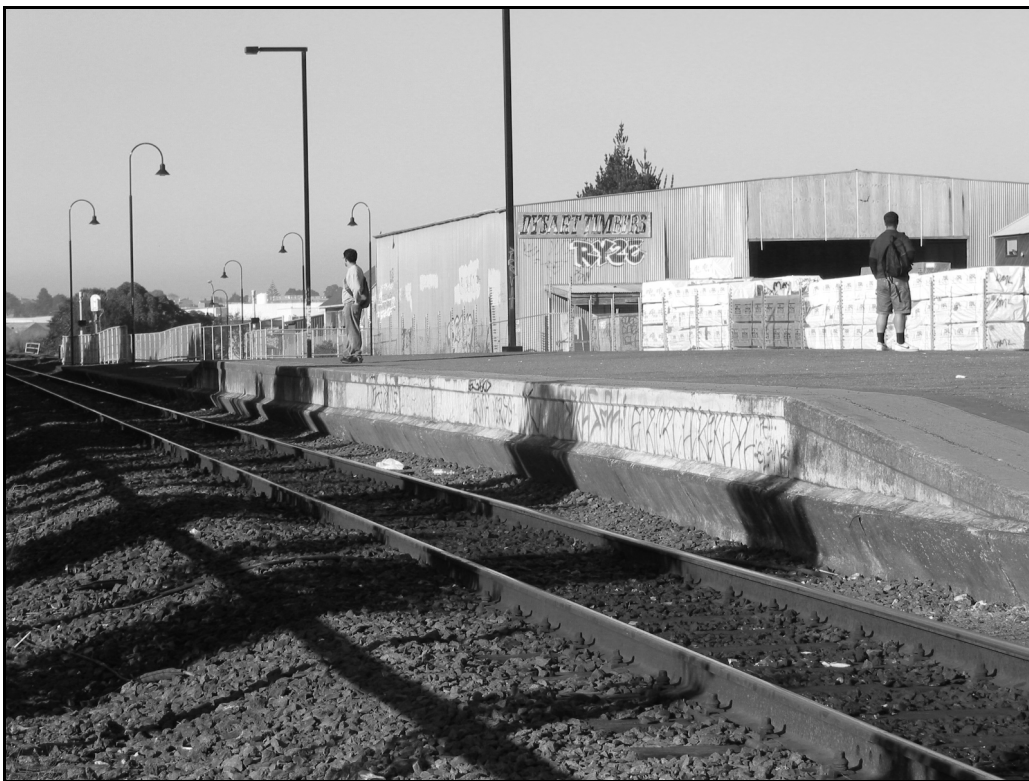
Figure 2
Down main line and platform at Glen Innes (looking south, direction of Train 3247)

- 1.2.1 Glen Innes station was an island platform with up and down main lines on either side of the platform. Auckland bound services were berthed on the up main line and services from Auckland were berthed on the down main line.

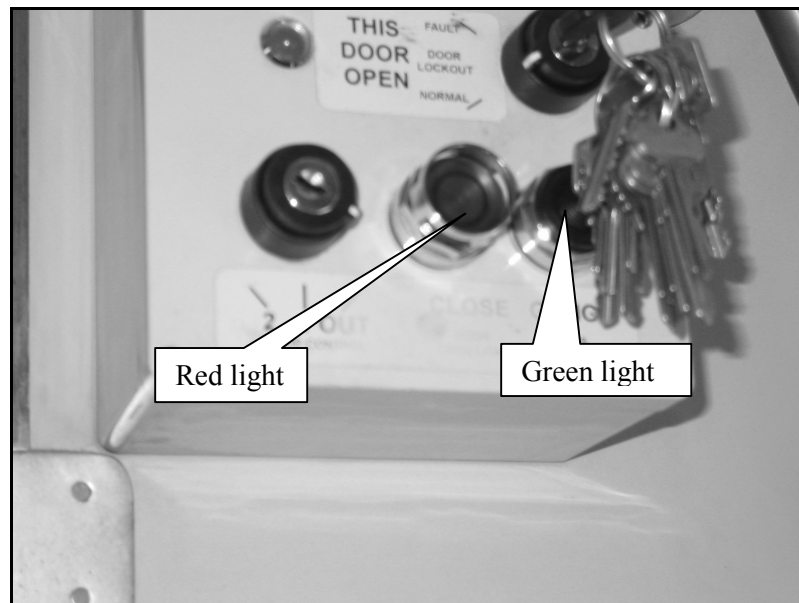
Figure 3
Train manager's door control box

- 1.3.1 Tranz Rail Operating Code instructions to the train manager for the operation of bi-parting doors on ADK and ADB passenger cars are summarised below:
- once the doors were opened by the driver, the train manager should insert his key in one of the control boxes located next to each bi-parting door and must turn the key to position "2". All control boxes show a red light when any door is open (see Figure 3)
 - having visually checked that all passengers were off/on and clear, the train manager should press the red "door close" button to close all the doors on the DMU except the local door beside the control box with the key inserted

- once all the remote doors were properly closed, a green light illuminated on the local control box
- the train manager should again visually check that passengers were clear of the doors before pressing the green button to send the 2-bells “right away” signal to the DMU driver
- as the train moves off the train manager must look along the train for any emergency signals or unusual situations
- if nothing is untoward, the train manager should turn the key to position 1 to close the local door and remove the key from the control box after these doors had closed.

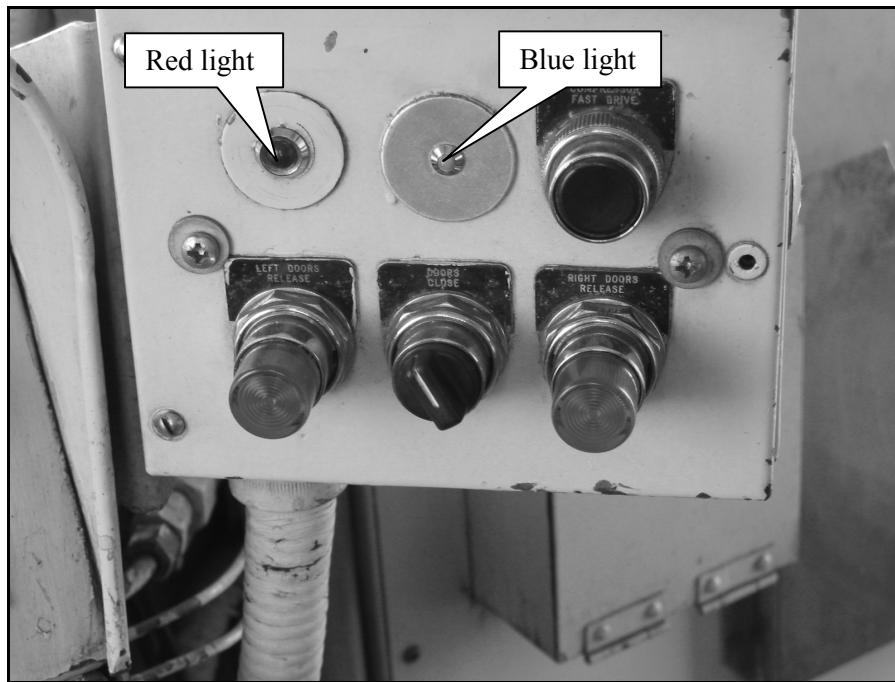
Figure 4
DMU driver's door status control console

- the DMU driver was the best person to ascertain when the DMU had stopped in the correct position at a station and so was responsible for opening the bi-parting doors on the appropriate side. A red light on the DMU driver's console was illuminated if any one of the bi-parting doors were open (see Figure 4)
- a full brake application must be made after the DMU has stopped at a station. If the controller was not in the brake position when the doors were opened, an alarm sounded
- a DMU driver must not depart from a passenger station until the blue “door closed” light was illuminated and the train manager has given the “right away” signal
- a DMU driver must stop the train if the warning buzzer sounded and/or the red “door open” light was illuminated.

1.3.3 A copy of Tranz Rail Operating Code Supplement CSR 4.10 Section 6 Issue 5, dated 19 November 2001 dealing with the operation of DMU doors is attached as Appendix 1. While the supplement was for ADL – ADC cars, all instructions for the operation of doors and bell codes were the same except that on the ADK and ADB cars, passengers were additionally given a 2-second audible warning before the doors began to close.
