## RAILWAY OCCURRENCE REPORT

03-109

diesel multiple unit passenger Train 3347, driveshaft failure,  
Meadowbank

27 June 2003

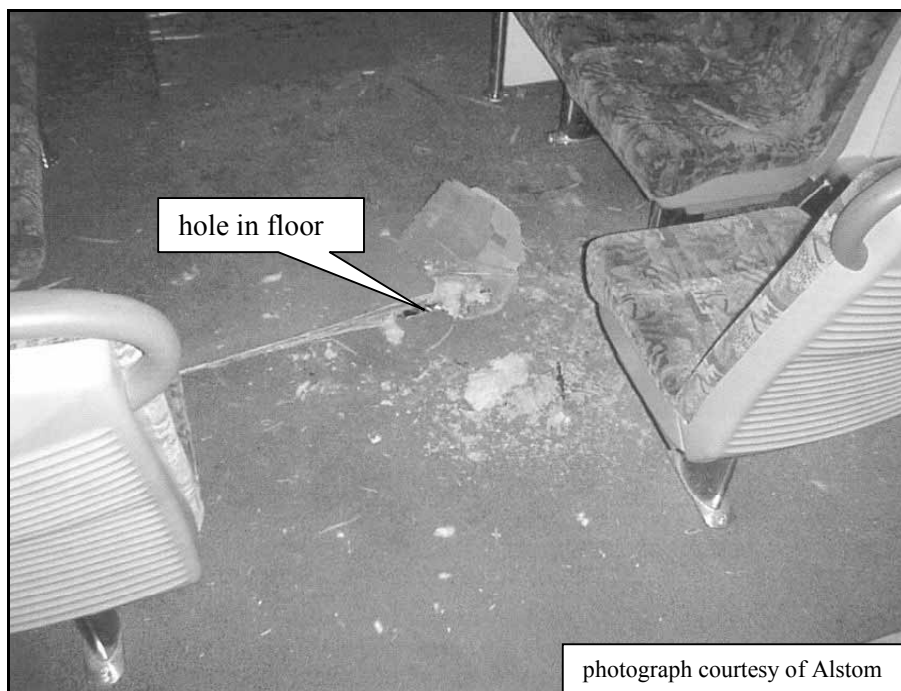
**Figure 1**  
**Damaged floor of passenger car ADL 810**

The free end of the failed driveshaft was not sufficiently restrained and it punctured the floor of the passenger compartment.

- 1.1.5 The DMU driver shut down both engines before alighting to assess the damage. He found that the free end of the driveshaft from No. 2 transmission to No. 3 final drive had punctured a hole in the floor of the passenger compartment (see Figure 1). The driveshaft was resting on No. 3 axle.

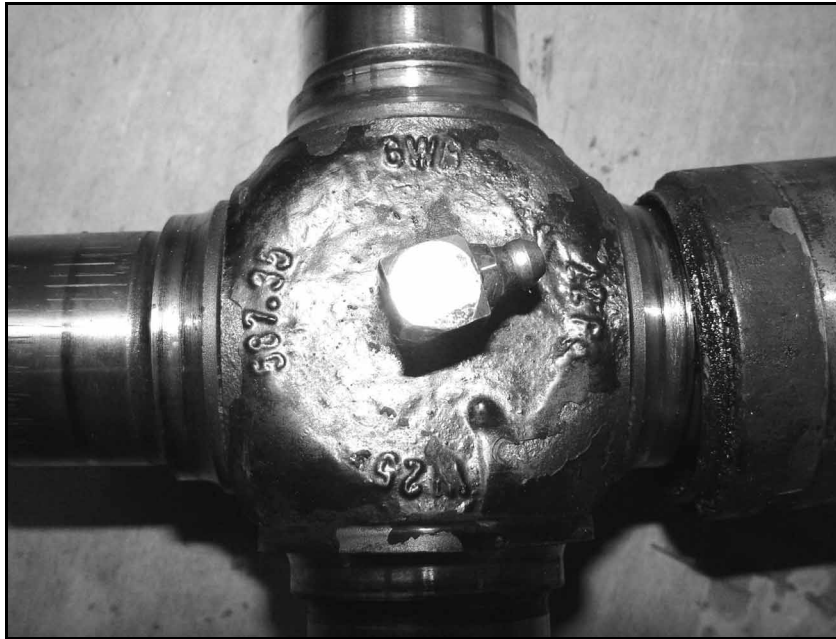
**Figure 3**  
**Universal joint cross**

1.5.1 The failed driveshaft was identified from the make and model details forged into the universal joint cross (see Figure 3). It was a model 587.35 and made by GWB. GWB was an established

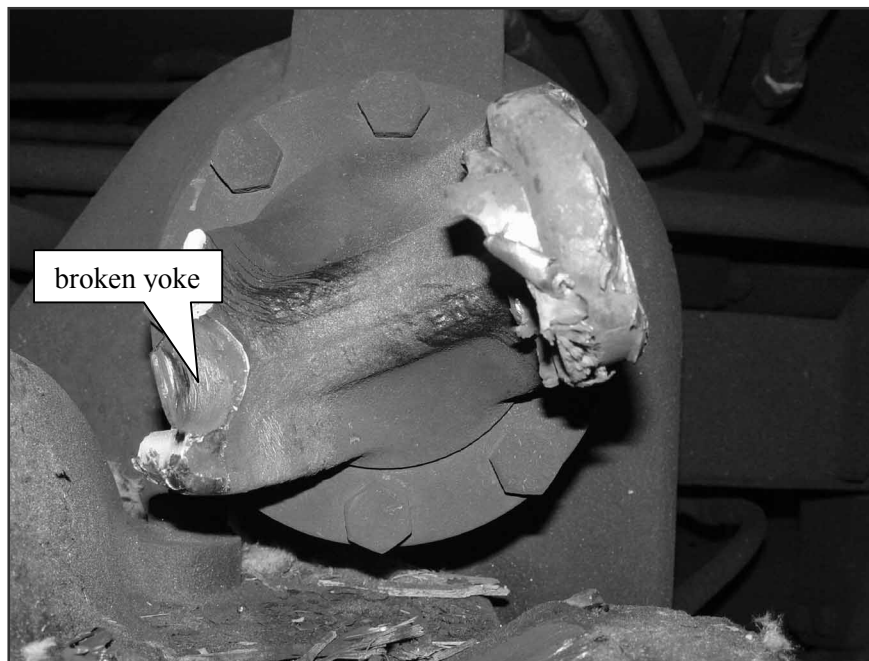
**Figure 5**  
**Damaged yoke**

- 1.6.1 The yoke on the axle end of the driveshaft failed (see Figure 5). The flailing driveshaft damaged pipe work under ADL 810 and penetrated the saloon floor. One end of the driveshaft remained attached to the hydraulic transmission while the free end was resting on the axle. A tubular safety stirrup was in place to restrain the driveshaft (see Figure 6).

- 2.1 The failure of the universal joint was consistent with the bearing being excessively worn, becoming overheated and subsequently seizing, resulting in the yoke bearing housing fracturing and releasing the driveshaft.

- 2.3 The bearing failure was consistent with a lubrication failure. Either the bearing had not been properly greased or the grease had degenerated. Because there was fresh grease in the joint assembly that did not fail, it was most likely that all bearings were greased at the same time. However, because of the heat build-up leading to the subsequent failure of the universal joint, the age of the remaining grease within the bearing could not be determined.

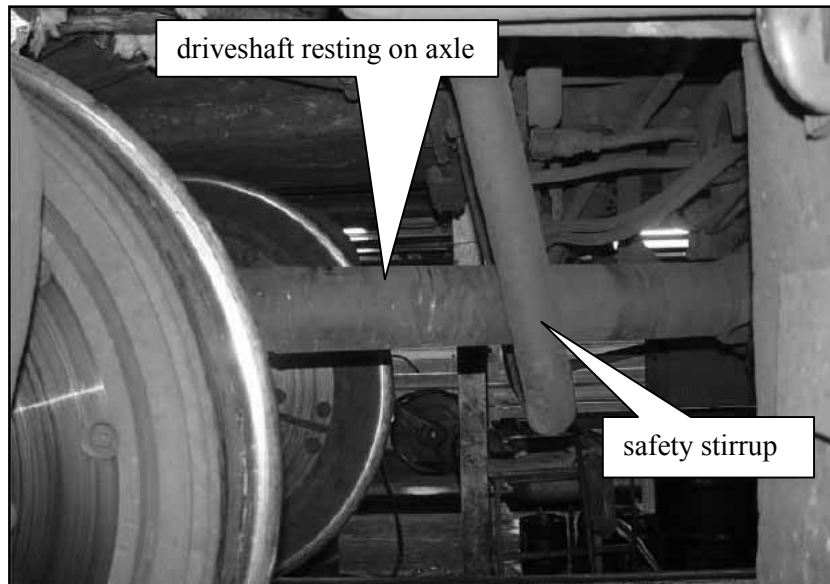
**Figure 6**  
**Driveshaft safety stirrup**

- 2.6 As long as the DMU continued to move after the driveshaft had failed, the free end would continue to be rotated by its connection to the final drive in the bogie. The safety stirrup intended to restrict the motion of the driveshaft prevented it falling to the track, but could not prevent the driveshaft from striking the underside of the passenger compartment floor. A safety recommendation to review and revise the design of the restraint has been made to the operator.

060/04 Toll NZ accepts this recommendation.  
Restraints have been fitted to the original driveshaft safety loop at a lower height than the original. The tubing that has been added below the original vertical restraint will arrest the shaft should a universal joint fail at the final drive end before the shaft makes contact with the underside of the floor.

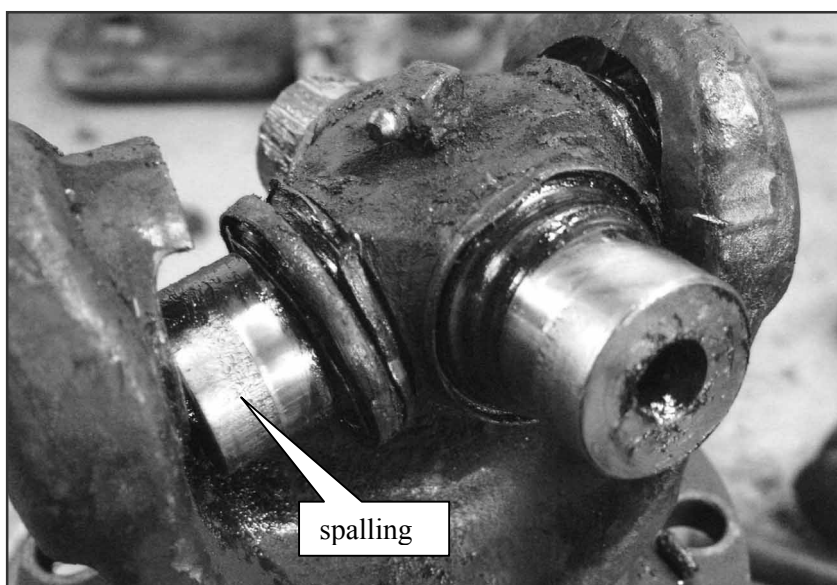
**Figure 7**  
**Spalling and pitting on bearing races**

- 1.6.2 The failed driveshaft was removed and taken to an independent driveshaft specialist for detailed examination. Damage to the failed end of the driveshaft made it difficult to remove some of the bearings. However, removal was achieved without further damage to critical components.
- 1.6.3 When dismantled, the bearing assembly was found to contain dry remnants of grease consistent with it being subjected to the heat generated in the universal joint up until the time of failure. One of the bearing races showed evidence of pitting and spalling.

- 2.4 The torque applied to the driveshaft caused the outermost rows of rollers to be most heavily loaded and therefore most prone to fatigue failure of the bearing surface. The damage to the raceways in both of the crosses was as expected when a bearing had run to the end of its useful life. The failure of the bearings caused the failure of the driveshaft.

- 2.5 The spalling and shedding flakes of steel on the still-intact universal joint were caused by the formation of many small fatigue cracks in the surface of the bearing race. These cracks penetrated the race and eventually joined up to allow small particles to break off completely. Such surface damage marks the end of the life of a roller bearing and signals eventual failure.

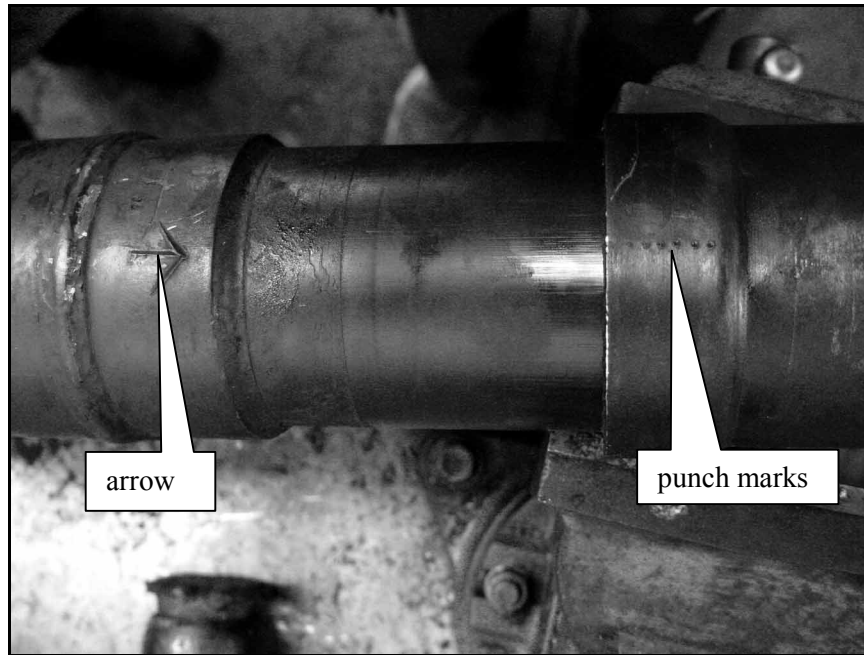
**Figure 8**  
**Sliding-joint section of the failed driveshaft**

- 1.6.4 The left-hand bearing from the end of the driveshaft that did not fail was examined and there was also evidence of spalling and shedding of flakes of steel on the 2 races (see Figure 7). Fresh grease was visible in the universal joint.
- 1.6.5 The driveshaft had the reference DS9141 stamped into it. If the driveshaft had been serviced within New Zealand it would have had either a 5-digit number with no alphabetic prefix or a 4-digit number prefixed by DSS.
- 1.6.6 The sliding-joint section of the driveshaft can be assembled in many different positions, only one of which is correct. The manufacturer marked the correct alignment with 2 arrow marks facing each other. The failed driveshaft exhibited different markings, having one arrow and a line of punch marks (see Figure 8).

- 2.7 In the event of a failure of a universal joint there was a serious risk of separation of the sliding joint in the driveshaft. Should the driveshaft continue to rotate and not be closely confined, it could not only flail beneath the floor but could also fling away the unattached end of the driveshaft, similar to a slingshot. This would pose an unacceptable risk to anyone in the vicinity. A safety recommendation to address this issue has been made to the operator.
