## RAILWAY OCCURRENCE REPORT

03-110      express freight Train 337, derailment, Kaimai Tunnel west portal    9 August 2003

## **Report 03-110**

### **Abstract**

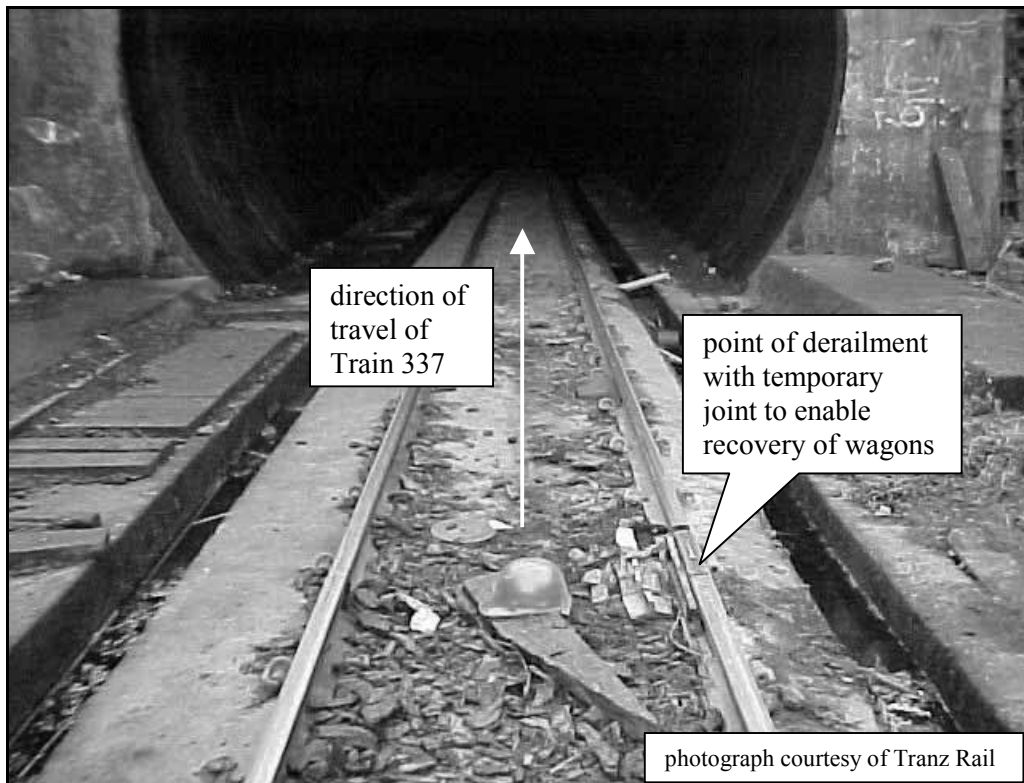
- 1.1.8 A subsequent investigation showed the point of derailment (POD) to be 63.323 km East Coast Main Trunk (ECMT) where a rail joint had broken (see Figure 1).

**Figure 1**  
**Track at the point of derailment**

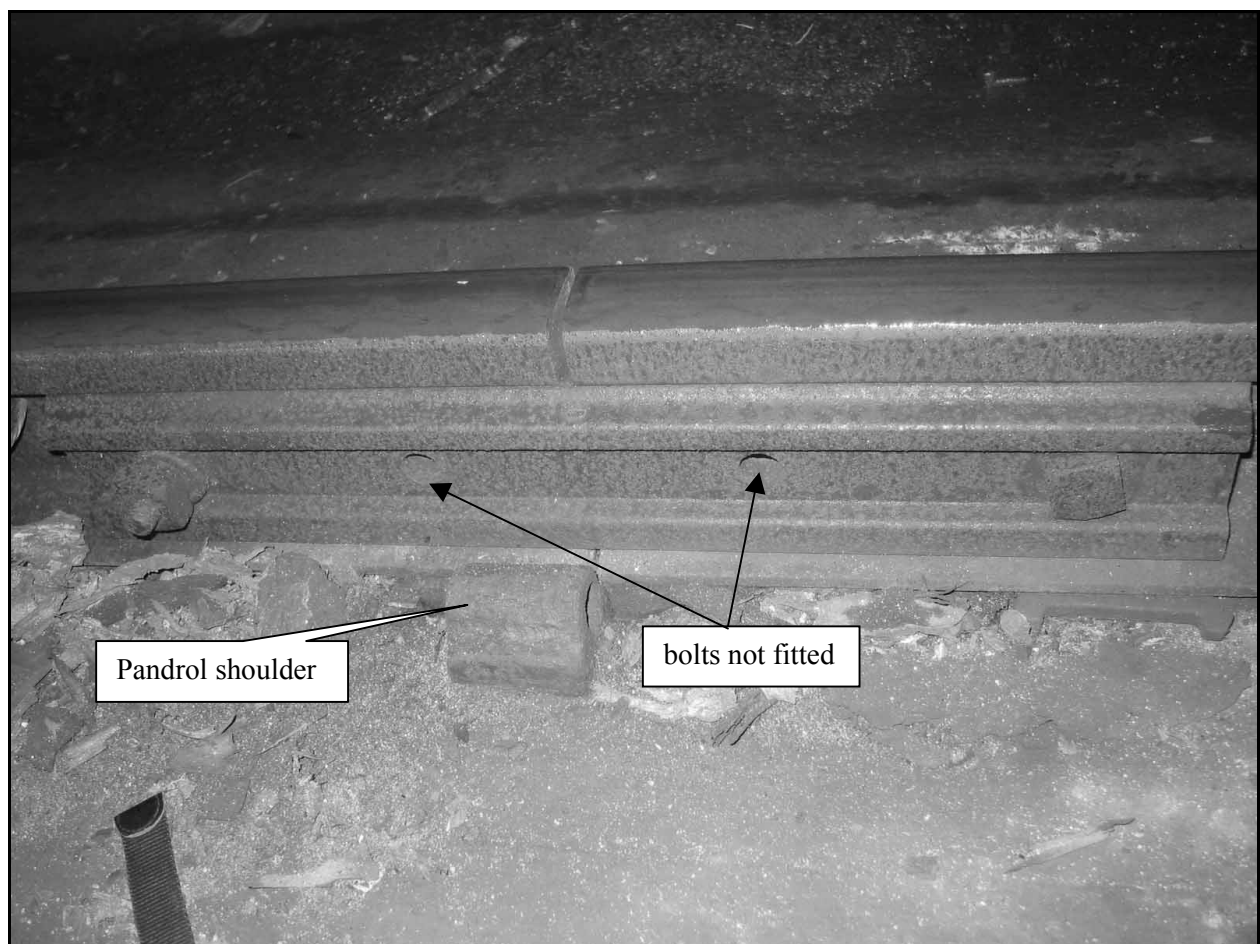
1.4.6 All the 5 joints remaining in track were fastened with 2 bolts per fishplate instead of the 4 required (see Figure 2). The bolt at each rail end was not fitted.

**Figure 2**  
**Bolted joint with 2 bolts only**

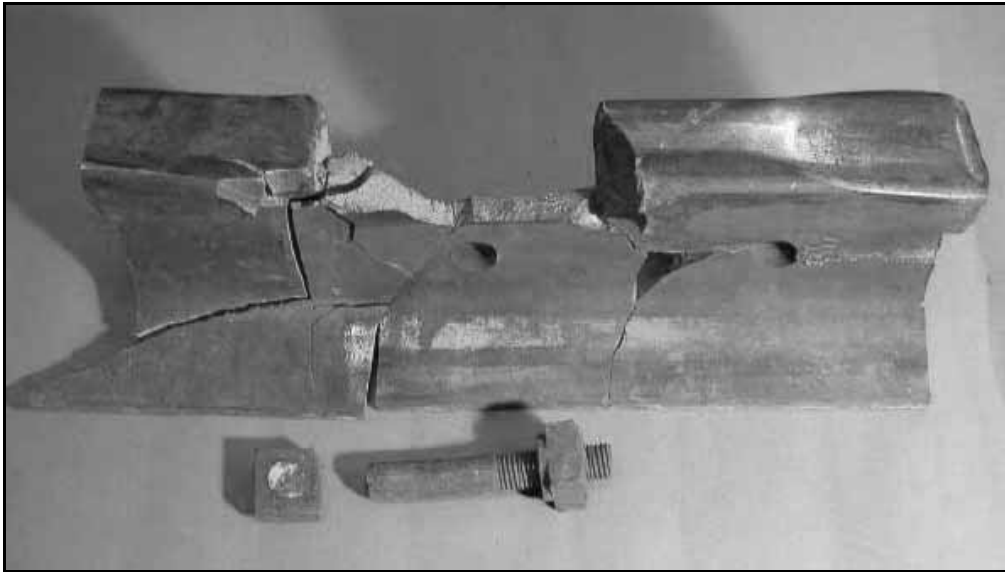
- 1.6.1 Not all fragments of the failed rail joint were recovered during a search of the area surrounding the point of derailment (see Figure 3).
- 1.6.2 A fatigue fracture ran from the end bolt hole parallel with the running surface of the rail to the rail end. This fracture surface, marked A in Figure 4, was smooth and heavily polished.
- 1.6.3 A second fatigue fracture surface, marked B in Figure 4, was also heavily polished.

**Figure 3**  
**Recovered section of failed rail end**

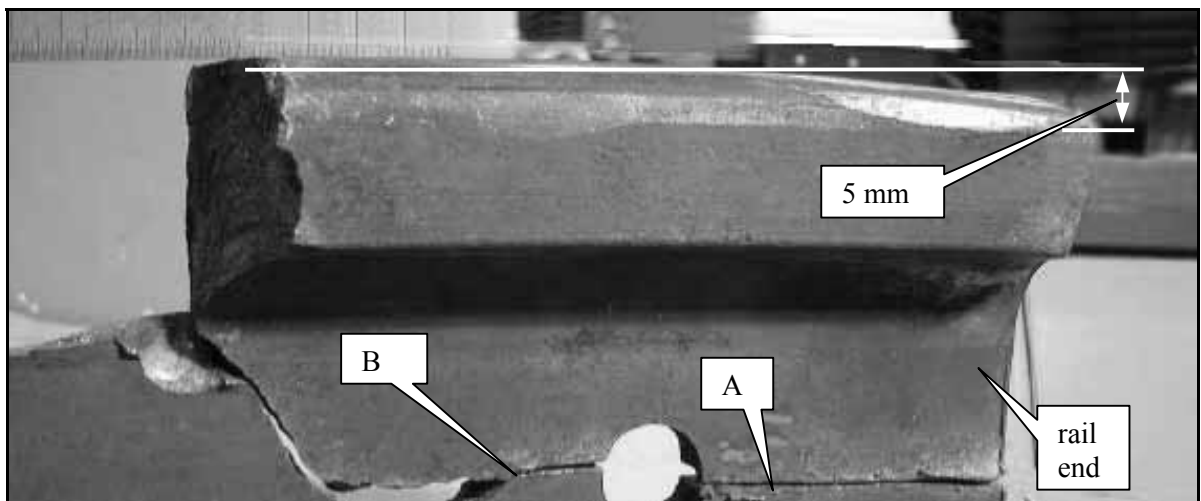
1.6.4 A vertical deformation of 5 mm was measured on the new rail at the failed rail joint (see Figure 4).

**Figure 4**  
**Vertical deformation on the new rail at the failed joint**

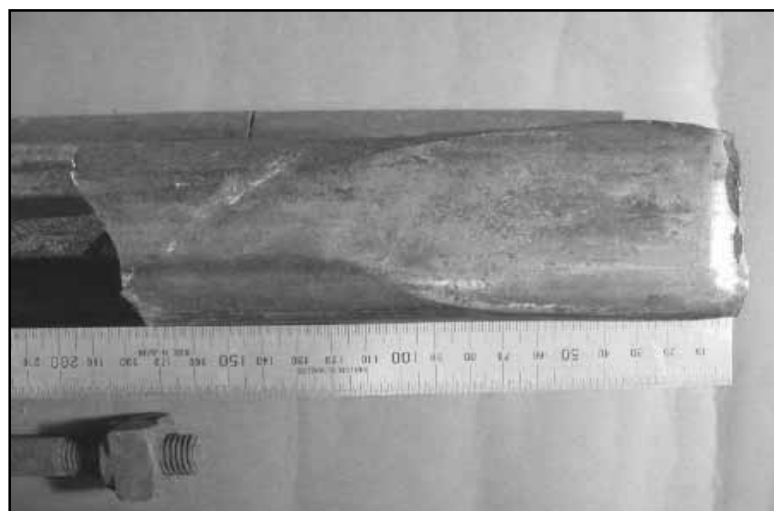
**Figure 5**  
**Horizontal deformation on the new rail at the failed joint**

- 1.6.5 The rail head was battered to the extent that metal flowed 10 mm to the outside of the head of the new rail (see Figure 5).
- 1.6.6 There were highly polished marks from the fishplate under the rail head of the deformed section of the replacement rail, and on the foot region of the original rail at the rail joint.
- 1.6.7 The bolt hole next to the end of the rail was undamaged but corroded. A significant wear/polishing pattern was present on the side of the other bolt hole facing the end of the rail. The edges of the hole were burred indicating that a significant amount of deformation had taken place.
