## RAILWAY OCCURRENCE REPORT

03-112

diesel multiple unit Train 2153, collision with truck,  
St Georges Road level crossing, Avondale

28 October 2003

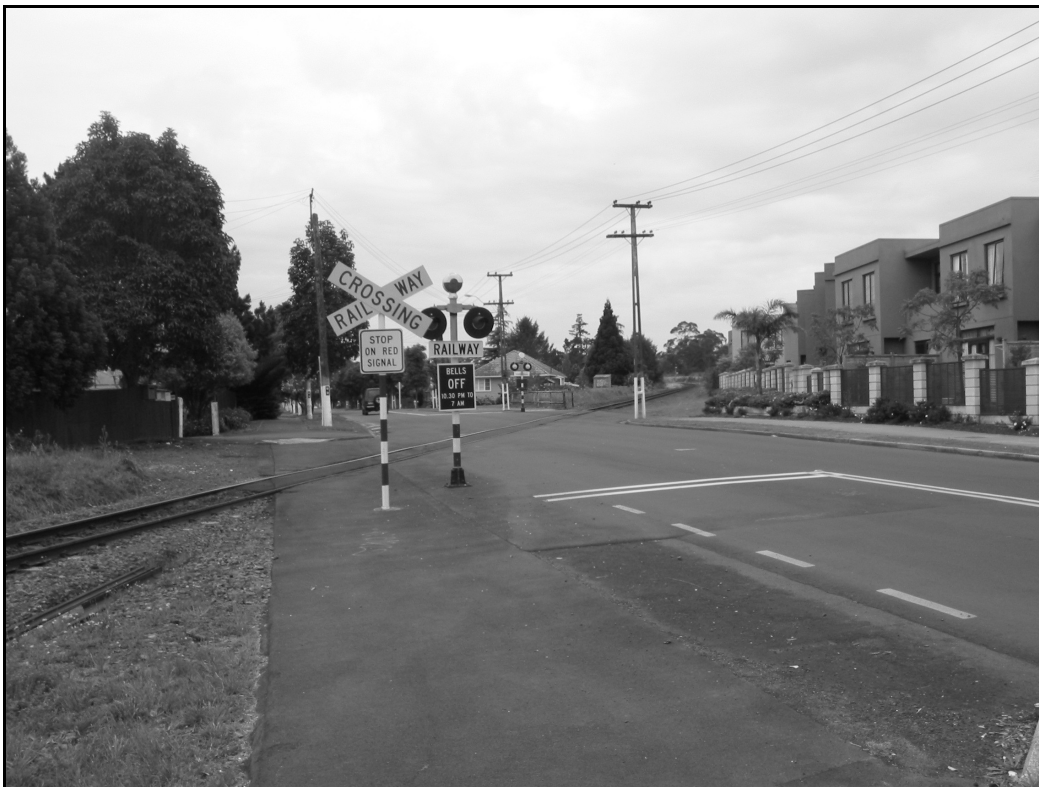
- 1.2.1 St Georges Road ran in a north - south direction and was bisected at an acute angle by the North Auckland railway line running east to west (see Figure 1).

**Figure 1**  
**St Georges Road level crossing looking north**

- 1.2.2 The level crossing was protected on both sides by signs, road markings, flashing lights and bells. All signage was in accordance with the “Manual of Traffic Signs and Markings”. The level crossing was not equipped with barriers.

- 1.2.3 Visibility for road traffic approaching from the north side of the level crossing was restricted because of the angle of approach of the railway line, the presence of houses and vegetation. There were no such restrictions when approaching from the south side of the level crossing.

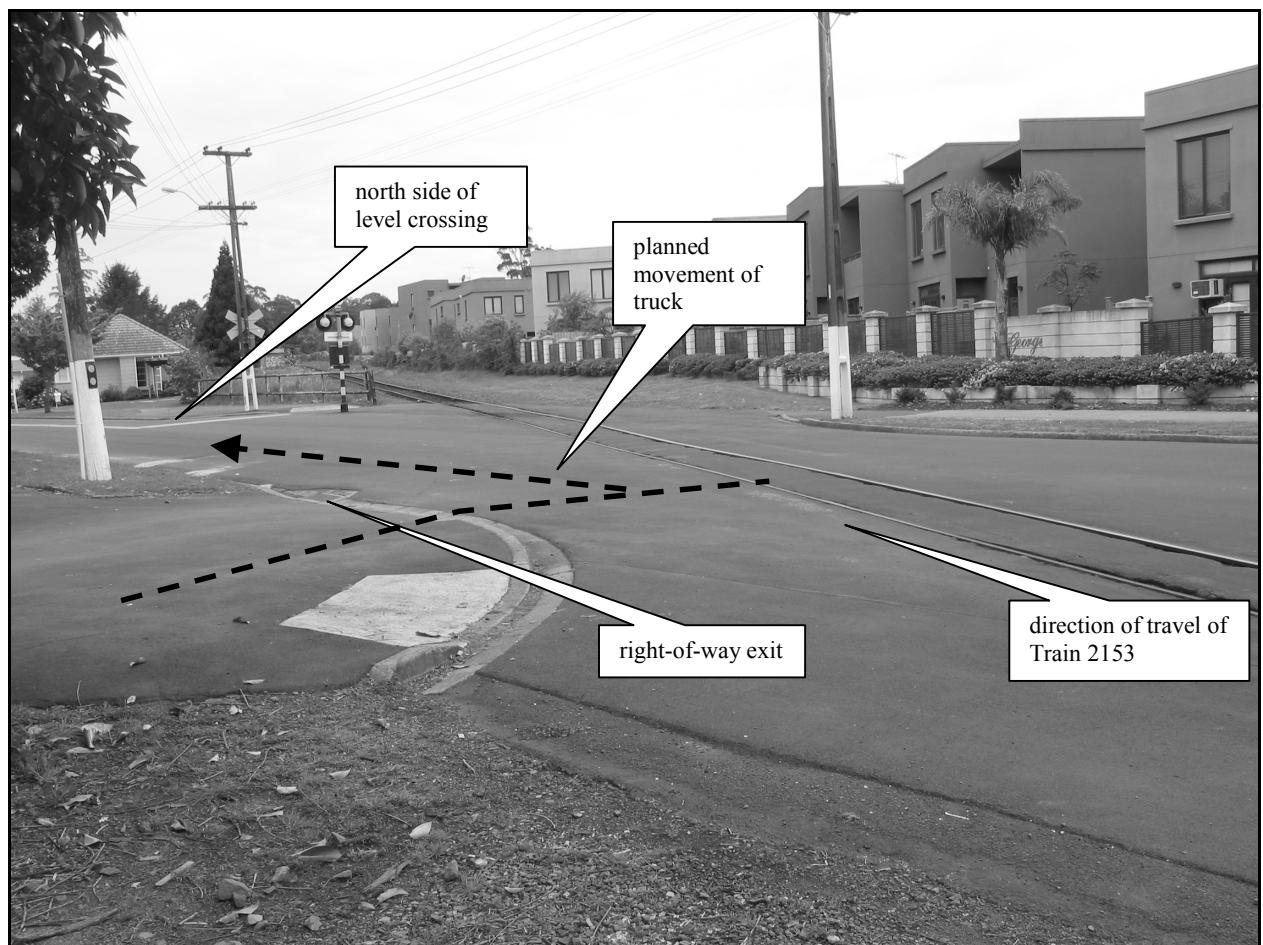
- 1.2.4 Auckland City Council advised that at the latest count, 7800 road vehicles used the crossing in each 24-hour period.
- 1.2.5 A private right-of-way, which serviced 3 houses near the railway line, joined St Georges Road between the railway line and the level crossing warning devices to the north . The distance from the right-of-way exit to the warning devices was about 20 m, and to the railway line about 5 m (see Figure 2). There was no signage or warning devices directed towards the right-of-way.

**Figure 2**  
**Where the private right-of-way joined St Georges Road on the north side of the level crossing**

- 2.1 The level crossing signage and road markings met the recommended guidelines, were clearly visible and in good condition for traffic using St Georges Road. However, the private right-of-way joined St Georges Road between the railway line and the warning devices and signage. As a result, vehicles exiting the right-of-way did so behind the warning devices, making the devices and signage ineffective from that direction.

- 2.2 The flashing lights on both sides of the level crossing were facing away from the right-of-way exit and therefore they would not have alerted the truck driver. The warning bells were about 20 m distant and were probably difficult to hear in the cab over the noise of the truck engine when reversing. Although the flashing lights would not have been visible, the driver of a vehicle going forward, rather than reversing, from the right-of-way would have had other opportunities to become aware of the approaching train by either sighting the train or noticing the cars stopped at the warning devices.

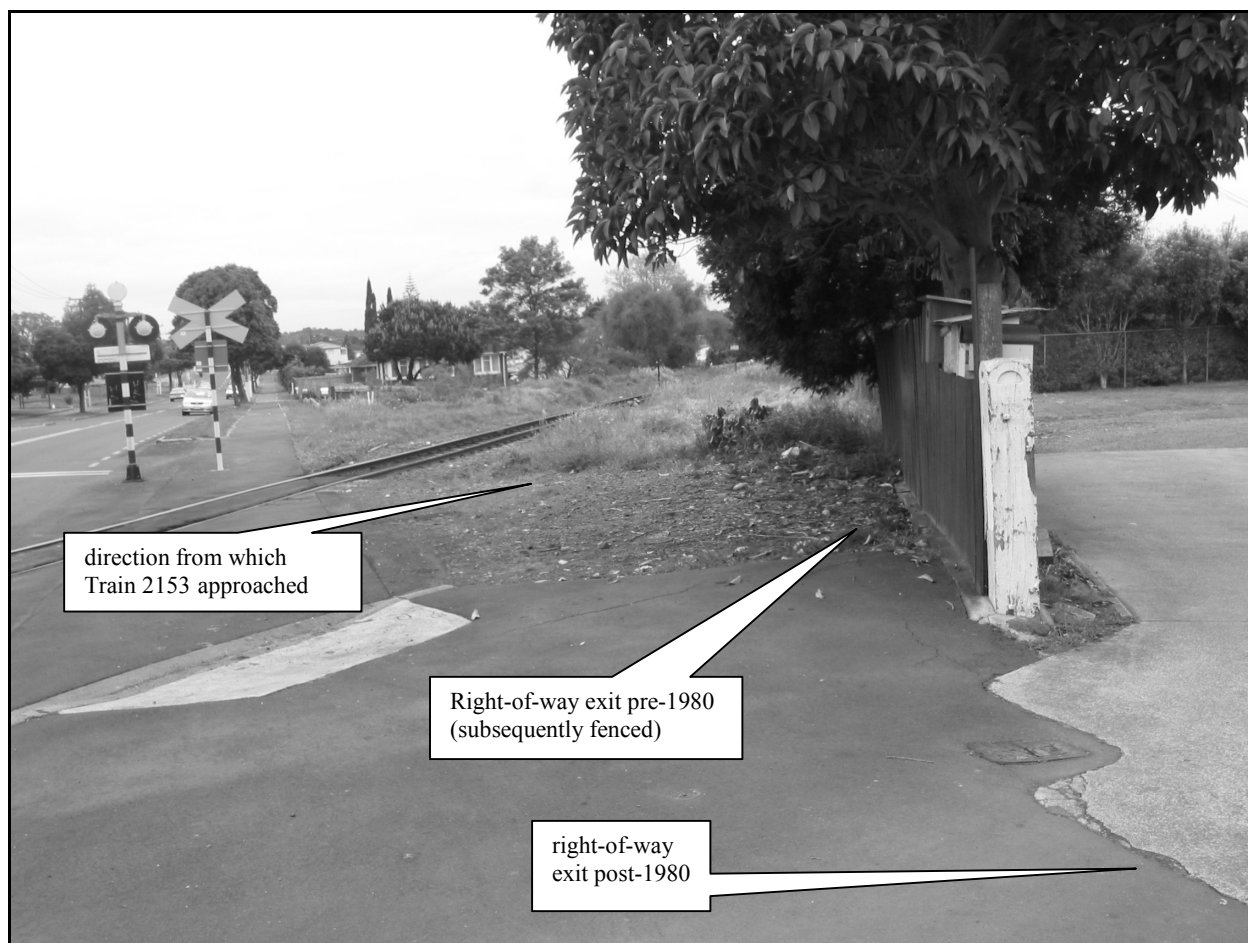
- 1.2.6 When exiting the right-of-way, line-of-sight in the direction from which Train 2153 approached was restricted by a boundary fence, a row of trees along the fence line and by the fact that the right-of-way joined St Georges Road almost parallel to the railway line (see Figure 3).

**Figure 3**  
**Looking east from the right-of-way exit in the direction from which Train 2153 approached**  
**St Georges Road**

- 3.3 In 1980 the repositioning of the right-of-way exit ensured compliance with the legal frontage on to St Georges Road, but the view lines for motorists approaching the level crossing from the right-of-way deteriorated as a result.
- 3.4 There were no warning signs or devices in place to alert motorists exiting the right-of-way of approaching trains.
- 3.5 The truck driver was familiar with the level crossing and its proximity to the right-of-way exit, but his previous experiences of never seeing trains had conditioned him to not expect them.
- 3.6 Train 2153 was being operated correctly and the actions of the DMU driver did not contribute to the accident.

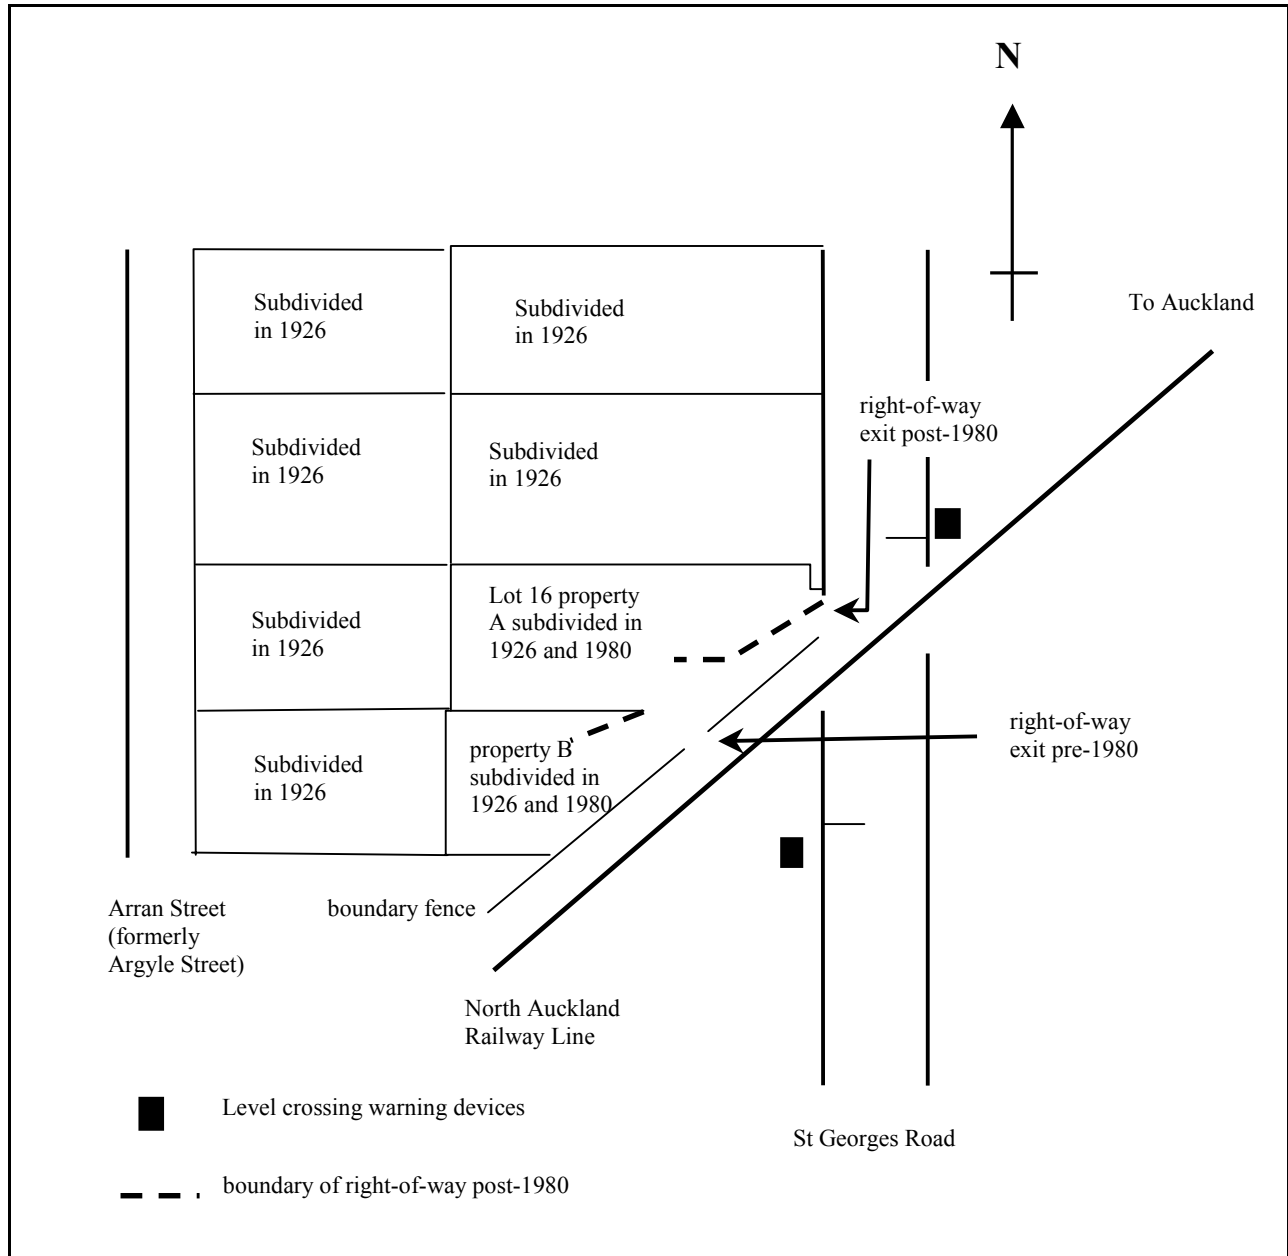
1.2.9 Before 1980 the right-of-way for the single residence on Lot 16, property A, exited on to St Georges Road near to the railway line (see Figures 3 and 4), although the legal frontage of the property to St Georges Road was further north. As a result, traffic exiting the right-of-way did so on to the railway corridor and not on to a public street. It was not possible to determine when the right-of-way had been established or if approval to exit on to the railway corridor had been received, either from the local authority of the time or from New Zealand Railways as the predecessor of Tranz Rail.

1.2.10 Lot 16 was about twice as big as the surrounding lots, and in 1980 it was again subdivided to allow for the construction of a second residence, property B. Included in this subdivision was the provision of a new right-of-way for property B, crossing the front of property A to connect with St Georges Road at the legal frontage. Because the location of the exit was the only option for access between the properties and St Georges Road, it then provided access for both properties. Figure 4 shows the location of these lots in relation to St Georges Road and the railway line.

**Figure 4**  
**Diagram showing locations of properties (not to scale)**
