RAILWAY OCCURRENCE REPORT

03-114 Express freight Train 220, derailment, Shannon

21 November 2003

**TRANSPORT ACCIDENT INVESTIGATION COMMISSION
NEW ZEALAND**

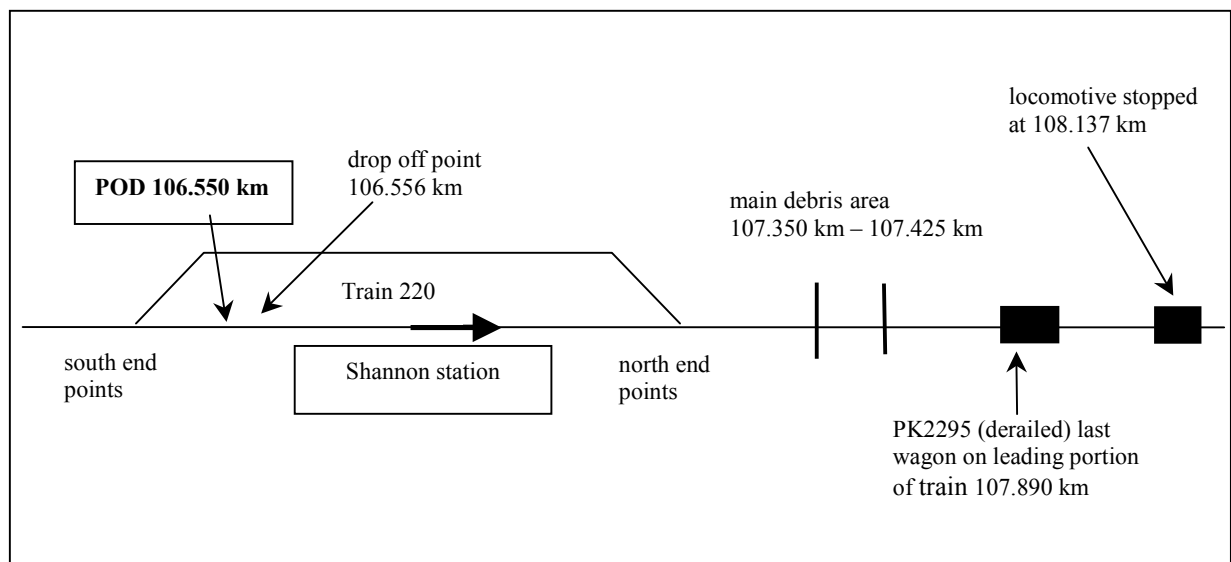
Figure 1
Diagram of derailment site (not to scale)

- 1.2.1 Twenty-five wagons remained on the front portion of the train, with all wheels of PK2295, the last wagon of the front portion, derailed to the right-hand side of the track. There was a gap of about 465 m separating the front and rear portions of the train. The first 9 wagons of the rear portion were derailed, but the last 8 wagons remained on the track.
- 1.2.2 A very light wheel flange mark on the right-hand rail identified the POD at 106.55 km. The marks indicated that the flange travelled along the railhead for a distance of 6 m before dropping off and hitting the rail fastenings (see Figure 2).
- 1.2.3 The maximum authorised line speed for express freight trains in the area of the derailment was 80 km/h.

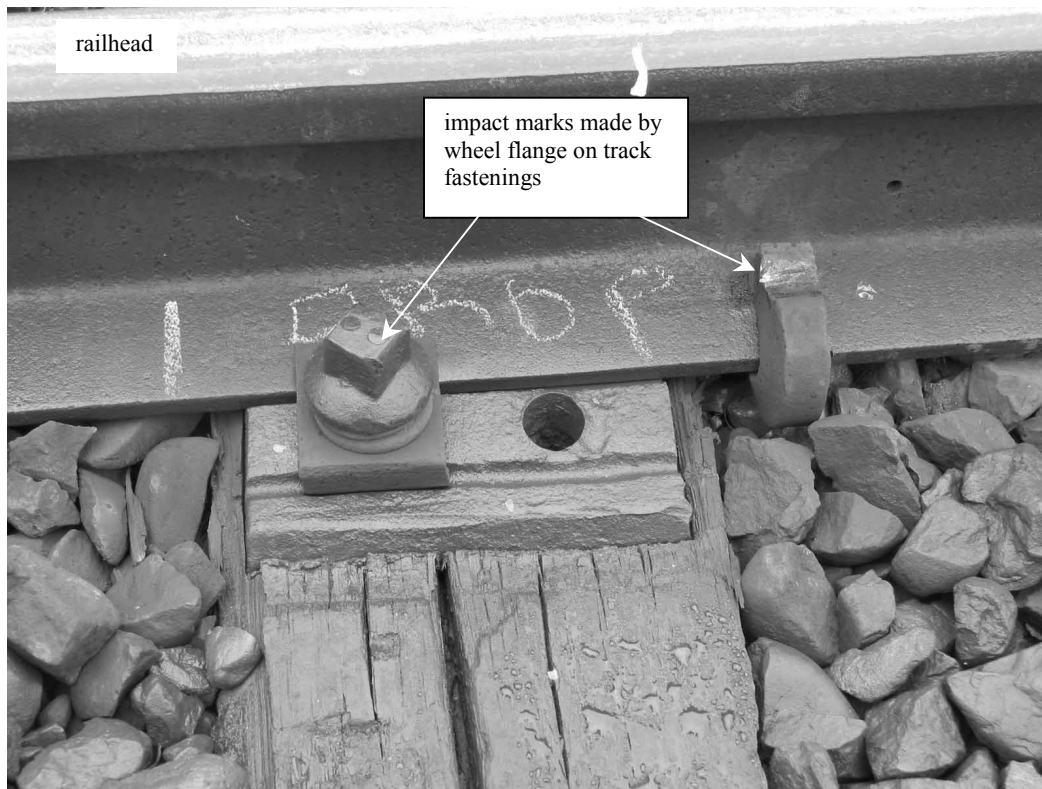
Figure 2
The point at which the wheel dropped from the railhead

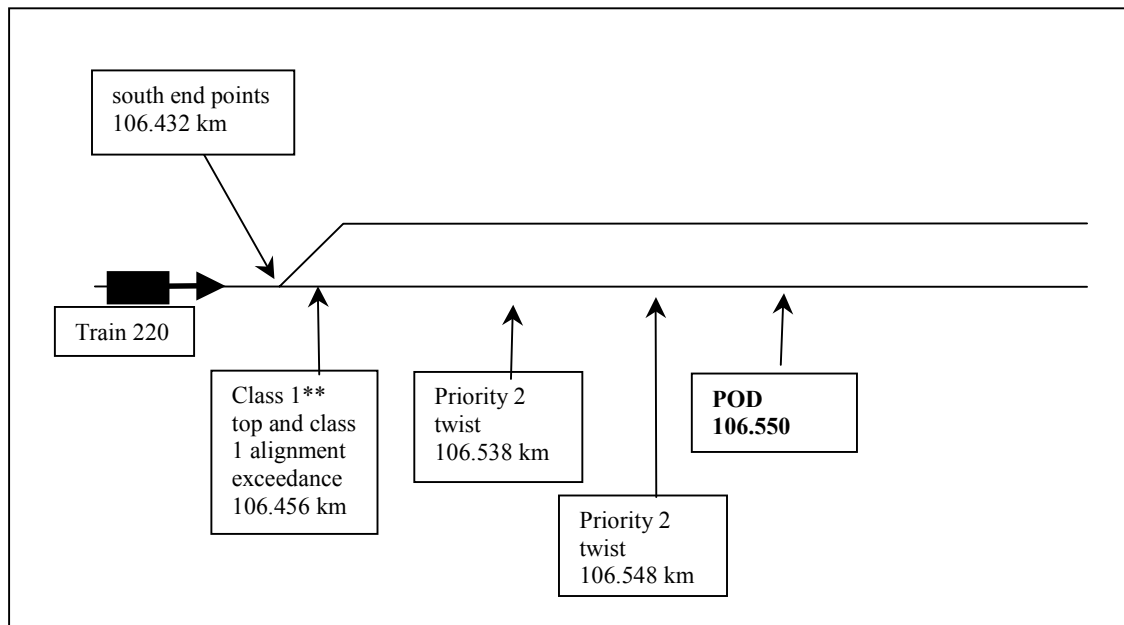
- 1.5.1 The track at the POD was 91lb continuous welded rail secured to pine sleepers with N type⁴ fastenings laid in 1972.
- 1.5.2 The measure-up of the track following the derailment identified two opposing priority 2, 18 mm cyclic twists⁵ about 12 m (106.538 km) and 2 m (106.548 km) respectively before the POD (see Figure 3). Tranz Rail's Track Code T003 defined priority 2 twists as those between 16 mm and 18 mm and required them to be programmed for maintenance. Both of these twists had been identified during the EM80 track evaluation car⁶ run over the section on 3 November 2003.

Figure 3
Diagram showing location of identified track faults (not to scale)

- 1.5.3 The EM80 track evaluation car had also identified a Class 1** (beyond Priority 1⁷) top exceedance and a Class 1 alignment exceedance about 100 metres before the point of derailment (see Figure 3). Tranz Rail's Track Code T003 required that a Class 1** exceedance was to be fixed within 24 hours if critical and, if necessary, a temporary speed restriction be imposed. Until the Class 1 has been corrected, competent track staff must check the condition of Class 1** exceedances during inspections.

- 1.5.4 The top exceedance had not been repaired, nor was there a speed restriction in place at the time of the derailment. New Zealand Railways Corporation⁸ advised that not all Class 1** exceedances required a temporary speed restriction until fixed, and the decision was based on material type and condition, other track geometry issues and the size of the exceedances. In this case the Class 1** alignment exceedance was not considered critical, so repair was programmed for some later date and no speed restriction was imposed. However, specific checks were initiated.

- 1.5.5 The 2 twists were within acceptable maintenance tolerances at the time of the derailment, and Tranz Rail considered that on their own they would not have caused the derailment.
