MARINE OCCURRENCE REPORT

03-202

restricted limits passenger vessel *Triptych* and pleasure motor launch *Barossa*, collision, Rangitoto Channel, Auckland

18 February
2003

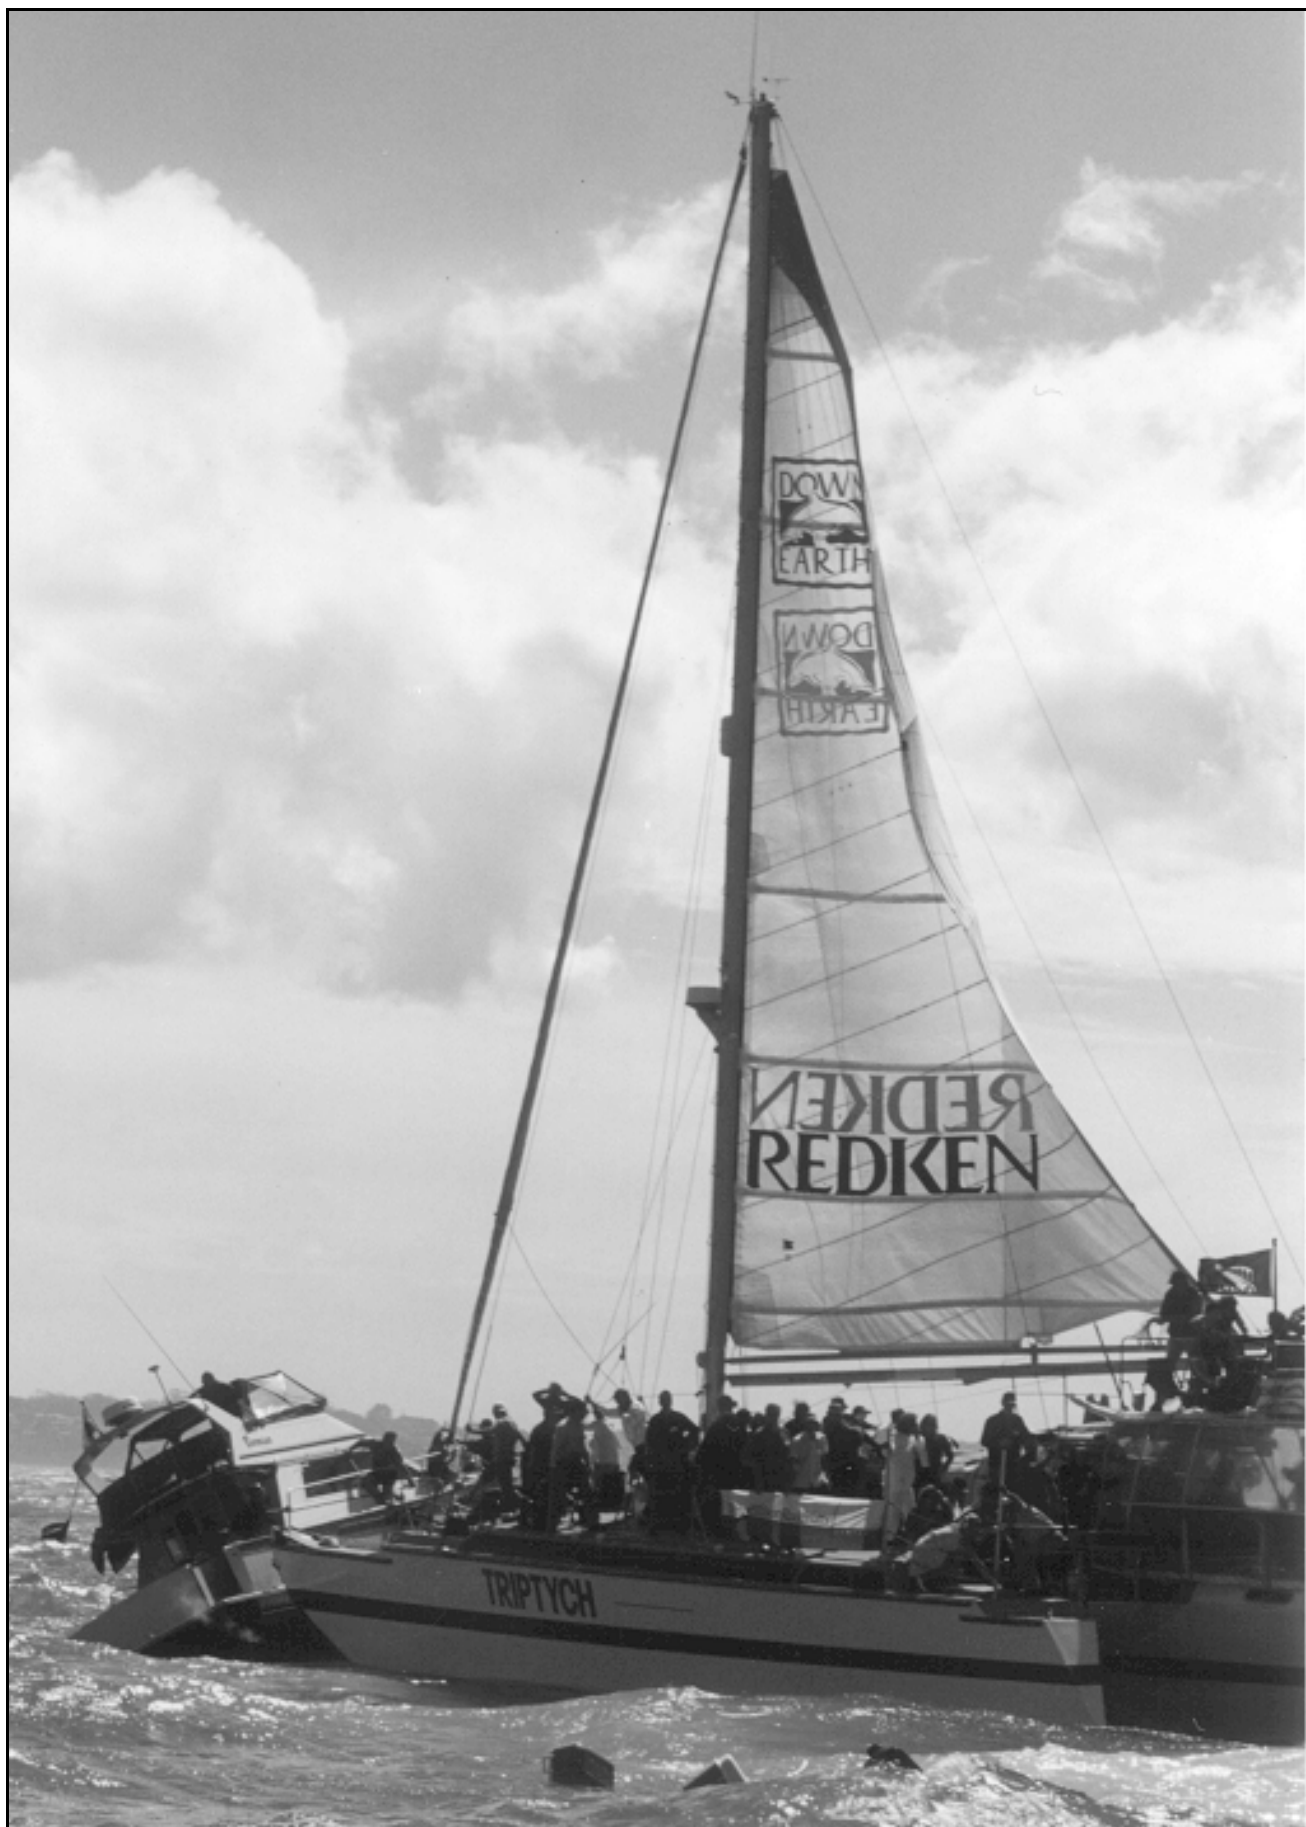
Barossa* fast across the bow of the *Triptych

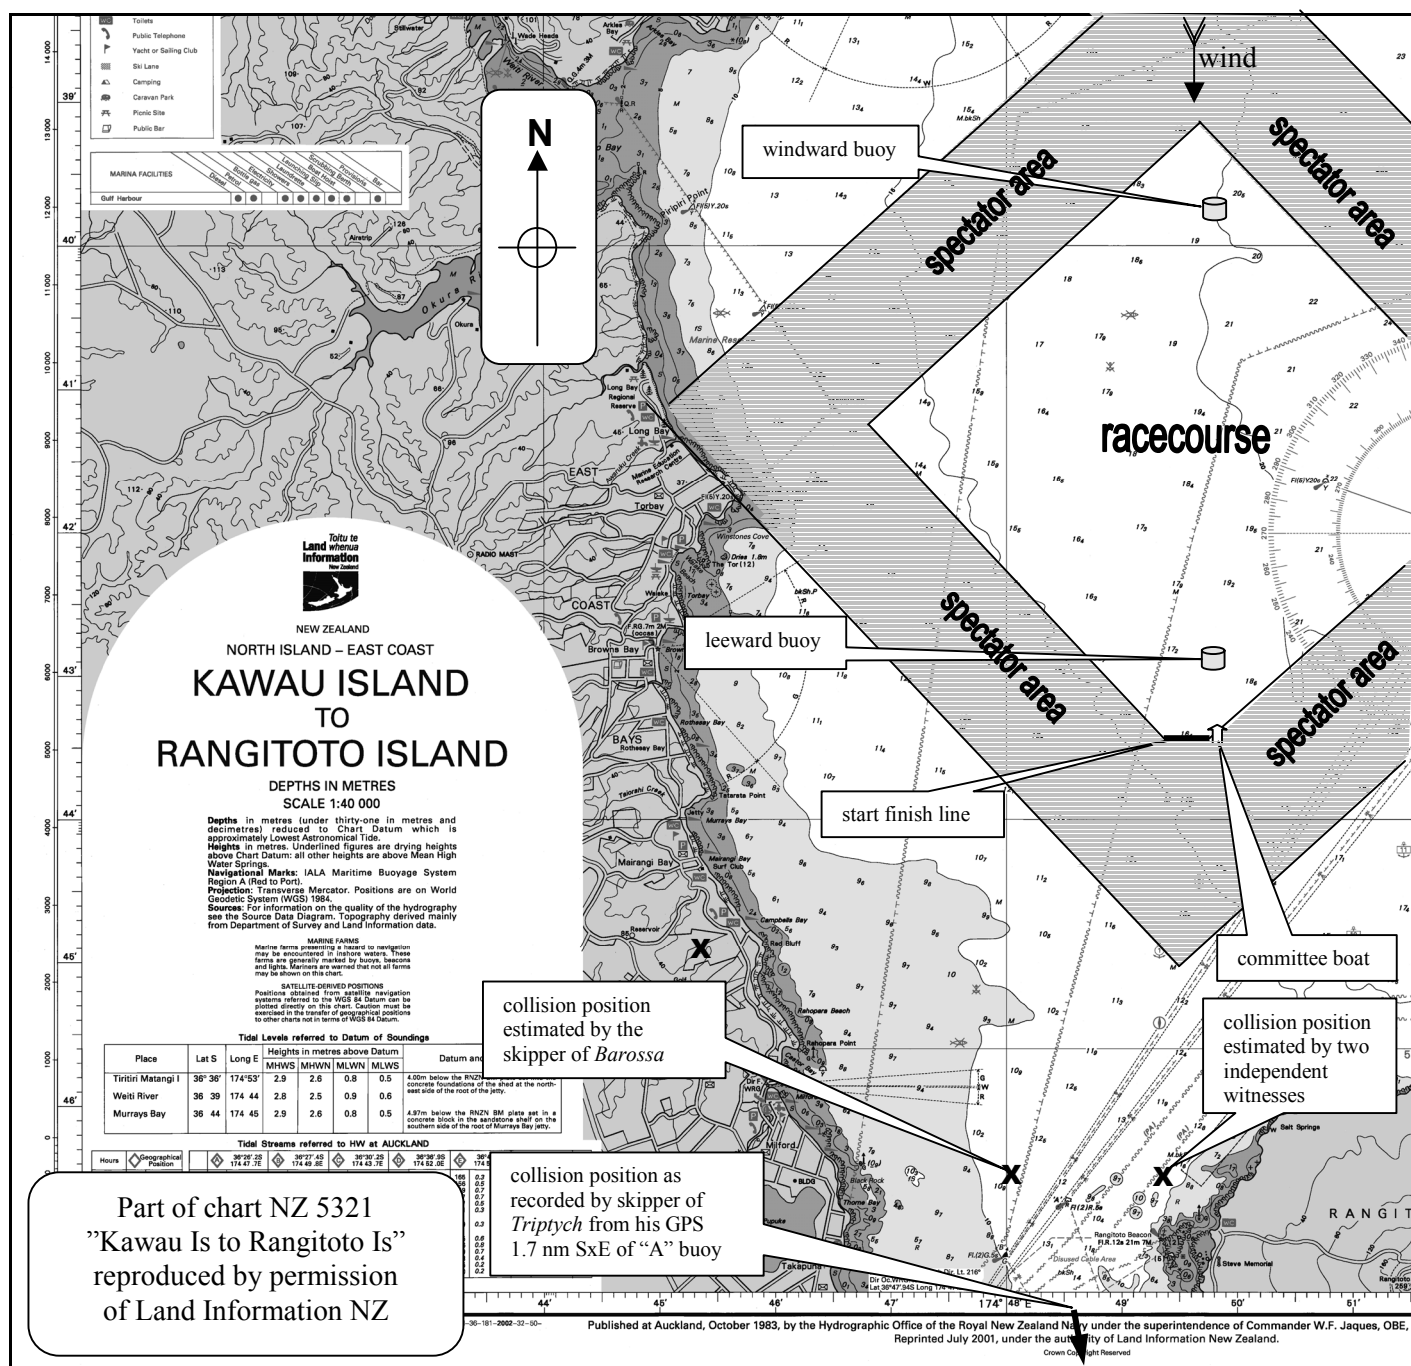
Figure 1
Chart showing position of the racecourse and estimations of collision position

- 1.1.1 On Tuesday 18 February 2003, the third race in the America's Cup regatta took place between the yachts *Team New Zealand* and *Alinghi*. Large numbers of spectator vessels, both commercial and private, sailed out to the racecourse (see Figure 1).

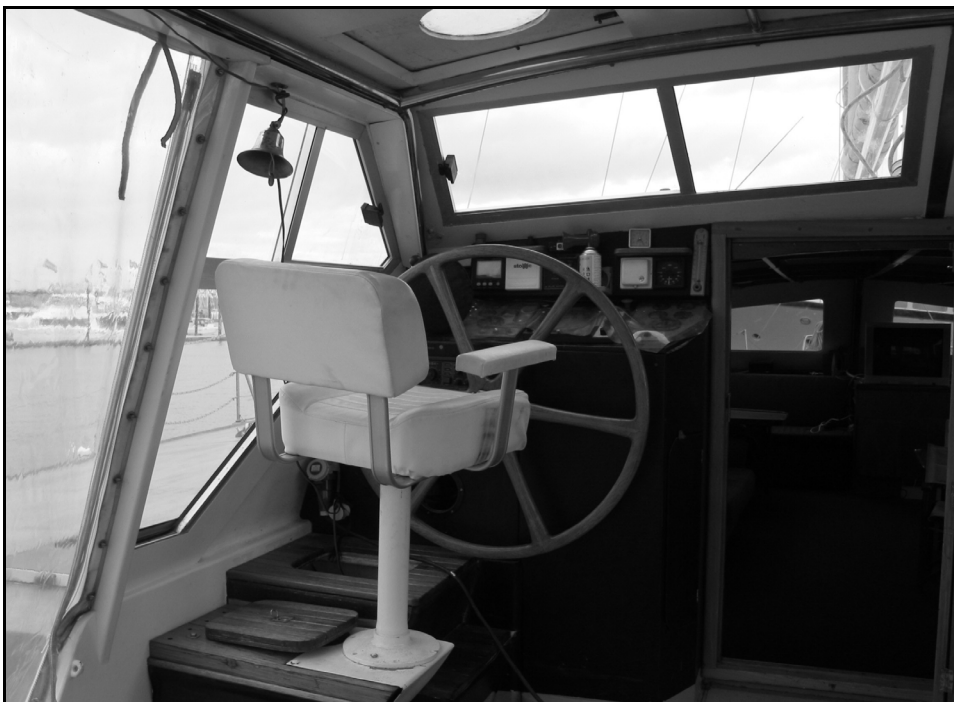
Figure 3
***Triptych* steering position and view to port**

- 1.2.3 The steering position of the *Triptych* was about 14 m from the bow and on the port side of the centre hull. The skipper was steering from here at the time of the collision. A chair was fixed on a raised platform immediately behind the wheel (see Figure 3) sufficiently close to prevent a helmsman from standing between the wheel and the chair. From the steering position, forward vision was through 2 windows each about 1000 mm wide by 250 mm high. These windows looked out onto the cabin roof (see Figures 2 and 3). There was a sliding side window immediately to the port side of the steering position. Above the chair there was a small hatchway through which the skipper could put his head to improve his all round visibility. One of the passengers reported that at times during the day the skipper had used this hatchway. The skipper said that to improve his visibility he was standing on the chair at the time of the collision steering with his hands or feet as appropriate. The instrument panel and engine controls were immediately in front of the steering wheel (refer Figure 3).

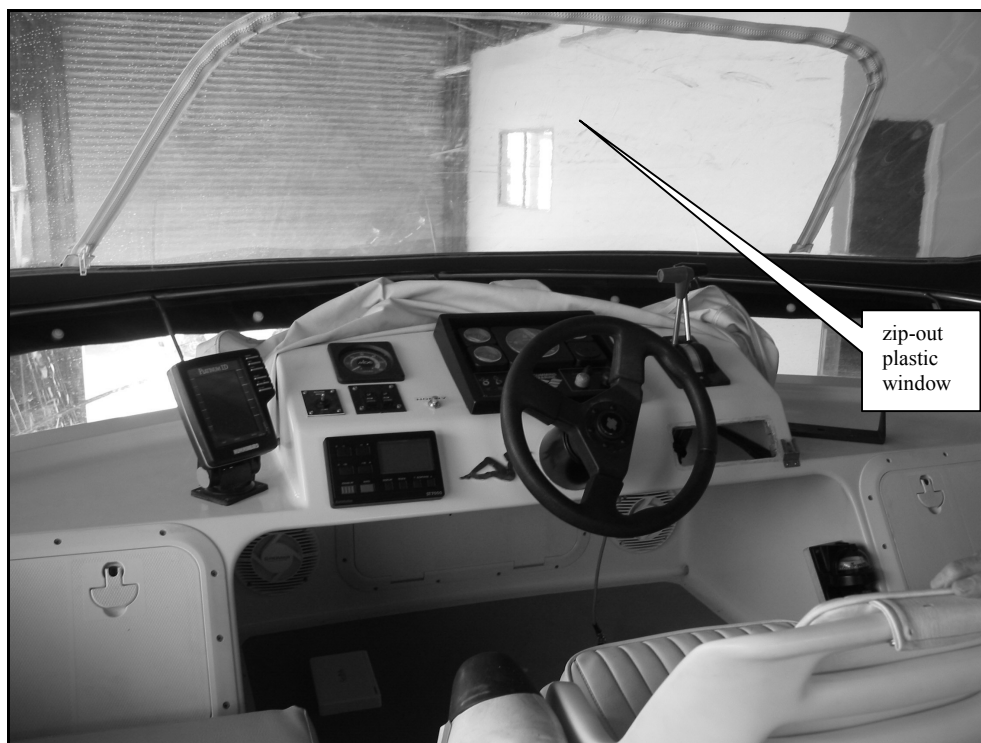
Figure 4
***Barossa's* steering position**

- 1.2.8 The skipper of the *Barossa* was conning the launch from the flying bridge. The steering position was towards the forward end of the flying bridge with a seat immediately behind the steering wheel (see Figure 4). There were clear plastic screens around the forward parts of the flying bridge. The removable zipped section immediately in front of the steering position, shown closed in Figure 4, was open at the time of the collision. At the after end of the flying bridge, the radar scanner and aerials were mounted on an arch, which was the only obstruction to all around visibility.
- 1.2.9 Two levers controlled the launch engine; one operated the gearbox to select ahead or astern and the other adjusted the speed.

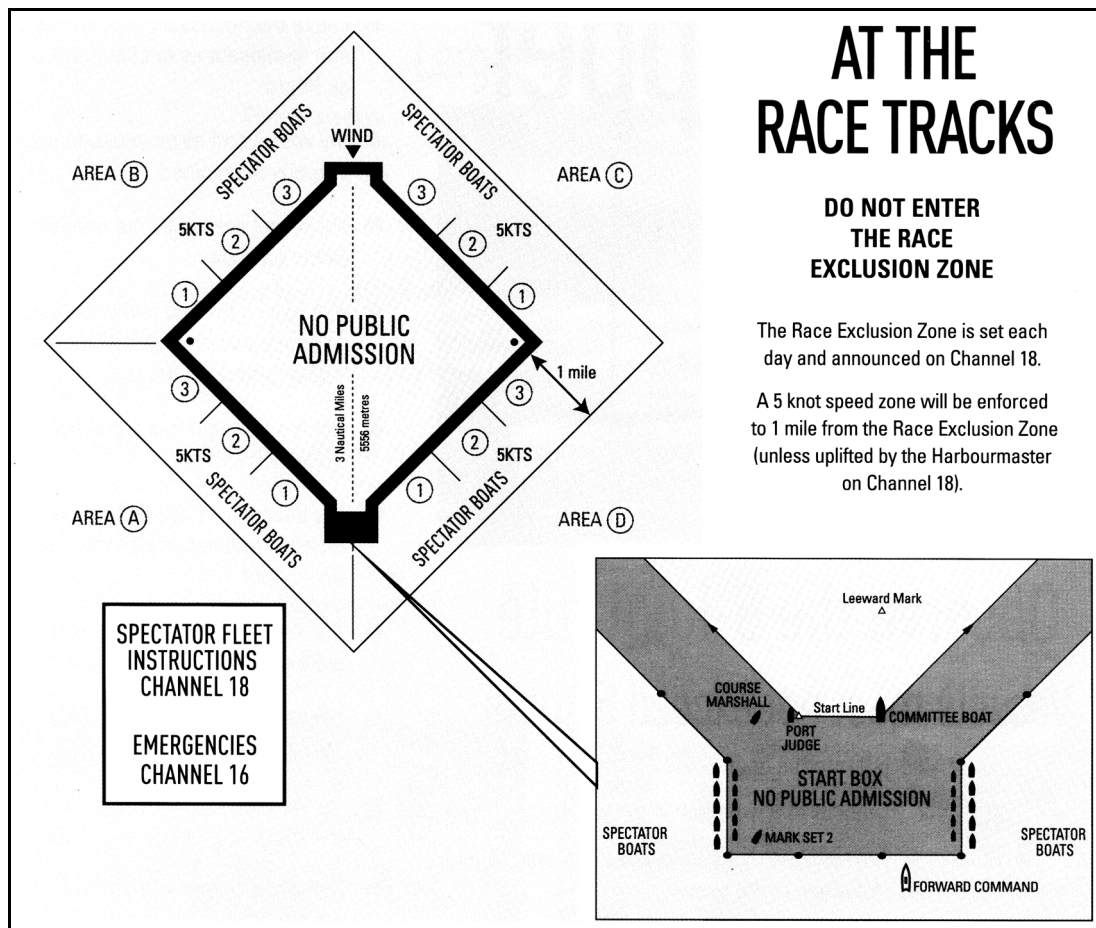
Figure 5

- 1.3.9 The racecourse was diamond shaped and was aligned to the wind direction. The windward and leeward markers were 3 nm apart and positioned close to the apexes of opposite corners of the diamond. Spectator craft were required to remain outside the perimeter of the course and a speed restriction of 5 knots was in place up to a mile off. (see Figure 5).

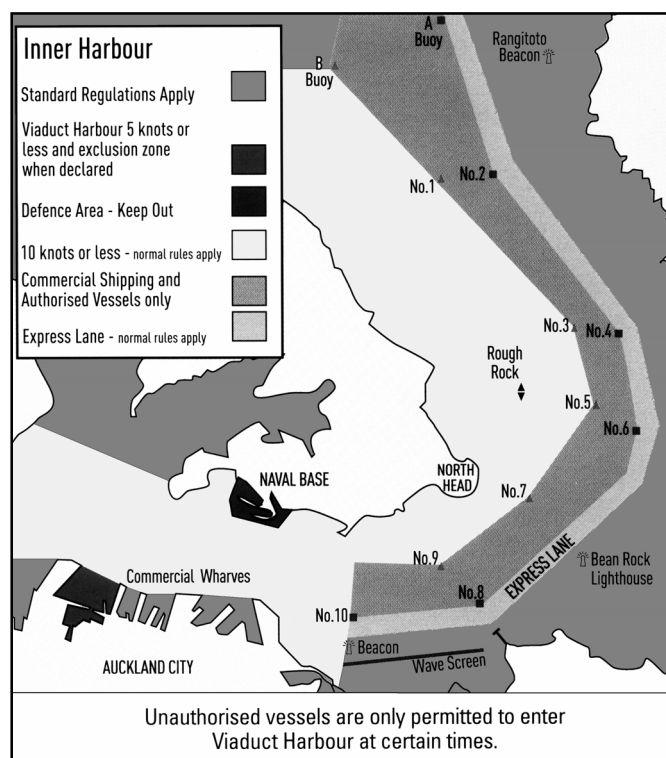
Figure 6

- 1.5.3 Under the special powers given to the harbourmaster by section 200B of the Maritime Transport Act 1994, he had divided the Rangitoto Channel into areas where the speed and type of vessel was controlled (see Figure 6):

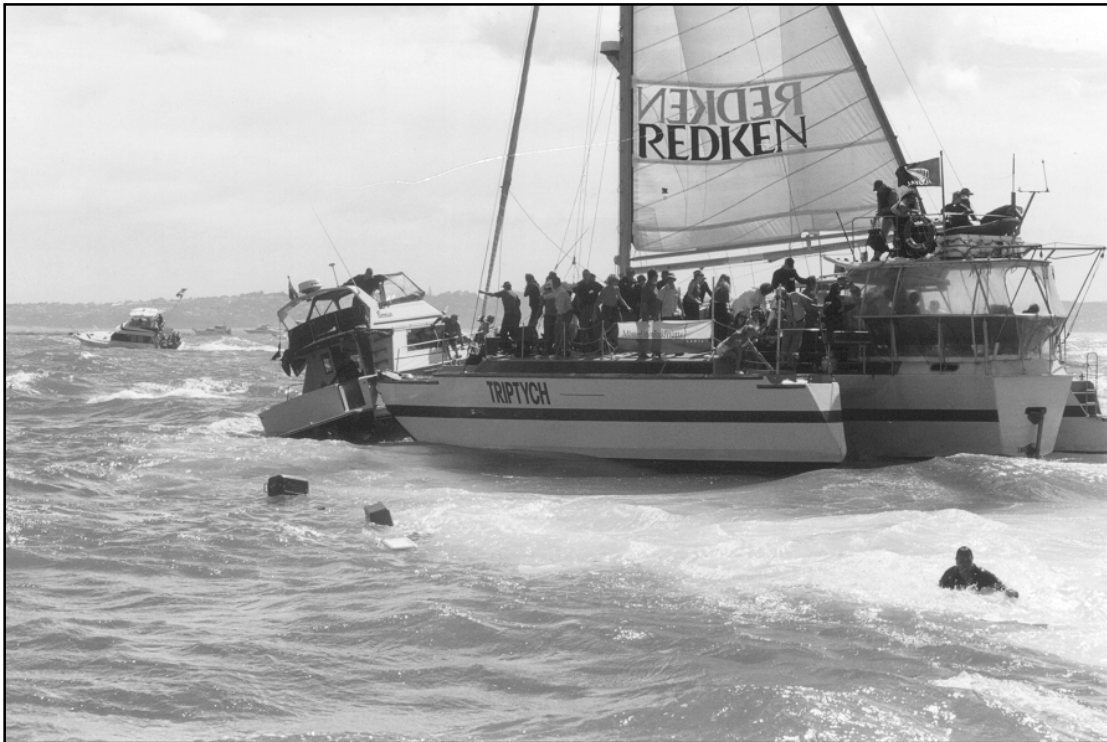
Figure 7

- 1.5.6 The 10-knot speed limit was below that necessary for planing and semi-displacement boats to achieve the plane and consequently they would have been less directionally stable and more liable to roll heavily than if they were at their normal service speed. The *Barossa* was reported to have taken a heavy roll to starboard shortly before the collision. A launch, of similar design to the *Barossa*, can be seen rolling heavily beyond the coupled vessels in Figure 7.

- 2.8 When the anchor pierced the hull of the *Barossa*, it became caught under the launch's deck. The forward momentum of the trimaran caused the launch to roll heavily to port. The trimaran did not over run the launch because the anchor remained fast and stopped the launch capsizing. If this had not happened, the launch would have been rolled over completely and probably run over by the trimaran, which might have led to the launch sinking. When the launch was cast across the front of the trimaran, it acted as a brake and reduced the forward momentum of the vessels, assisting the trimaran to stop. When the trimaran stopped and reversed under the astern engine power, the anchor, which was caught under the deck of the launch, pulled the launch upright before the vessels separated.

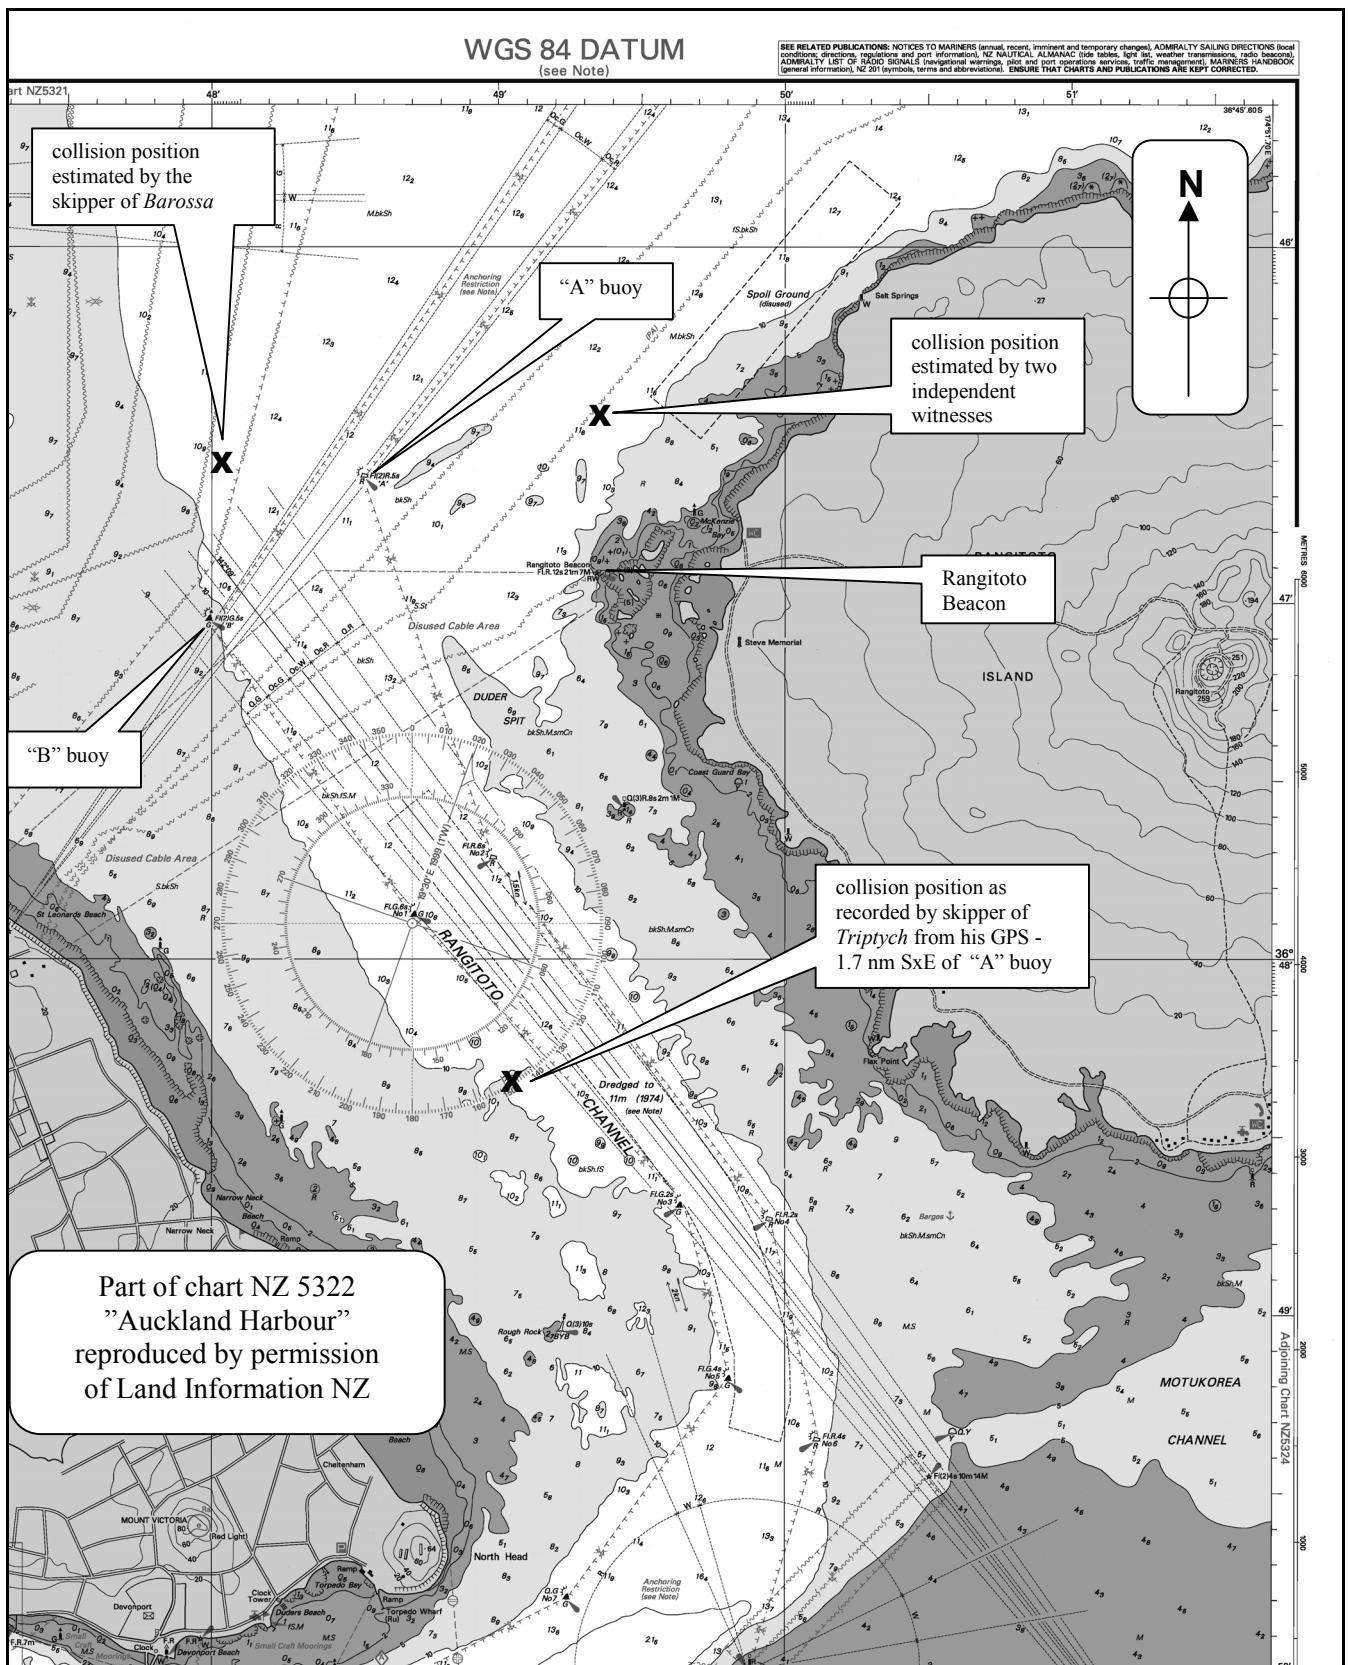
Figure 8
Chart of Rangitoto Channel showing disparity of the estimated positions of the collision

- 1.7.2 After the collision, the skipper of the *Triptych* took a position from his GPS, 36° 48.35'S 174° 49.05'E, which put the collision inside the channel and about 1.7 nm south-by-east of "A" buoy. The skipper of *Barossa* assessed his position to be 0.4 nm north of and midway between "A" and "B" buoy. Other witnesses, including the police unit that attended the accident, noted the position of the collision as north of the Rangitoto Beacon, just outside the Rangitoto Channel. Contemporaneous photographs appeared to confirm that the collision occurred to the north of "A" buoy.

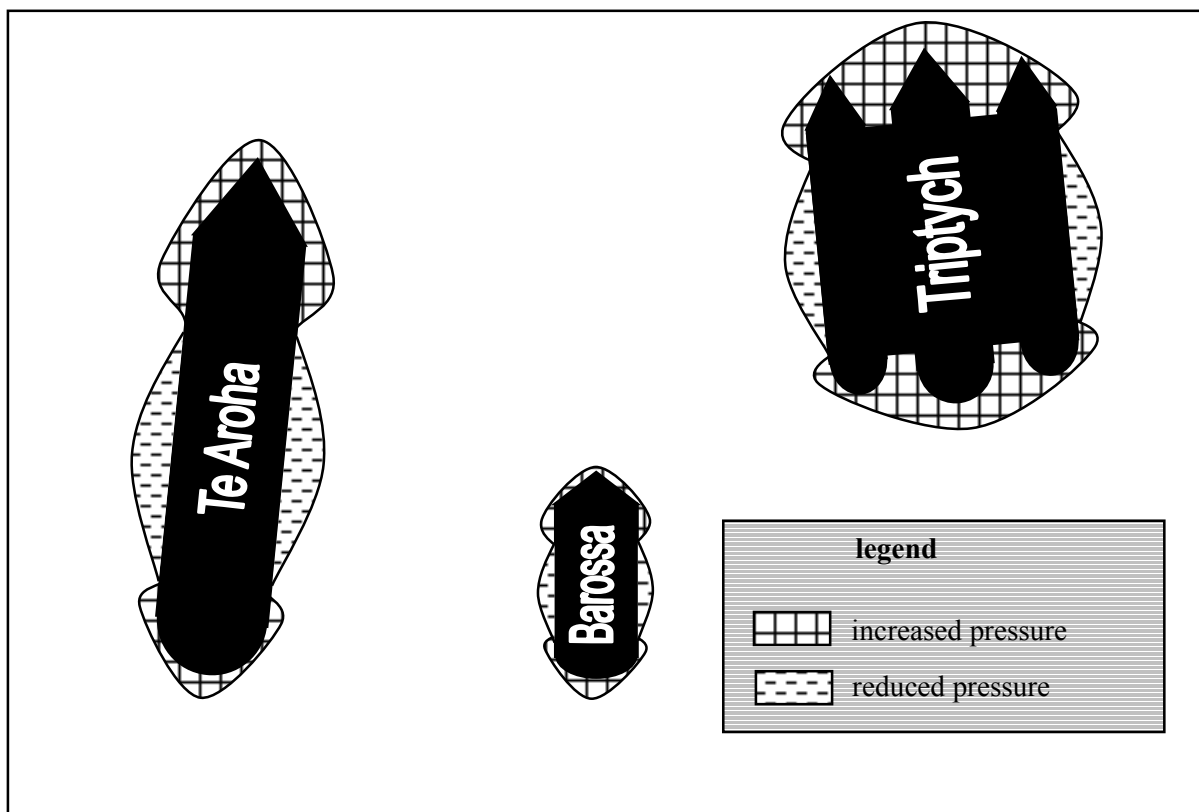
Figure 9
Illustration of hydrodynamic pressure waves created by vessels moving through the water

- 1.9.1 Bernoulli's theorem stated that the pressure of a fluid at a point is dependant on its speed past that point. When a vessel moves through the water, an increase in water pressure occurs at the bow and, to a lesser degree, at the stern. At the same time, there is a reduction in pressure amidships (see Figure 9). When 2 or more vessels are operating in close proximity, interaction between the varying water pressures about their hulls can cause rapid and unexpected loss of control and direction of one or more vessels.

- 1.9.2 A small vessel is usually at greater risk of being affected than a large vessel. The extent of the interaction depends upon the speeds of the vessels, the distance between them and the depth of water. On this occasion, the *Barossa* was travelling at just below 10 knots and was passing through a narrow gap between the 2 larger vessels and so was liable to be affected.
