M A R I N E O C C U R R E N C E R E P O R T

03-207

fishing vessel *Solander Kariqa*, fire, 300 nautical miles west of
Suva, Fiji

5 May 2003

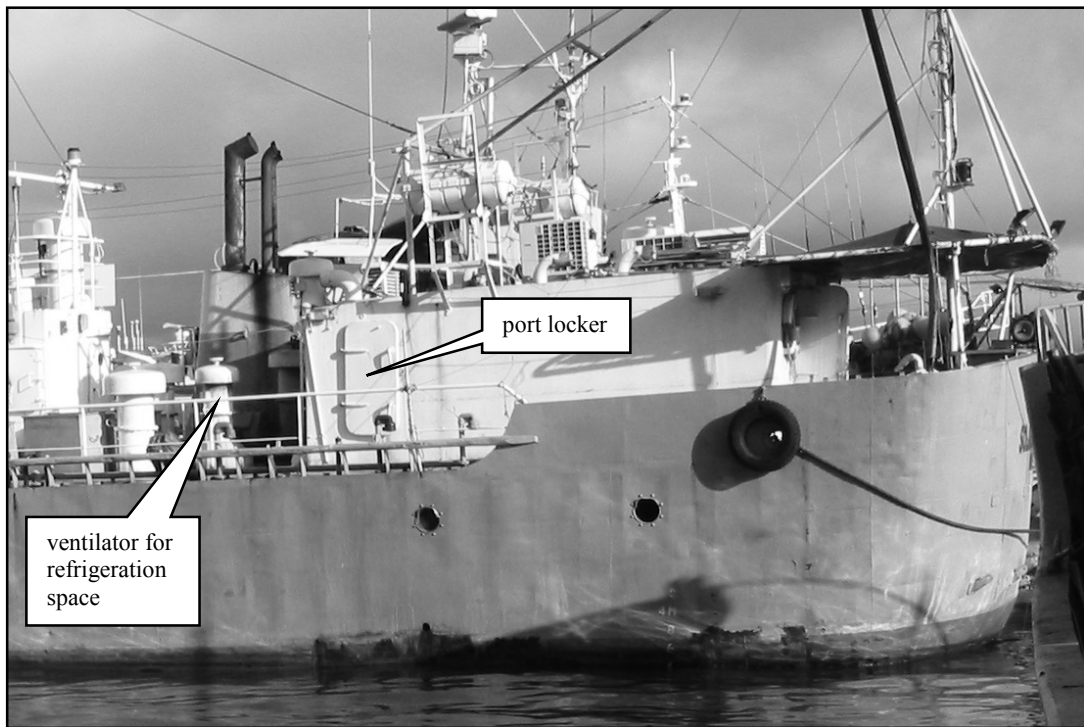
Figure 4
Port afterdeck of *Solander Kariqa*

- 1.6.8 At about 0800, it was noted that the deck in a locker on the port side (see Figure 4) of the aftercastle was getting hot, so water was sprayed into this space to assist boundary cooling. The flaps on the ventilators on the afterdeck were closed but smoke continued to exude from the ventilator that serviced the refrigeration space and the galley. The second engineer unbolted and removed the top of the ventilator and the crew sealed the trunking with a plywood plug and plastic bags.

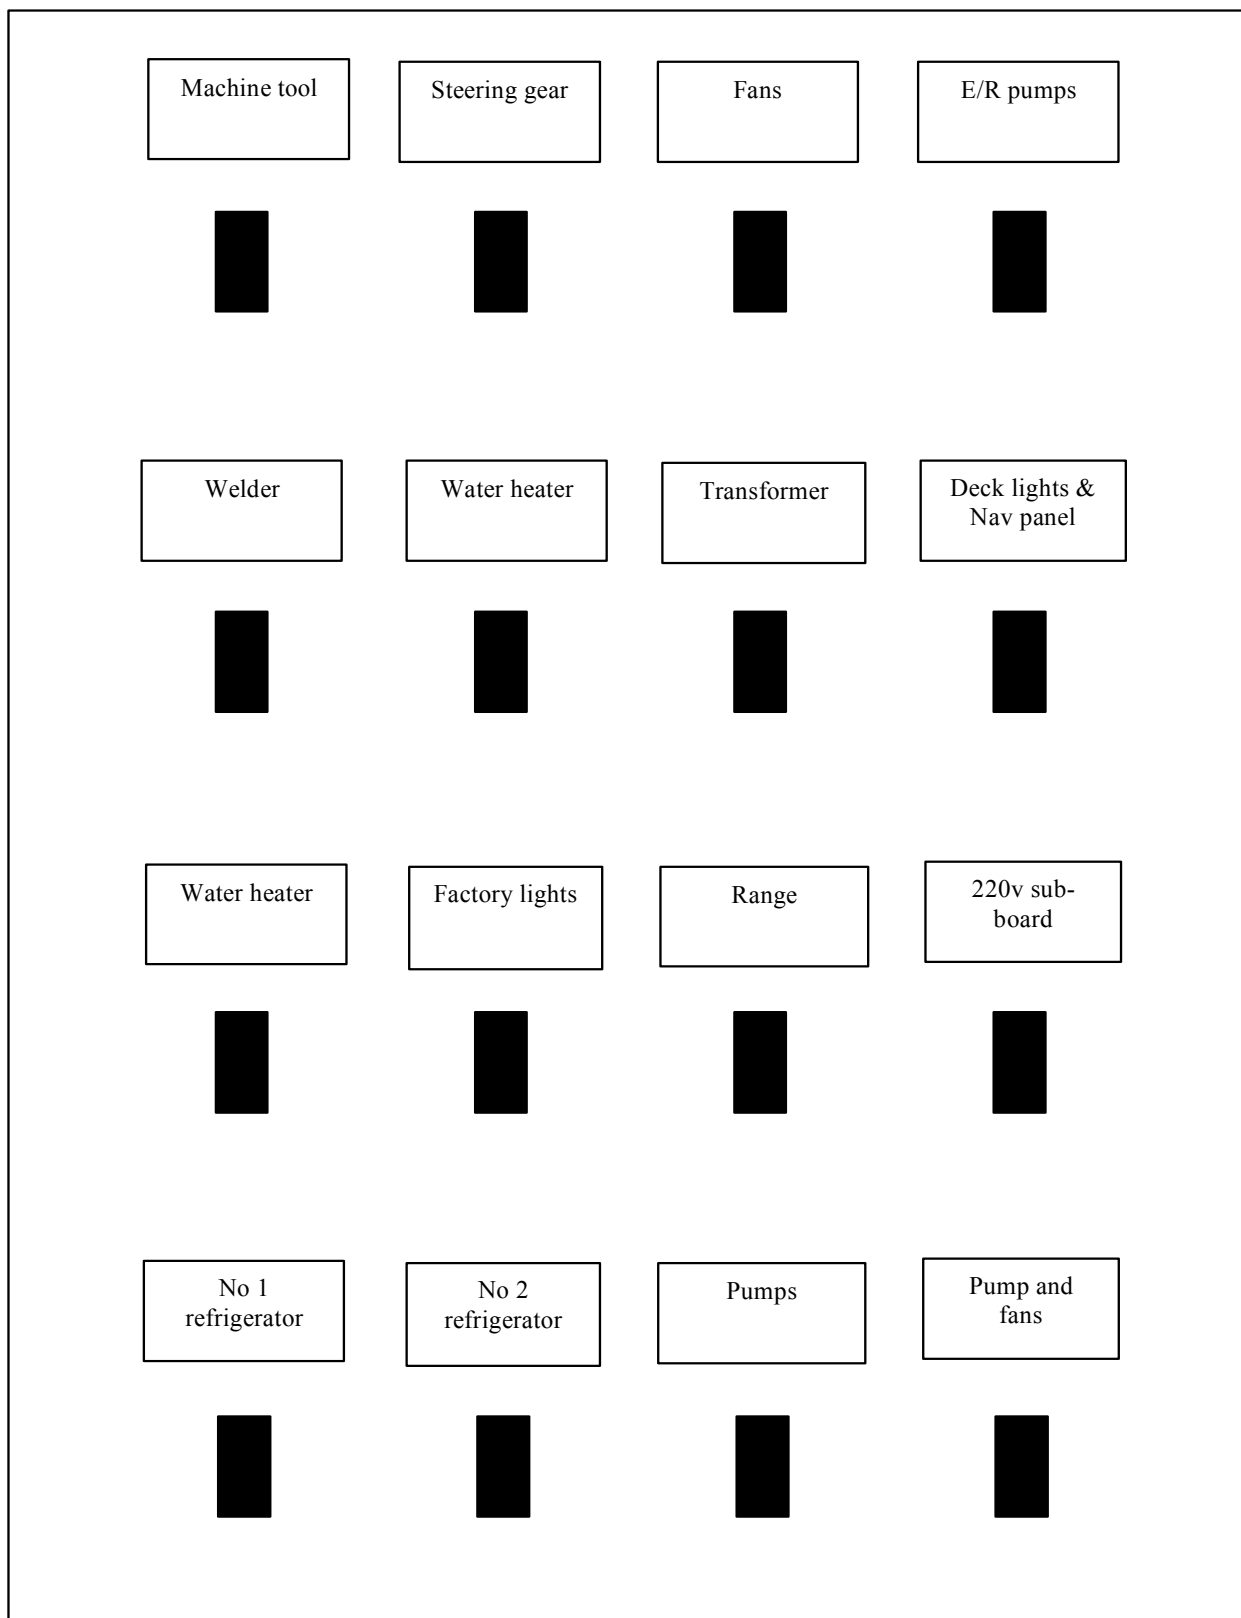
Figure 5
Layout of circuit breakers on the upper centre section of the switchboard showing the main circuits that they protected

1.6.15 During the entire period the ship's engines continued to propel the vessel and full electrical services were maintained. The chief engineer was concerned that if the main 220v AC accommodation circuit were turned off the vessel would lose its steering gear. However, the

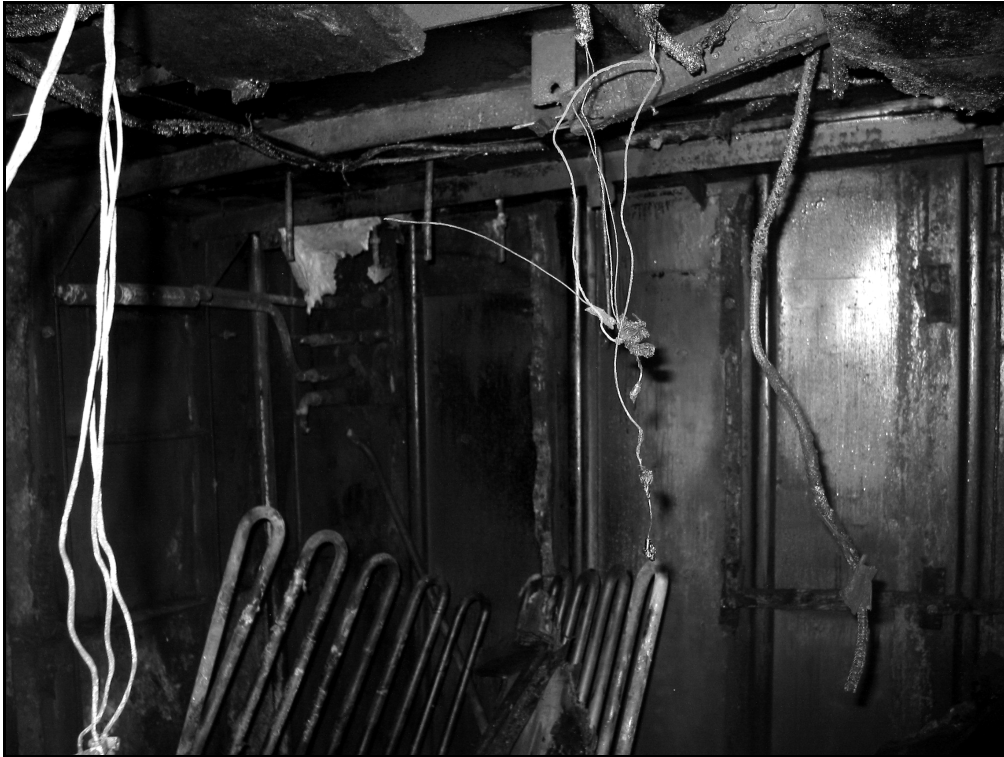
- 1.7.1 The accommodation was extensively damaged by smoke and fire. The refrigeration space was gutted with almost all combustible materials being spent. In the galley/messroom area, a large section of structural timber, and bulkhead and deckhead panelling were burnt, with fire damage to electrical cables and plastic water pipes that ran through the area. The whole of the accommodation, including those cabins whose doors were closed throughout, was smoke damaged. Most of the appliances in the messroom were destroyed.

Figure 6
Refrigeration space showing fallen coils and hanging wires

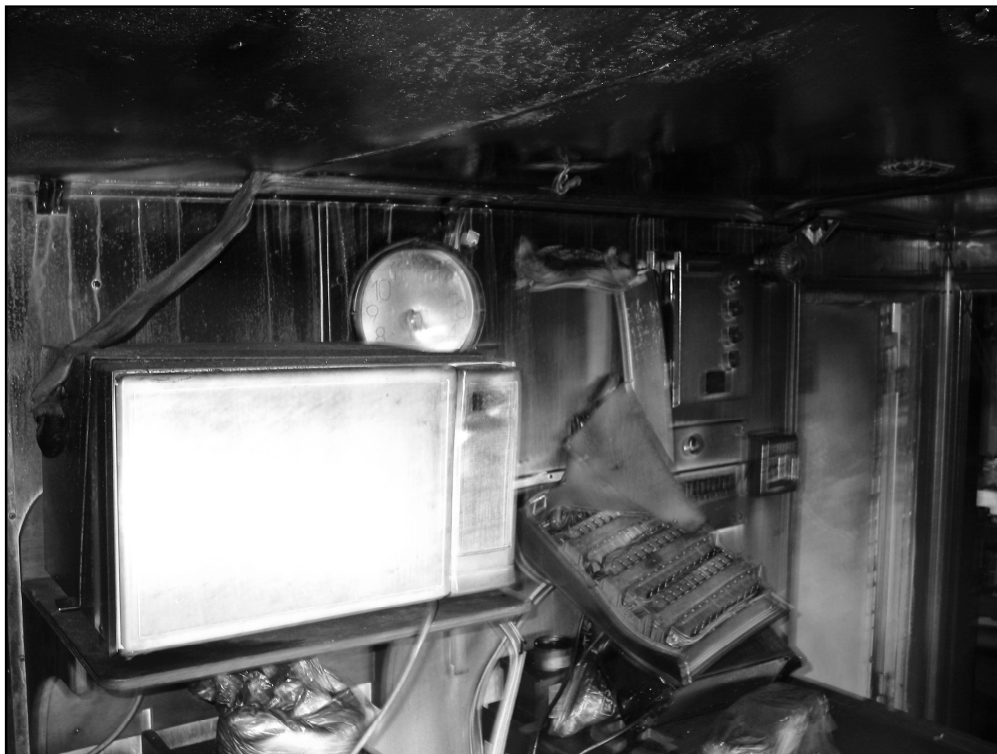
Figure 7
Forward bulkhead of the messroom showing microwave, melted clock and circuit breaker cabinet

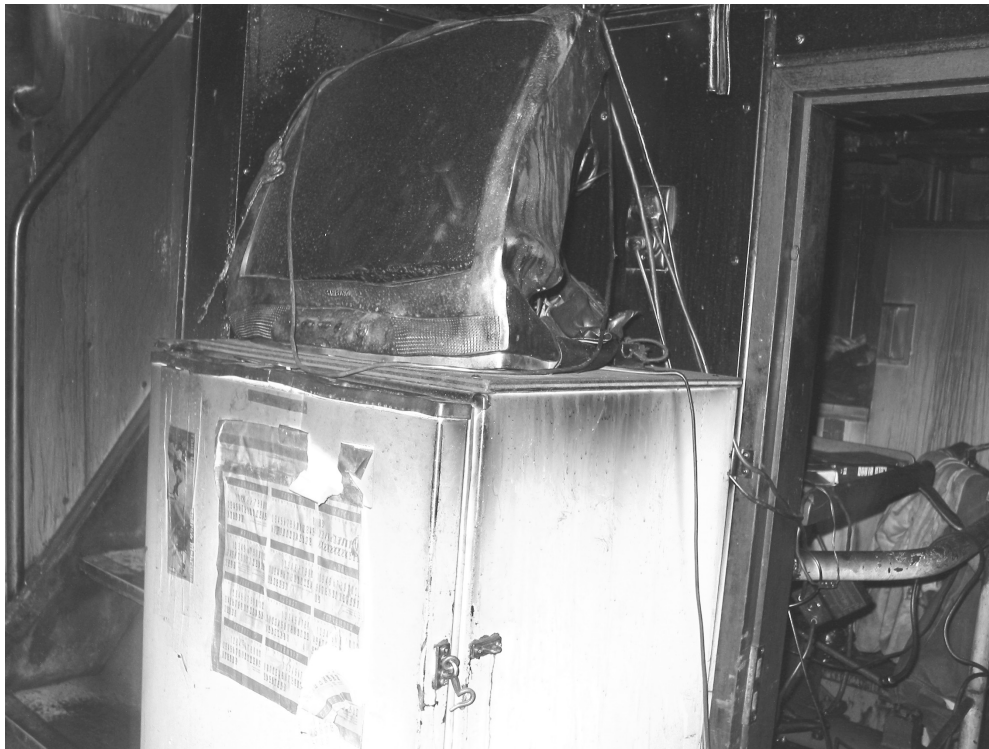
Figure 8
Refrigerator by doorway into steering gear, with melted television on top
