## MARINE OCCURRENCE REPORT

03-212

container ship *Spirit of Enterprise*, touching bottom and loss of rudder, Manukau Bar

16 August 2003

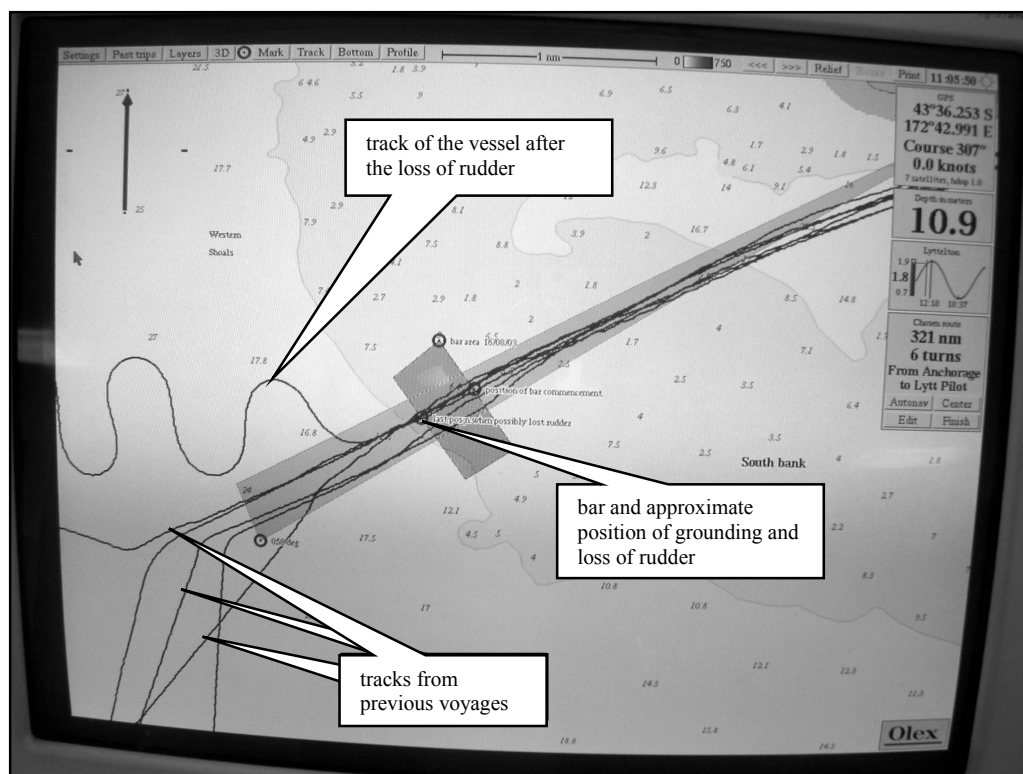
**Figure 3**  
**The track of the *Spirit of Enterprise* as recorded on the electronic chart system**

- 2.7 With the loss of the rudder, the ship lost directional control. Initially the bow paid off to starboard under the influence of the wind and the waves. When the ship came beam on to the wind, the tall accommodation at the after end of the vessel acted like a sail and caused the ship to turn to port, into and through the wind until it again came beam on. This time the wind was on its starboard side and the sail effect caused the ship to turn to starboard. The ship continued these oscillations until the master used the bow thruster to steady the ship's head. Once it was steady he was able to con the ship away from the coast into safety. It was fortunate that the accommodation block did act as a sail; otherwise the ship may have completed its turn to starboard and grounded to the north of the bar.

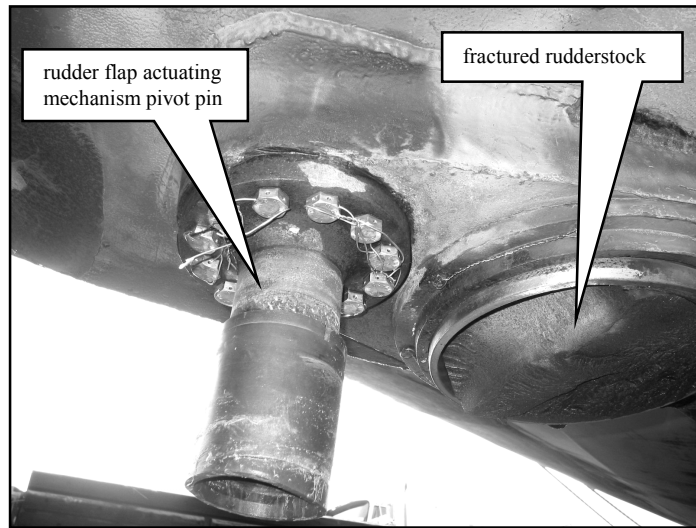
**Figure 4**  
**Rudderstock and rudder flap actuator mechanism pivot pin**

- 1.2.3 The ship was in class with Bureau Veritas, and Pacifica Shipping used Germanischer Lloyd to audit the International Ship Management system.
- 1.2.4 The ship was fitted with a "Becker type" high-lift rudder manufactured by the engineering company Gurdesan Limited of Turkey. The rudder had an active trailing edge, or flap, that increased its turning efficiency. The flap actuating mechanism pivoted about a pin fixed to the hull immediately behind the rudderstock (see Figure 4).

- 1.2.5 The billet of steel from which the rudderstock had been manufactured had a test certificate which gave a yield strength of 417.2 N/mm<sup>2</sup> (MPa) and a tensile strength of 801.4 N/mm<sup>2</sup> (MPa). The Bureau Veritas rules extant at the time of construction contained a formula to determine the minimum size of a rudderstock assuming that standard (mild) steel of tensile strength of 400 MPa was used. This formula was complex and took into account many factors including; area of the rudder, length of the rudder, distance of the trailing edge of the rudder from the rudderstock, speed of the ship both ahead and astern, type of rudder and whether it had an active flap. Where steel of different characteristics was used, the Bureau Veritas rules granted a reduction of rudderstock diameter, calculated from an additional formula. The *Spirit of Enterprise* rudderstock had a final maximum diameter of 415 mm and Bureau Veritas confirmed that at the time of manufacture, this was in compliance with its rules.

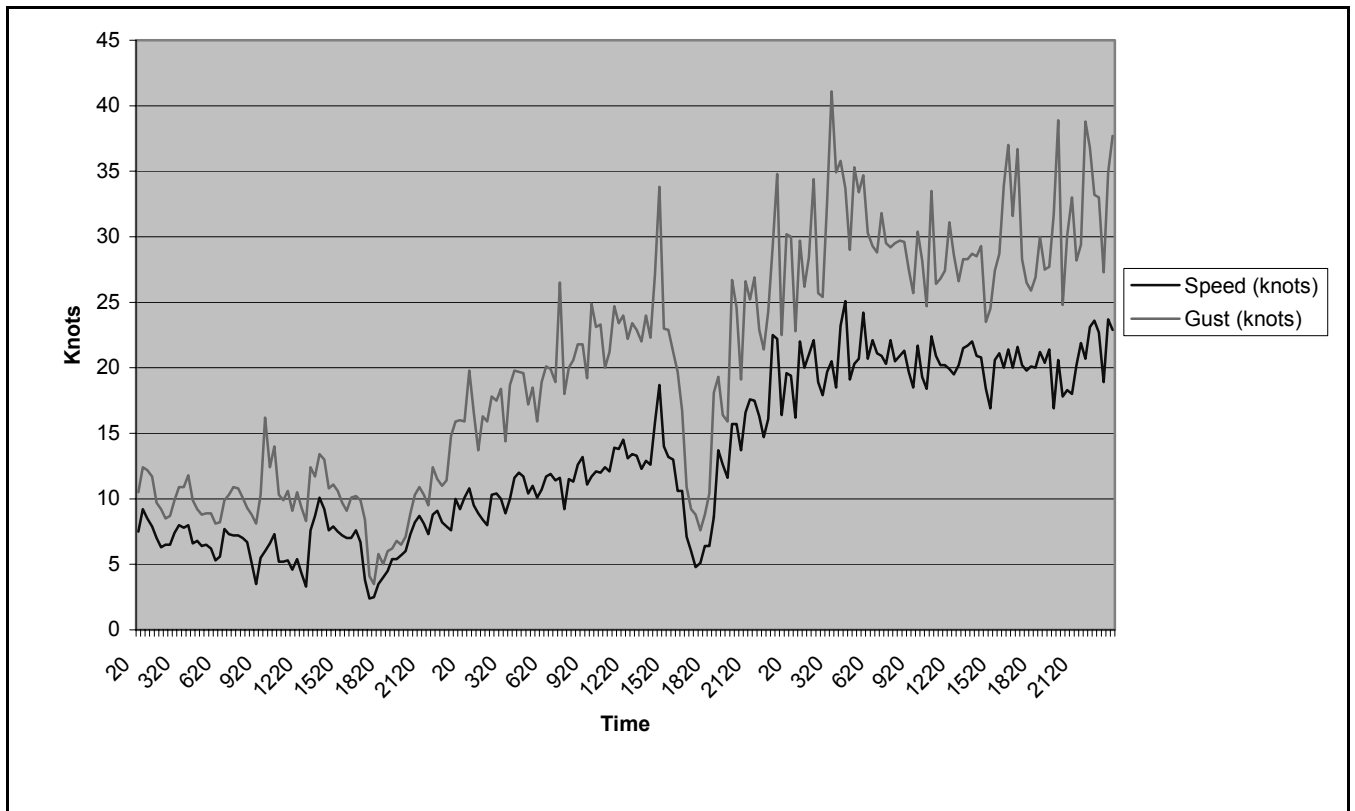
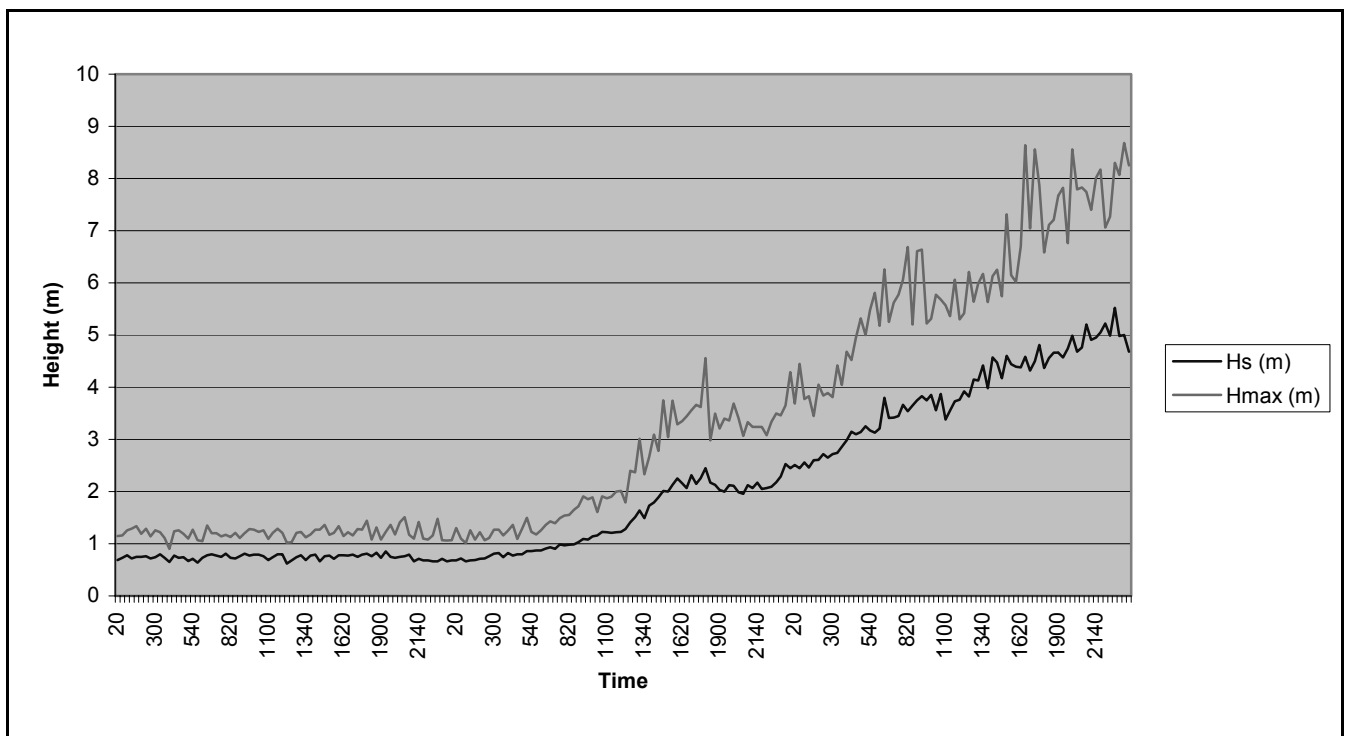
The graphs in Figures 6 and 7 show the trend of the wind speed and swell heights at Taharoa between the 14 and 16 August 2003.

The graphs indicate that the swell height increased the longer the wind prevailed from one direction. This information was not available to the signalman at South Head Signal Station or POAL.

5.1.1 provide accurate sea condition information to masters and pilots of ships transiting the Manukau bar. In the first instance he should endeavour to gain access to the data from the Taharoa wave rider buoy, either in real time or within one hour of its measurement. (020/04)

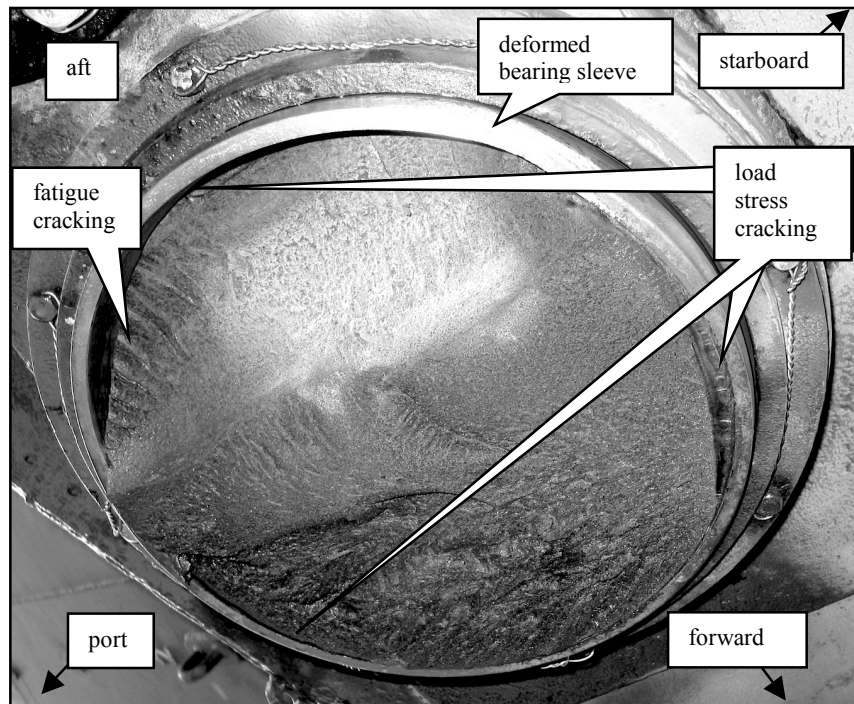
**Figure 9**  
**Fractured surface of the rudderstock**

- 1.8.1 On 26 August 2003 the remaining upper section of the rudderstock was sent to a metallurgist for analysis of the fracture surface. The analysis noted that the rudderstock had fractured on 2 planes, just outside, and about 1 cm inside the stainless "shrink fit" bearing sleeve. On the planes of the fracture there were areas of load stress cracking on the forward starboard and port sides of the stock and on the after part (see Figure 9). From the pattern of the fracture surface, the metallurgist deduced that the penultimate fracture had occurred at the after part cracking aft to forward and the ultimate fracture propagated from the starboard side load stress crack towards the port side. The final failure would probably have been fast (a cleavage fracture).

- A The rudderstock had been made from carbon steel (AISI 1060) having an ultimate tensile strength of the order of 700 MPa.
- B Failure occurred as a consequence of corrosion-fatigue cracking at a number of positions around the surface of the shaft.
- C Fatigue cracking resulted in the spread of these cracks.
- D Final failure by overload had occurred by a cleavage (fast, brittle) failure mechanism.

- 1.8.5 A second metallurgist assisted the investigation with interpretation of the metallurgy report. His view was that the penultimate fracture was the one that propagated from the load stress crack on the starboard side with the ultimate event being the fracture at the after part of the rudderstock propagating from forward to aft. He agreed that final failures would have been very fast, almost instantaneous, and caused by a significant force. He also suggested that high-strength steel was more susceptible to corrosion in salt water and that it was less ductile, making it more likely to crack rather than bend when an unusual force was exerted on it.

- 1.8.6 The after section of the stainless steel bearing sleeve was deformed outwards, that is towards the stern (see Figure 9).
- 1.8.7 There was severe denting, piercing and tearing of a weld on the plate work on the underside of the after end of the rudderstock housing, approximately in line with the after extremity of the flap actuator gear attached to the top of the rudder and to the port side of the centreline (see Figure 10). There was no damage to the vessel other than that associated with the loss of its rudder.

put in place an inspection regime to check for load stress cracks in rudderstocks made from high-grade steel that were manufactured to comply with the 1996 rules. (022/04)

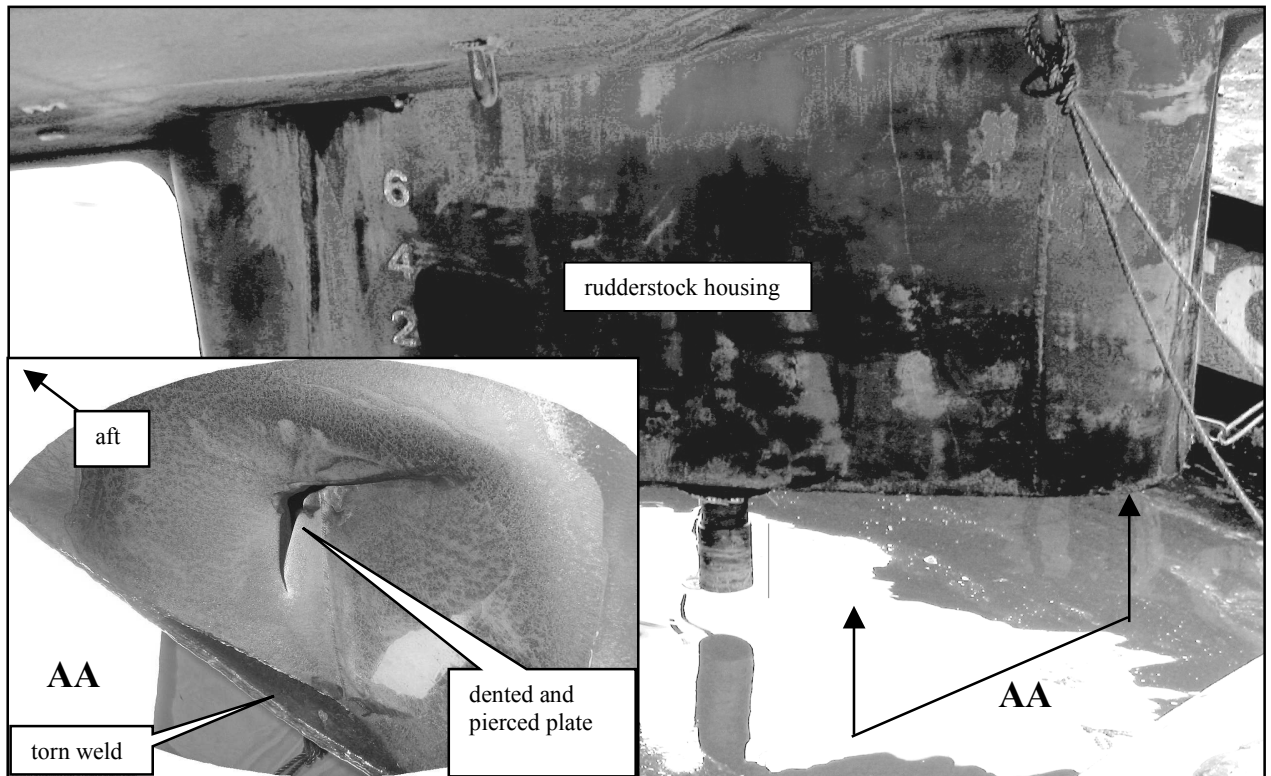
**Figure 10**  
**Rudderstock housing with inset AA showing the damage to underside**

- 2.1 The extent and severity of the damage to the underside of the rudderstock housing indicated that the flap actuating mechanism on top of the rudder was driven up into the plate work with some considerable force, not consistent with the rudder just falling off.

- 2.2 The deformed stainless steel bearing sleeve indicated that the rudderstock had been bent towards the stern, either before or during the fracture event. The physical evidence indicated that the bottom of the rudder made contact with the seabed and that, with the combination of the ship's momentum, pushed the rudder upwards and backwards into the rudderstock housing.

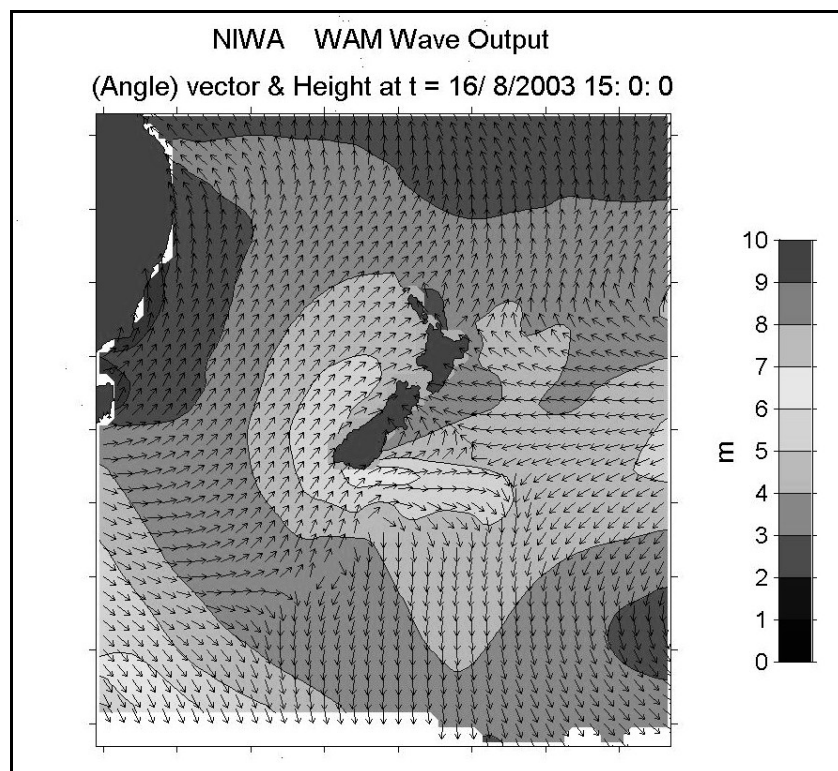
**Figure 11**  
**Wave direction and height from wave model**

- 1.9.4 The NIWA scientists used a wave model (WAM) to predict the waves around the New Zealand coast for the days either side of the accident (see Figure 11). From that model they concluded that at 1500 on 16 August there were 4.0 m waves from a south west direction. They also considered the data from the wave buoy at Taharoa, and a wave model from the National Ocean and Atmospheric Administration of the United States of America. The trends in each of the models were similar, but the wave buoy gave a higher wave height than the model at the time of the accident.
